Professional Real Estate Inspector Sam Hestand TREC #24118

Date: 07/07/2023

# PROPERTY INSPECTION REPORT FORM

1011 Whitestone Ln, Houston, TX 77073

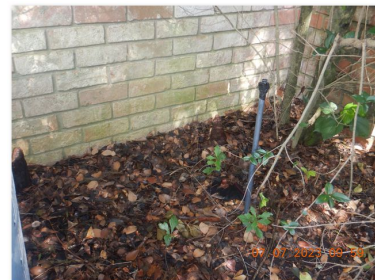
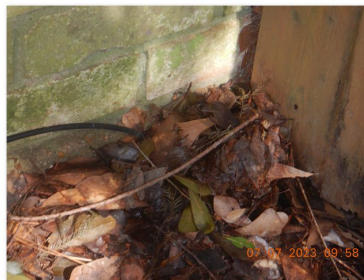
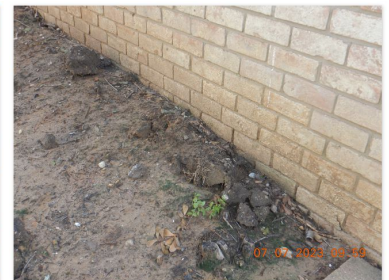
High soil levels exposed under brick surfaces.

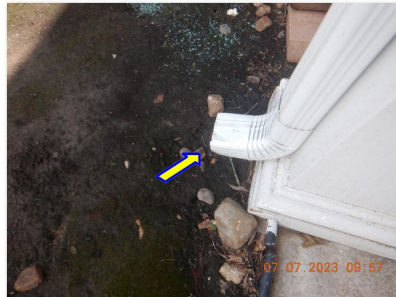
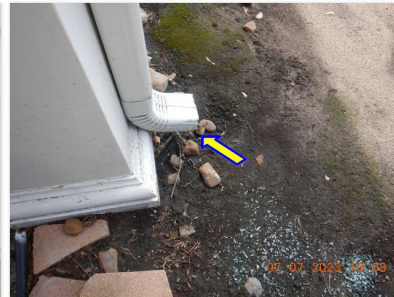
Splash blocks should be placed in areas where water can accumulate near the foundation edge. The discharging of the rainwater from the gutters needs to be directed away from the foundation edge.

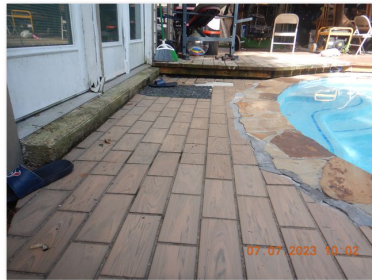
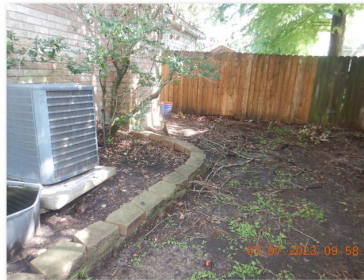
The drainage and grading around this home is inadequate. In order for the drainage to be effective, the landscaping must be configured so that the yard is sloped away from the foundation by at least 6 inches in the first 10 feet and/or adding additional gutters/downspouts to the house is another option to improve drainage and/or in- ground drains should be designed and added to divert rainwater and runoff away from the house as appropriate and/or drainage swale should be improved/installed.

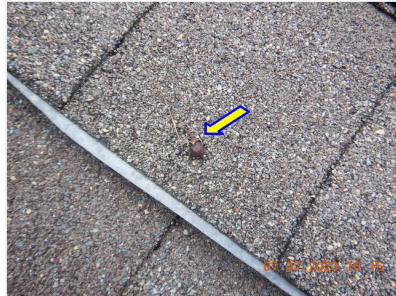
Nail heads are exposed at the flashing and/or composition shingle.

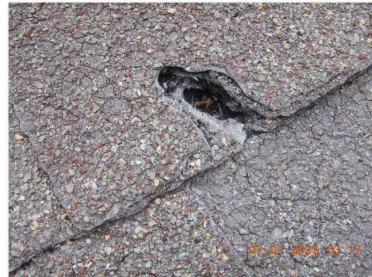
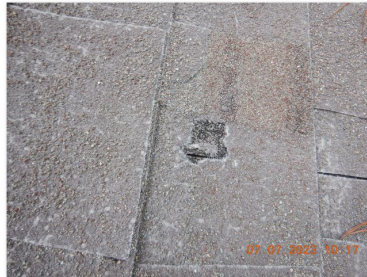
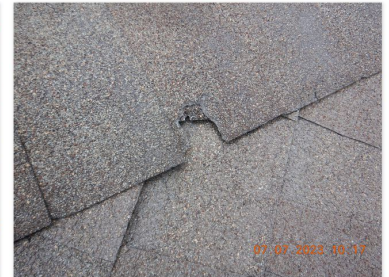
Scuffed and/or damaged shingles were noted.

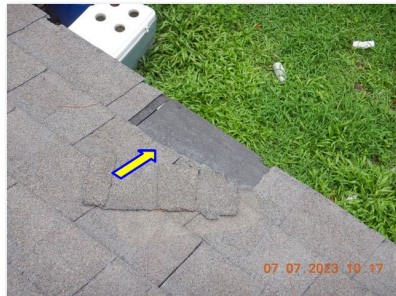
Weathered and/or wind damage and/or missing shingle tabs was noted.

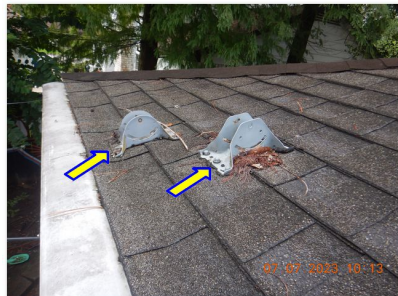
Note: Multiple satellite dishes have been installed on the roof. Some satellite dishes and/or mounting brackets have been abandoned. These penetrations should be caulked at the fasteners.

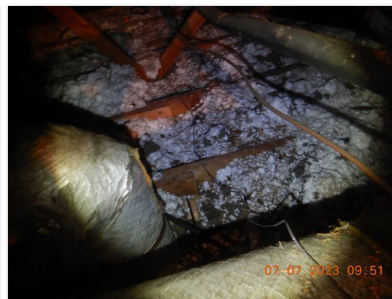
Redistribute insulation where missing or moved at the attic floor.

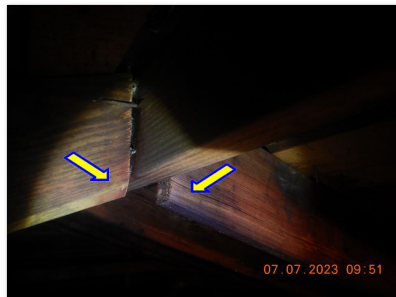
Ridge boards are undersized. The ridge boards should be the depth of the rafter end cuts.

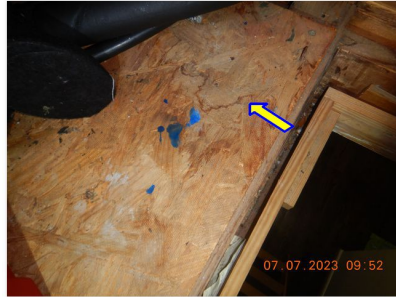
- ☑ Evidence of moisture stains was noted. This was dry at the time of inspection.
- ☑ Insulation is missing on the condensate drain line and/or water lines in the attic. The water and drain lines should be completely insulated in the attic.

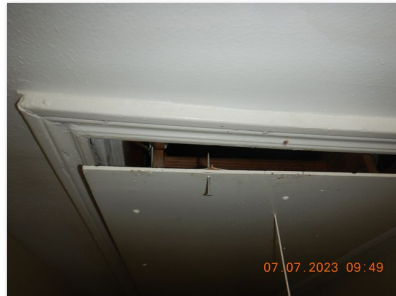
- ☑ Disappearing attic access ladder is not sealing properly at the attic.

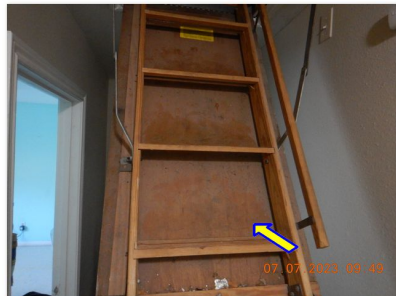
- ☑ Disappearing attic access ladder ceiling panel is not insulated at the attic.

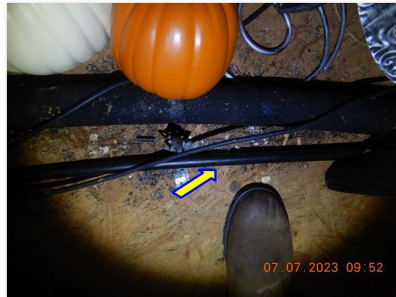
Gas pipes and/or wires and/or water lines are crossing directly over the top of the attic service walkway.

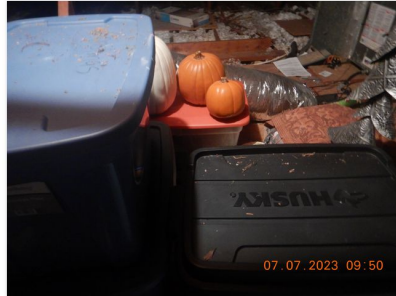
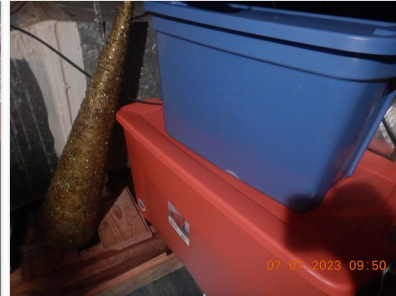
The construction debris and other material should be removed from the attic, or appropriately placed out of the way.

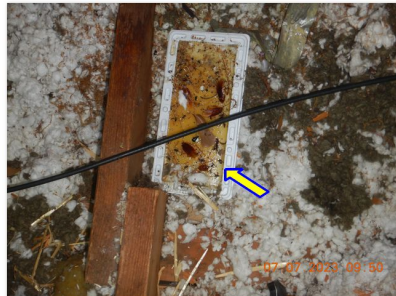
Evidence of rodent activity observed at the attic. Further evaluation by a licensed pest control company is recommended.

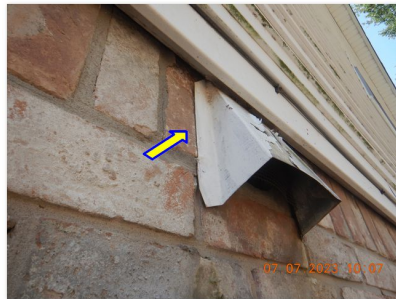
Seal around penetrations at the exterior walls.

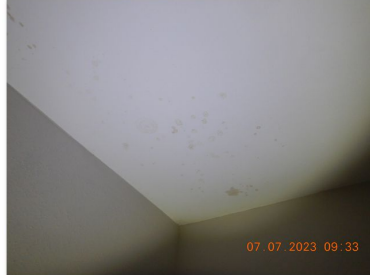
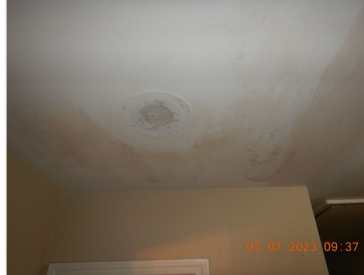
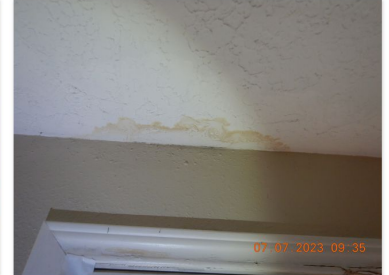
Evidence of moisture stains observed at the following locations: 1st floor water closet, Living room, 2nd floor hallway. These were dry at the time of inspection.

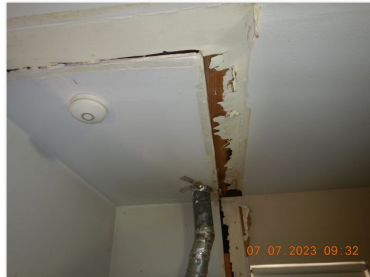
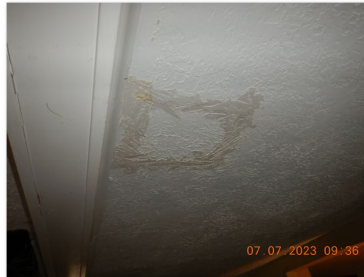
Cracks/damage/repairs in the ceiling drywall observed.

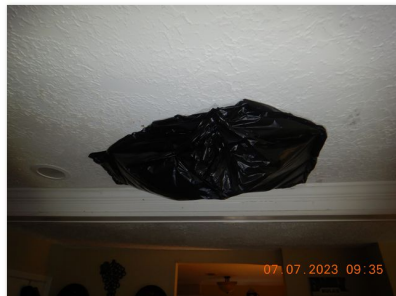
Note: A plastic bag is secured to the ceiling in the living room.

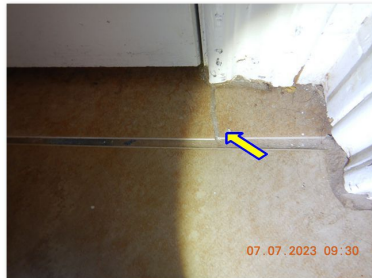
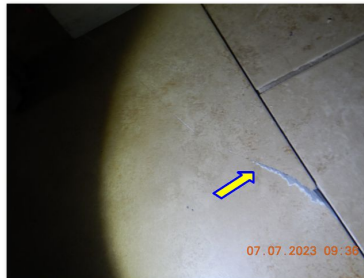
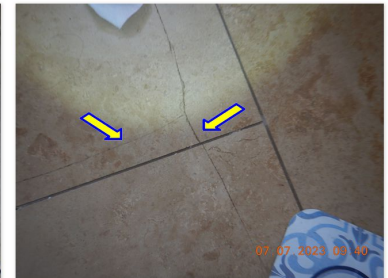
Broken or cracked floor tiles observed at some locations.

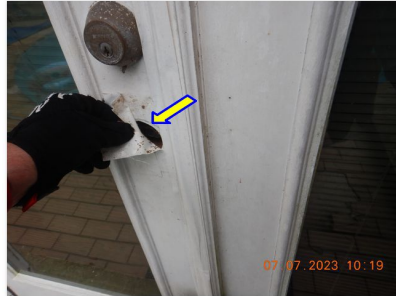
- Doors do not properly latch at the following locations: Master bathroom, 2nd floor front middle bedroom closet, Pantry, 2nd floor front right bedroom closet.
- Door out of balance and not holding desired position at the following locations: 2nd floor front middle bedroom.
- The garage entry door is damaged. This door could not be operated due to stored items being in the way.
- The back right patio doors are not opening.

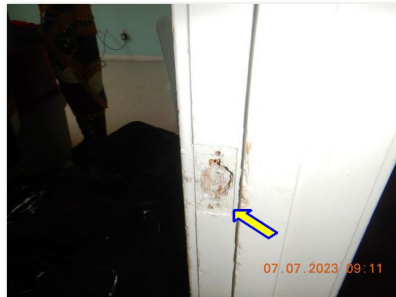
- Door knobs missing at the following locations: Back right patio door.
- Door knobs are loose at various locations.

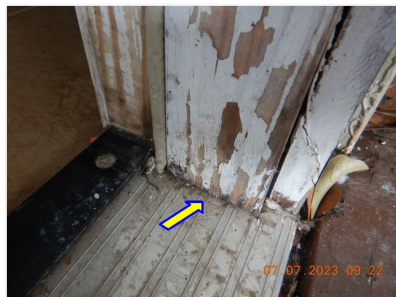
- Caulking around the door missing or deteriorated. Some Examples: Front entry, Back patio, Garage entry.

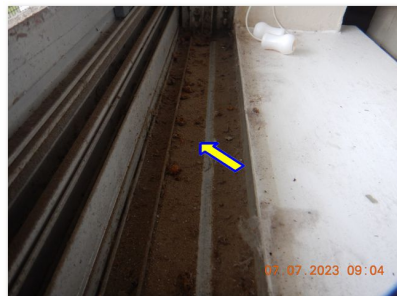
Window drainage ports obstructed with dirt and debris. Window drainage ports and other components should be cleaned on an annual basis. Otherwise, drainage ports can be blocked allowing water to back up into the wall area below the windows.

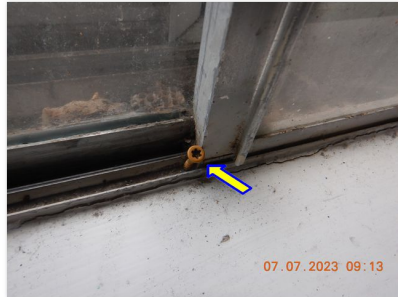
The window at the 2nd floor back right bedroom is secured shut with a screw.

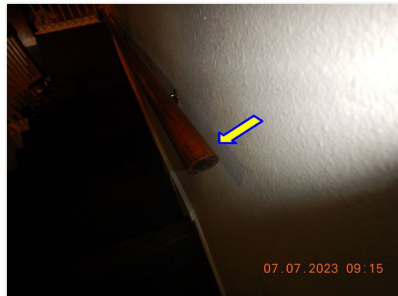
Stairway hand railing ends should terminate into the wall or newel post.

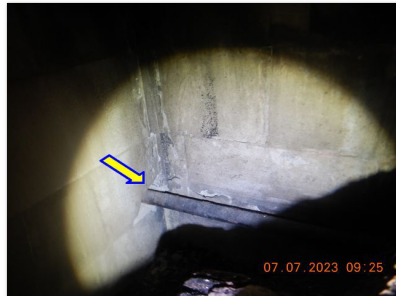
The area where the gas line enters the fireplace should be sealed.

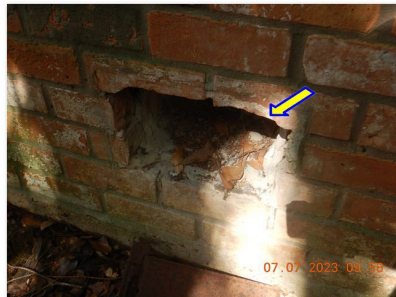
Chimney cleanout access panel is damaged.

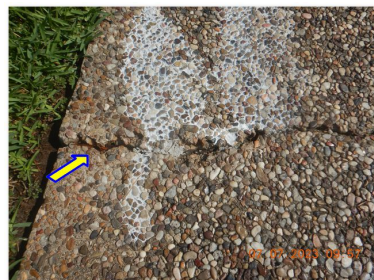
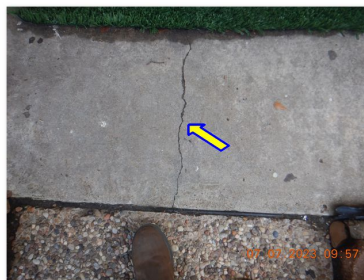
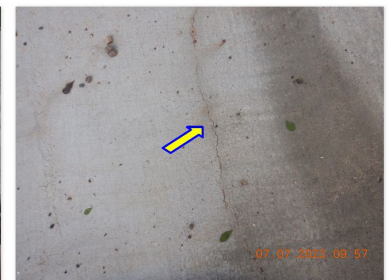
Settlement cracks observed at the flatwork at the following locations: Front walkway, Driveway, Front patio, Back patio.

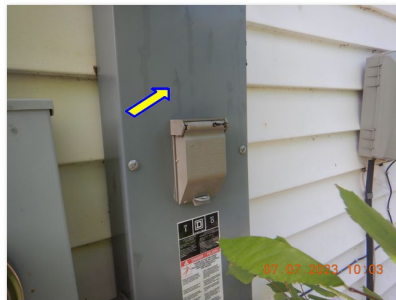
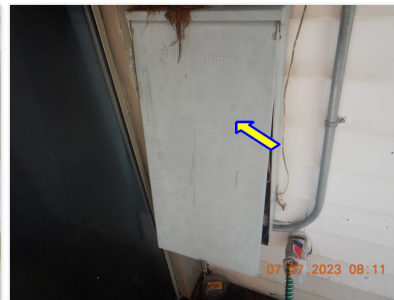
The new NEC changes state that the emergency electric shut off should be labeled with a non-removable plaque.

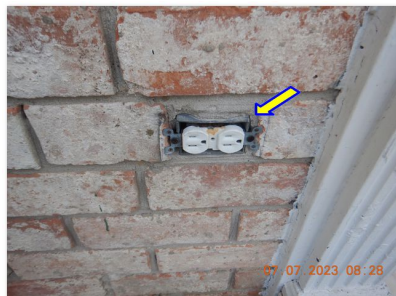
Receptacle cover plates observed broken at the following locations: Master bedroom.

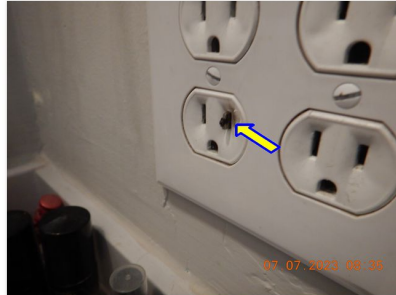
- ☑ An item is lodged in one of the outlets in the master bathroom.

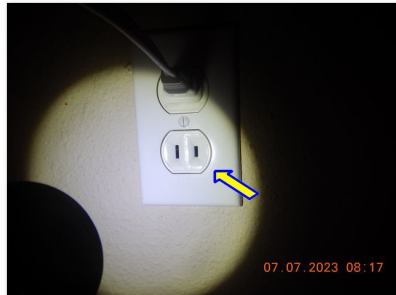
- ☑ 2 prong plugs are installed at some locations. These are a type of plug that is not grounded.

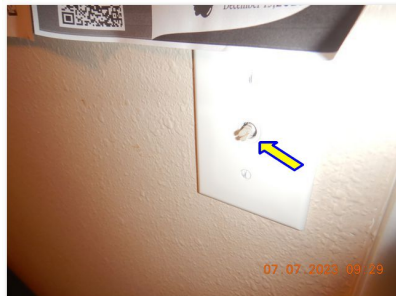
- ☑ Switch knob is missing at the formal dining room.

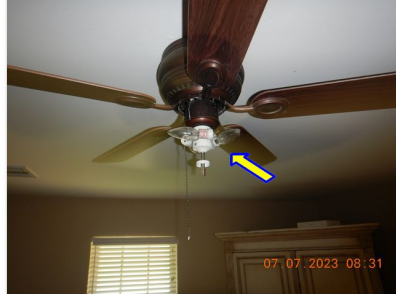
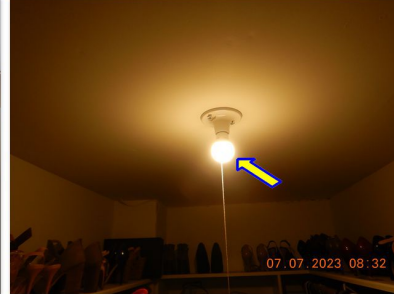
- ☑ Light fixture globes missing at the following locations: Garage, Master bedroom, Master closet, 2nd floor hallway closet, 2nd floor front middle bedroom closet, 2nd floor front right bedroom closet, 2nd floor back right bedroom closet, Attic.

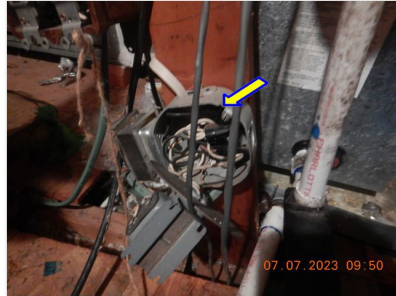
Junction box cover plates observed missing at the following locations: Attic.

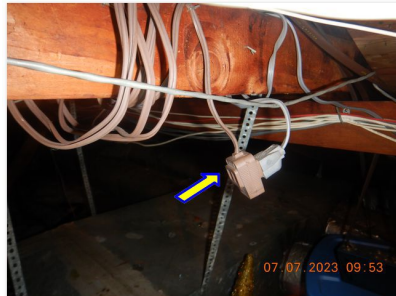
Improper use of an extension cord at the following locations: Attic.

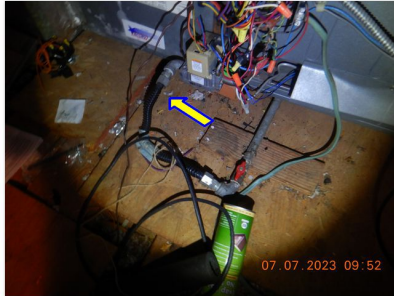
☑ Gas supply to furnace is not installed with a sediment trap at the connection to the unit.

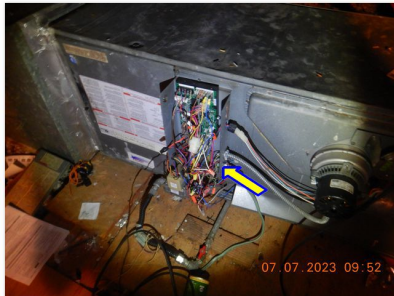
☑ Furnace access cover is not in place.

Servicing the furnace and inspecting the heat exchanger when the air conditioning system is evaluated is recommended.

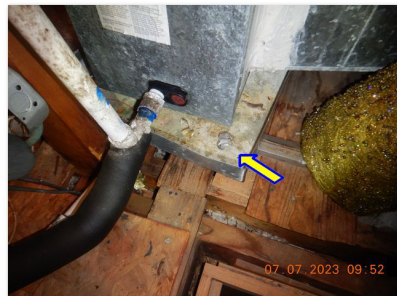
- Insulation/debris observed at the A/C auxiliary condensate drain pan.
- Recommend installing a drain line float switch in case of a primary drain line blockage or back-up.

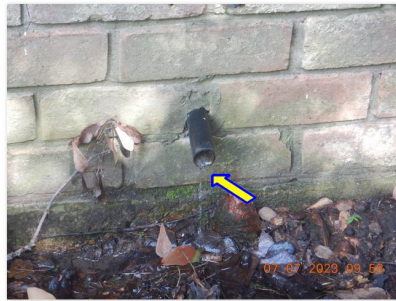
The condensate drain line is depositing water at the exterior of the dwelling. Condensate drain line should deposit into the sanitary sewer system at a sink or tub trap.

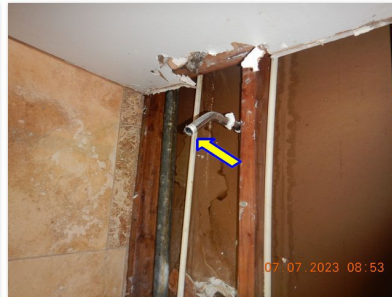
2nd floor right bathroom fixtures are missing.

The master bathroom shower handle is loose.

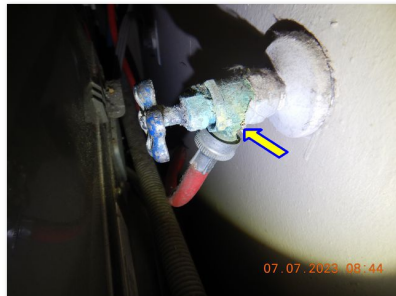
UTILITY ROOM:

Utility room washing machine bibs are corroded.

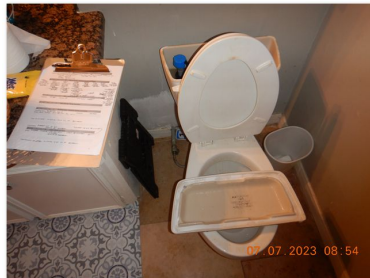
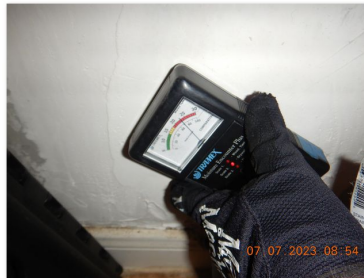
Commode area- High moisture readings were noted with the moisture meter in the tested area.

Location: 2nd floor right bathroom.

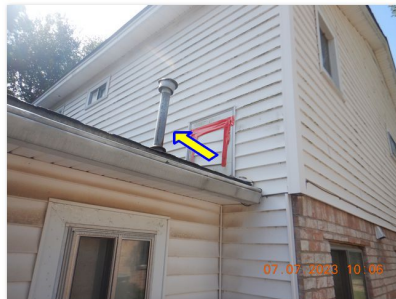
The water heater vent pipe terminates within 8 feet from vertical wall or eave at roof level.

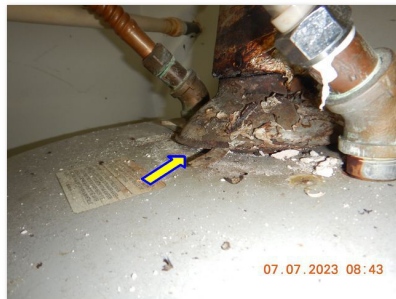
The water heater vent draft diverter is not properly secured at the top of the unit.

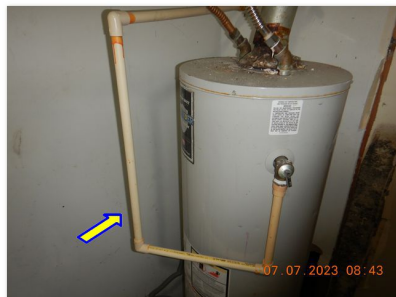
The drain line for temperature and pressure relief valve is not installed with positive flow allowing standing water to corrode the valve.

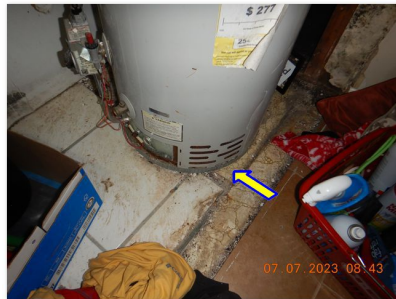
DRAIN PAN:

No drain pan is installed under the water heater.

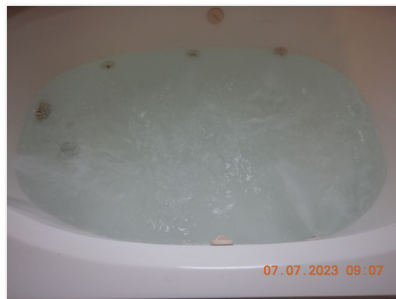
Note: The hydro-massage therapy tub pump equipment was tested at the time of inspection and it is working properly.

Note: The GFCI at the hydro-massage therapy equipment could not be located.

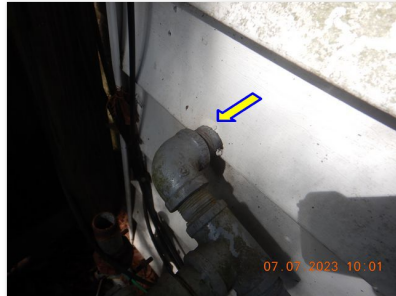
The gas lines are not properly sleeved or wrapped with PVC plumbing tape where passing through the exterior veneer at the following locations: Right exterior hose bib.

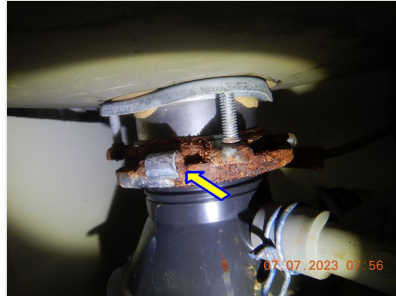
The food waste disposal connection clamp is not locked into place at the sink flange. Disposal vibration may cause the unit to leak or detach at the sink connection.

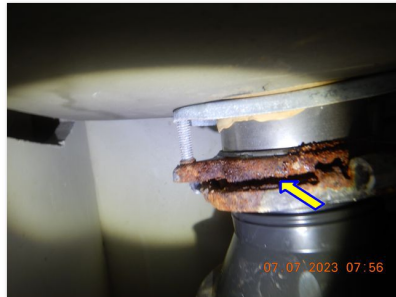
The food waste disposal housing connection is deteriorated/rusted.

The food waste disposal did not respond to controls when tested.

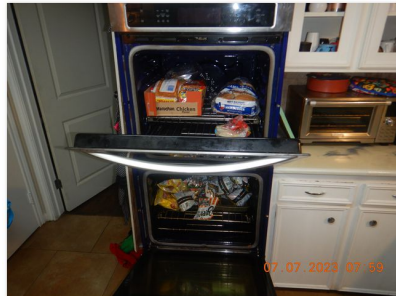
OVEN:

The ovens could not be tested due to items being stored in them at the time of inspection.

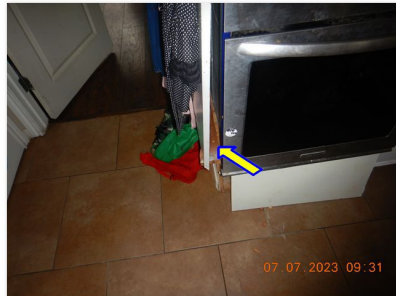
The oven cabinet is damaged.

Oven and oven light were inoperable at the time of inspection.
