NEW CONSTRUCTION FINAL INSPECTION

6126 Hazel Lake
Conroe, TX 77303

PROPERTY INSPECTION REPORT FORM

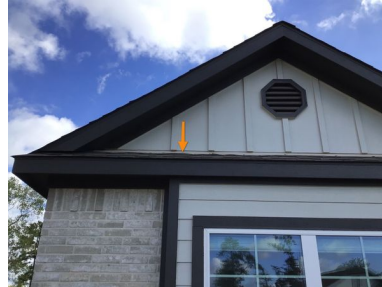
Lifted/front

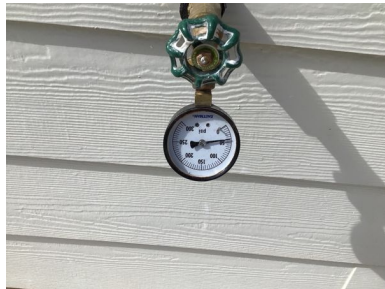
Static Water Pressure Reading: 40

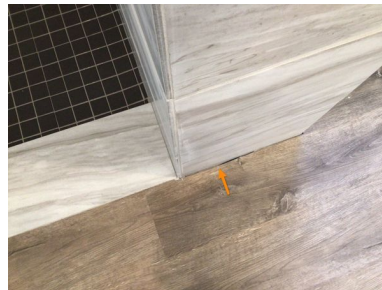
Left Hall Bathroom

2: Shower: Missing/Deteriorated Caulking or Grout

Evaluation and remediation is recommended.

Recommendation: Contact your builder.

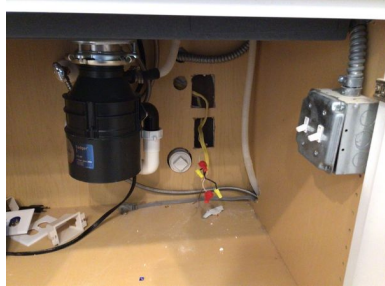
Dishwasher power install not complete:

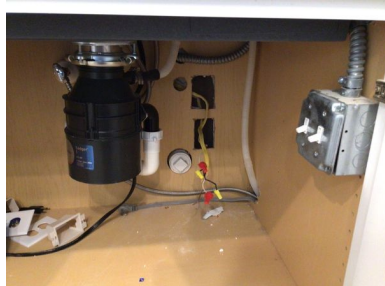
Disposal powered install not completed:
