Professional Real Estate Inspector Sam Hestand TREC #24118

Prepared for: Emmalee Webster

Date: 07/12/2023

18603 Canyon Cove Dr., Crosby, TX 77532

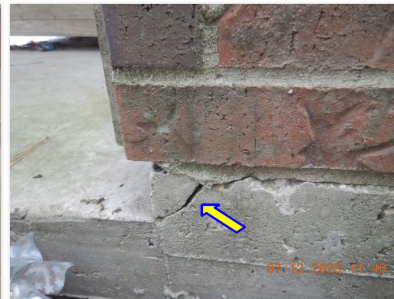
CORNER FRACTURES:

Corner fractures (possible insect penetration)

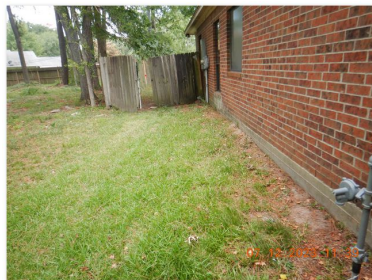
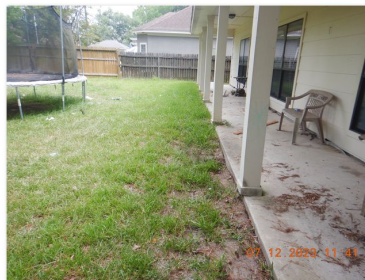
The drainage and grading around this home is inadequate. In order for the drainage to be effective, the landscaping must be configured so that the yard is sloped away from the foundation by at least 6 inches in the first 10 feet and/or adding additional gutters/downspouts to the house is another option to improve drainage and/or in- ground drains should be designed and added to divert rainwater and runoff away from the house as appropriate and/or drainage swale should be improved/installed.

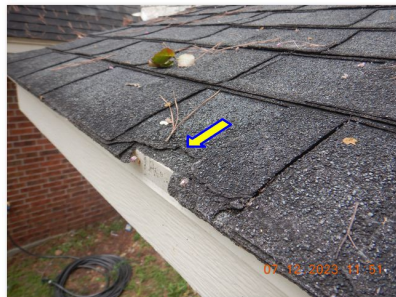
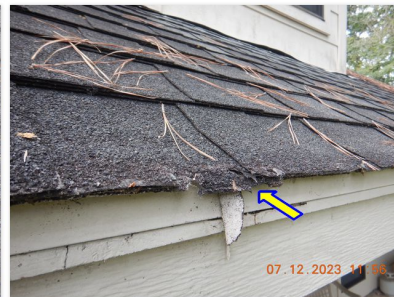
- Scuffed and/or damaged shingles were noted.

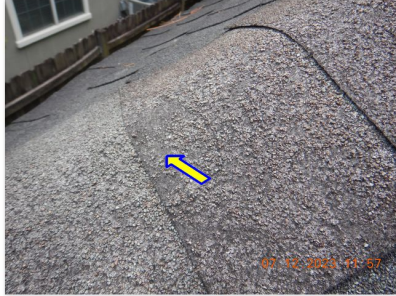
RIDGE CAP SHINGLES:

Excessive aggregate loss observed at ridge cap shingles was noted.

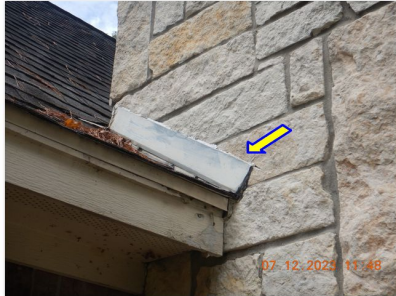
Kickout flashing missing and or inadequate at some locations.

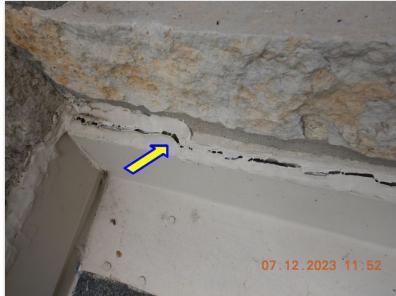
Caulking is deteriorated at some of the roof flashing locations.

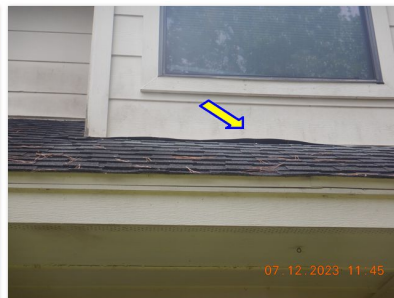
Some of the flashing has come up from the roof surface and should be re-secured.

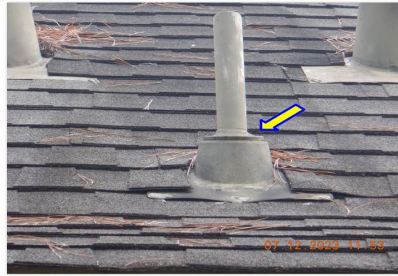
The house is old enough to require the boot jacks to be re caulked due to deterioration at the seal or possibly changed.

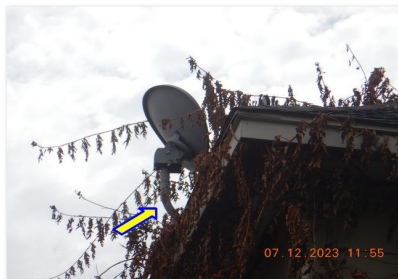
Note: Satellite dish has been installed on the roof. Some satellite dishes and/or mounting brackets have been abandoned. These penetrations should be caulked at the fasteners.

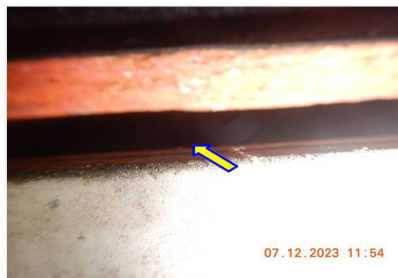
The roofing felt did not extend to the rakes or bottom of the roof deck in all of the areas that were inspected.

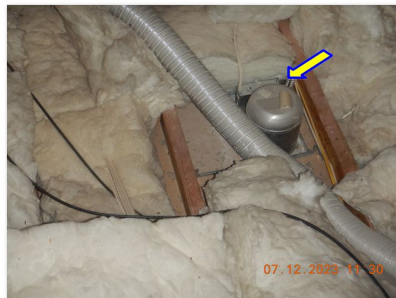
- Clear insulation from around the recessed light fixtures at the attic.

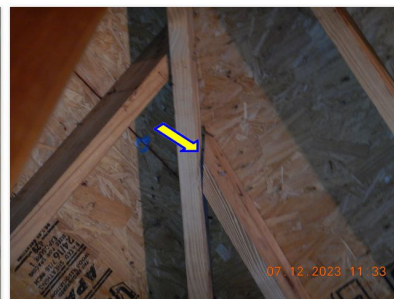
- ☑ Rafters cuts not flush at the ridge, hip and or valley boards in the attic.

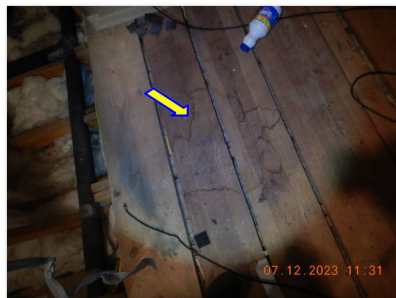
- ☑ Evidence of moisture stains was noted.

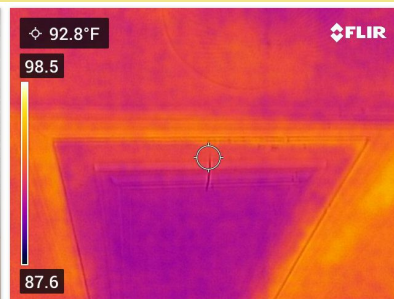
- ☑ Disappearing attic access ladder is not sealing properly at the attic. There is no weather strip installed at this location.

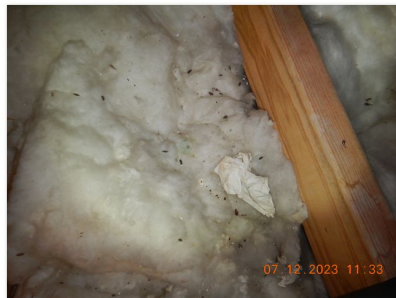
Evidence of rodent activity observed at the attic. Further evaluation by a licensed pest control company is recommended.

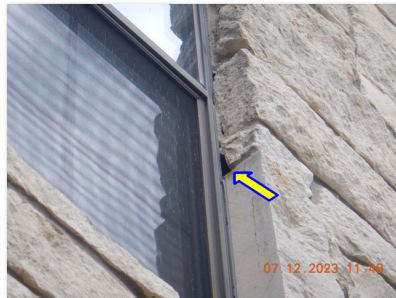
Mortar is missing at some areas of the stone/brick work.

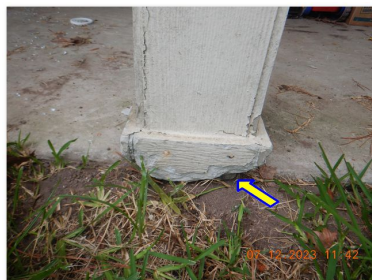
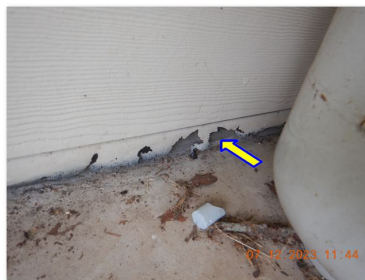
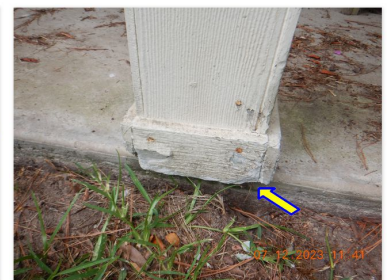
Cement board siding and/or trim damage was noted.

Nails in the siding should be pitted and caulked over.

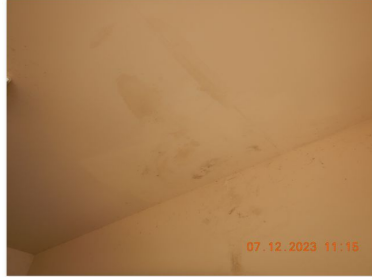
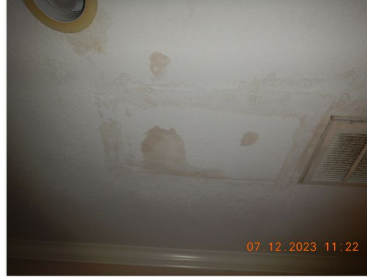
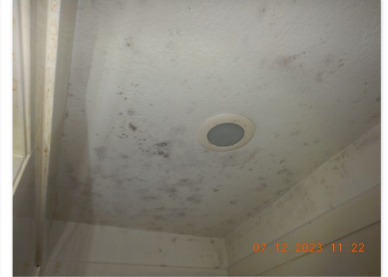
Evidence of moisture stains observed. Some Examples: Garage, Master bedroom, Master bathroom, 2nd floor stair landing.

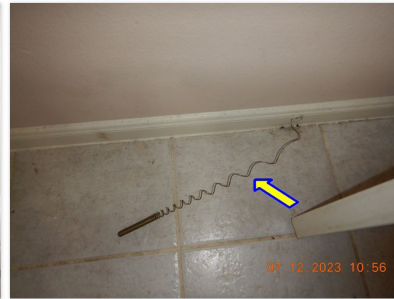
Door stop springs are missing at some locations.

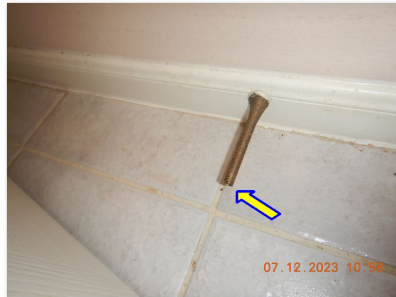
Door stop spring rubber covers are missing at some locations.

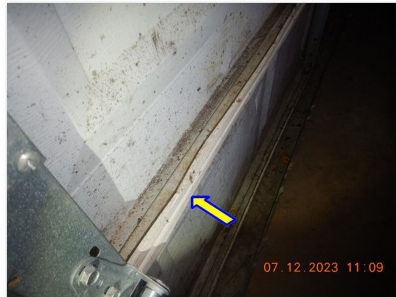
Garage door panels bent at some locations.

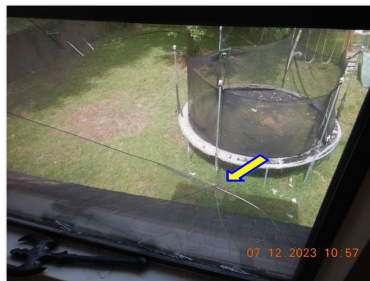
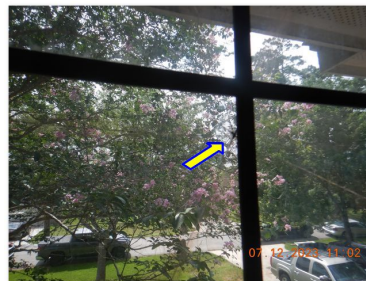
Broken windows observed at the following locations: Front entry, Master bedroom, 2nd floor front right bedroom, 2nd floor back left bedroom.

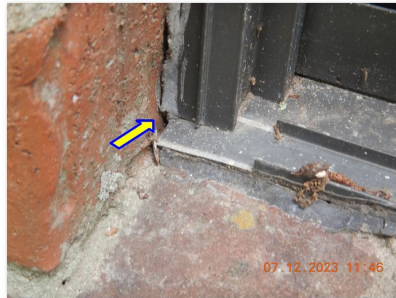
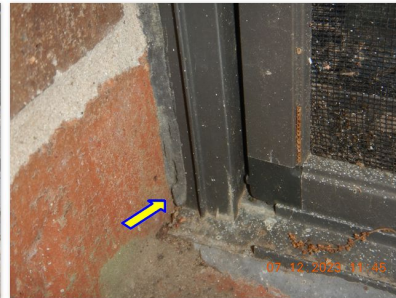
Caulking around exterior windows deteriorating.

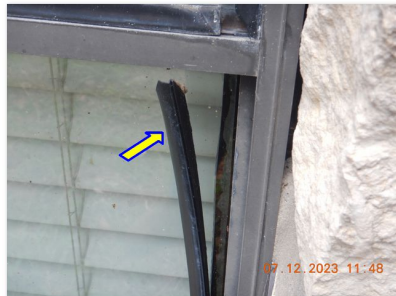
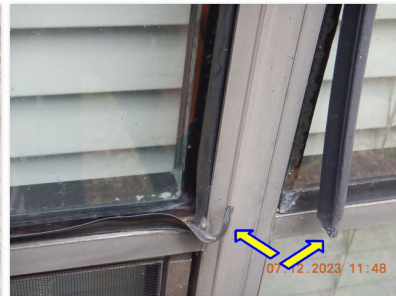
Exterior plastic window strips are damaged at some locations.

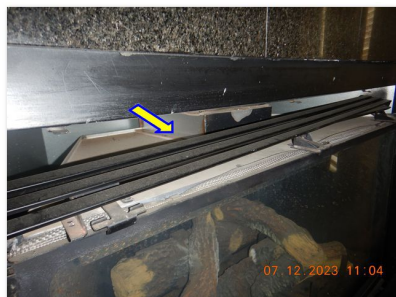
The top fireplace cover is loose/detached.

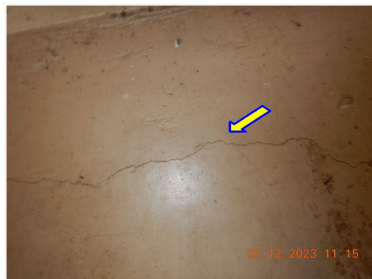
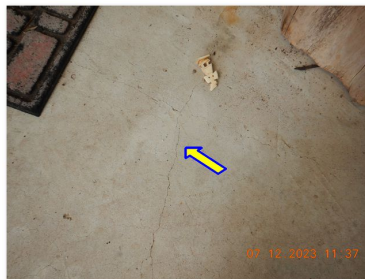
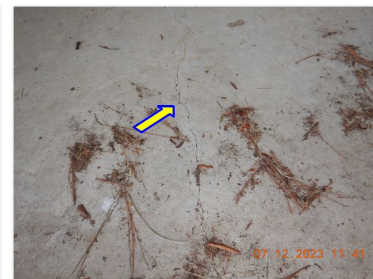
FLATWORK:

Settlement cracks observed at the flatwork at the following locations: Garage, Front patio, Back patio, Garage.

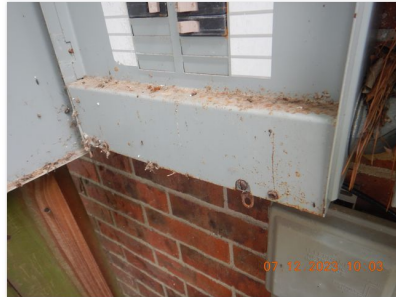
- ☑ The service equipment disconnecting means panel board dead front cover is missing one or more set screws.

- ☑ The service equipment disconnecting means panel board dead front cover is rusted.

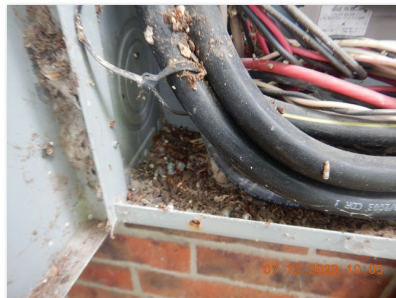
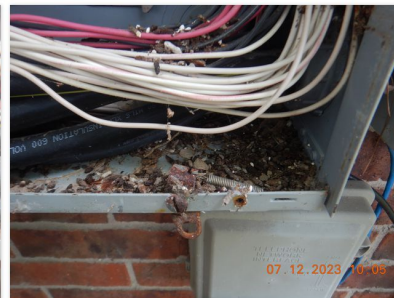
INTERIOR PANEL BOARD:

- ☑ Debris observed at the interior of the service equipment disconnecting means panel board enclosure.

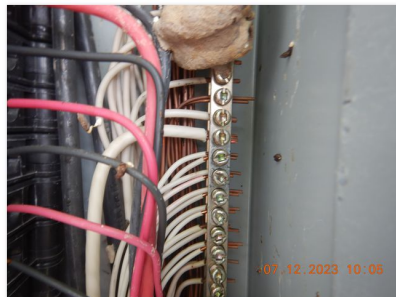
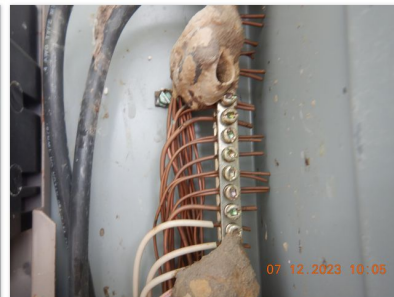
NEUTRALS/GROUNDS:

- ☑ Several neutral conductors and grounding conductors are double terminated. The neutral conductors should be installed under separate terminal screws. This is a possible electrocution hazard.

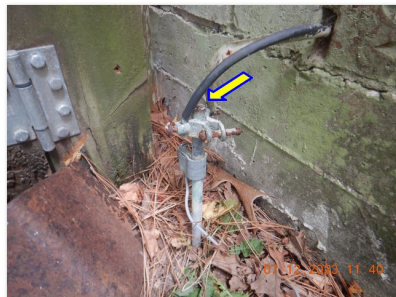
☑ The grounding electrodes should be driven to below top surface of the soil.

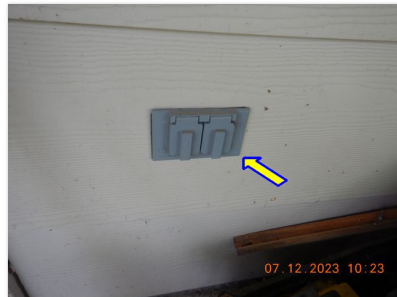
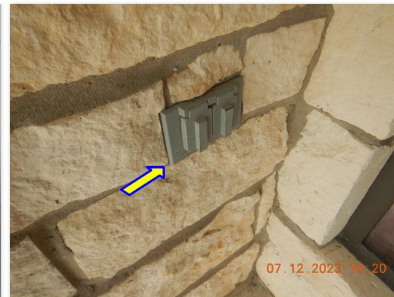
RECEPTACLES:

Exterior receptacles are currently required to have a "weatherproof while in use" cover, also known as a plastic "bubble cover" type.

Receptacles have an open ground at the following locations: 2nd floor back left bedroom.

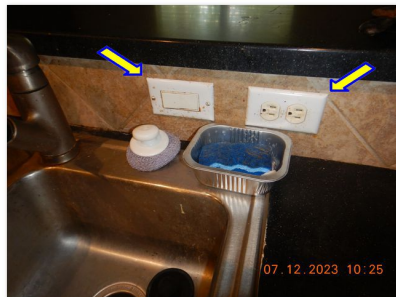
WIRING AND CONDUIT:

- Switch and plug are installed at a prohibited location at the kitchen.

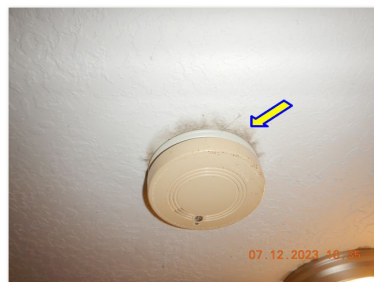
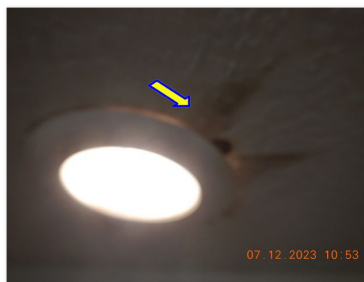
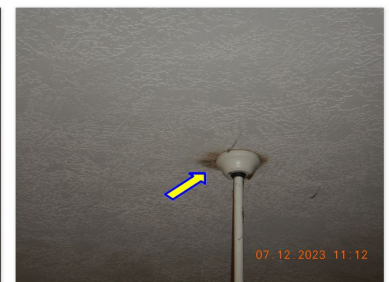
- Singe marks were observed around multiple electrical fixtures.

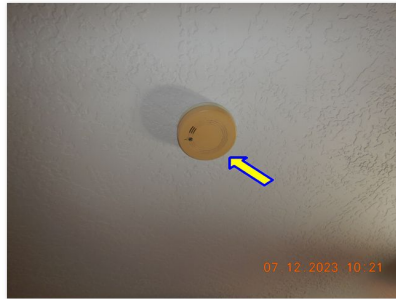
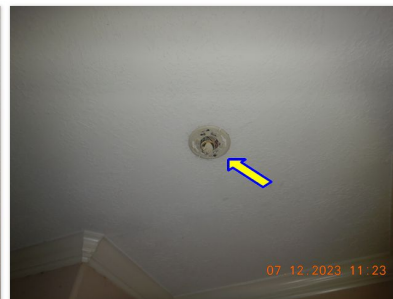
Smoke alarms missing at some locations.

Carbon monoxide alarms was not found and/or missing. An approved carbon monoxide alarm should be installed outside of the each separate sleeping area in the immediate vicinity of the bedrooms in dwelling units within which fuel fired appliances are installed and in dwelling units that have attached garages.

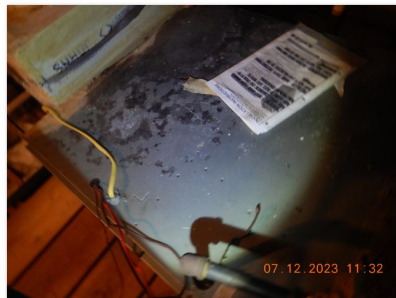
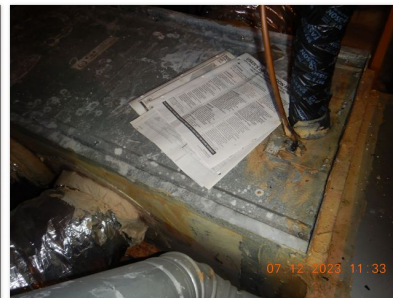
EVAPORATOR:

Debris should be cleared from the top of the HVAC equipment.

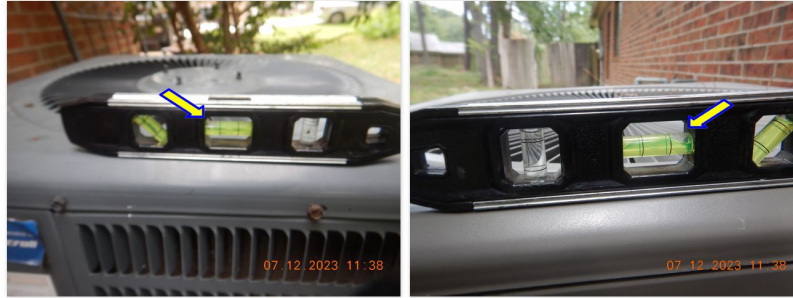
CONDENSING UNIT:

Condensing unit not properly leveled.

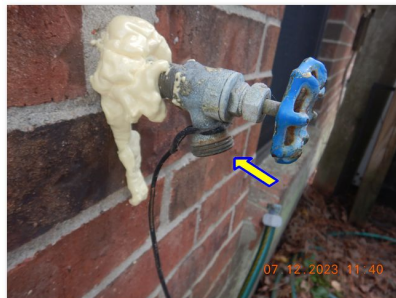
EXTERIOR:

- Exterior hose bibs not installed with anti-siphon devices at some locations.

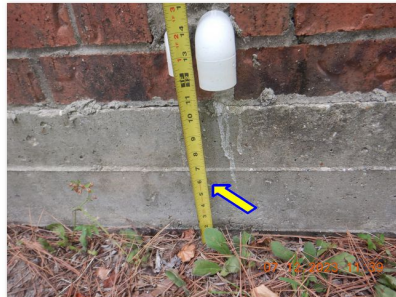
T&P DRAIN:

The water heater temperature and pressure relief drain line should terminate within 6 inches of grade at the exterior.

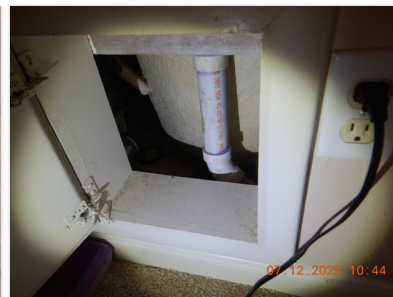
The hydro-massage therapy tub pump equipment did not respond to controls when tested.

The hydro-massage therapy tub at the master bathroom is not installed with an easily accessible inspection panel. The circulation lines and pump/motor could not be visually inspected at the time of inspection. A panel is present but the equipment is not accessible.

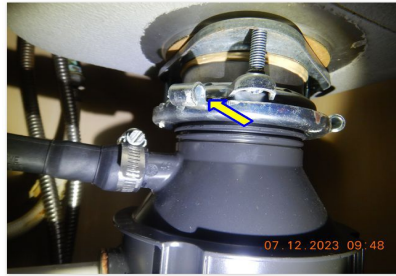
- The food waste disposal connection clamp is not locked into place at the sink flange. Disposal vibration may cause the unit to leak or detach at the sink connection.
- The food waste disposal is seized up and not working properly.

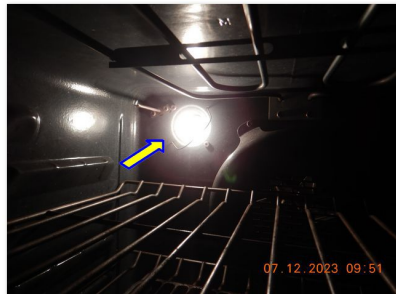
OVEN:

- Oven did not respond to controls when tested at the time of inspection.
