HOME INSPECTION REPORT

Prepared For:	Ken Goolsby
	(Name of Client)
Concerning:	6075 Fm 222 Loop S, Shepherd, TX, 77371
	(Address or Other Identification of Inspected Property)
By:	David Jones (# 22116) Charles Rowden (# 22155)
	(Name and License Number of Inspector)
	10-8-2019
	(Date)
	(Name, License Number of Sponsoring Inspector)

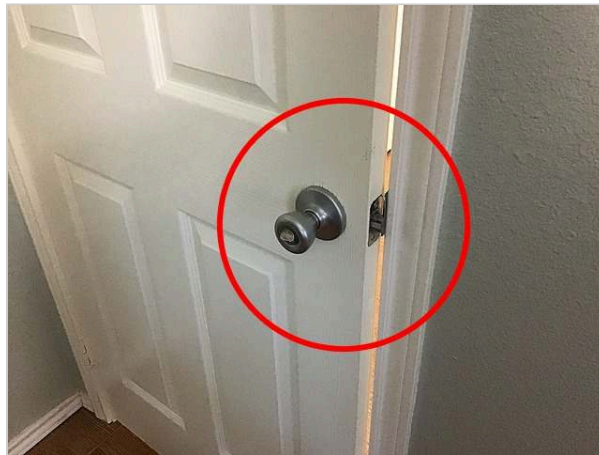
The front bedroom door would not latch in the closed position.

Would not latch (front bedroom)

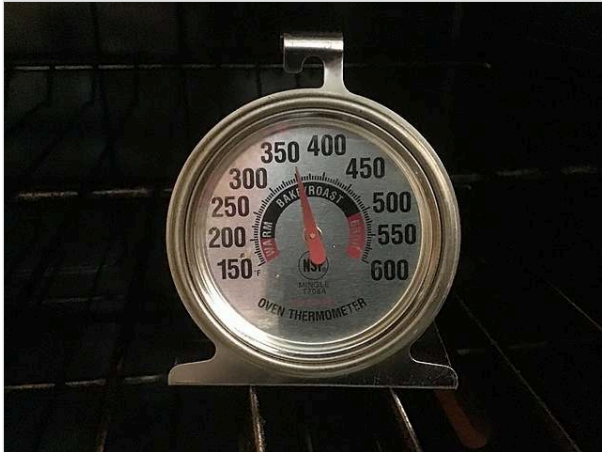
Oven thermometer showing +/-350 degrees
