Web Presentation

Stanley Garment

Property Address: 20006 Ambervine Circle, Katy, Texas 77450

ABET Inspections

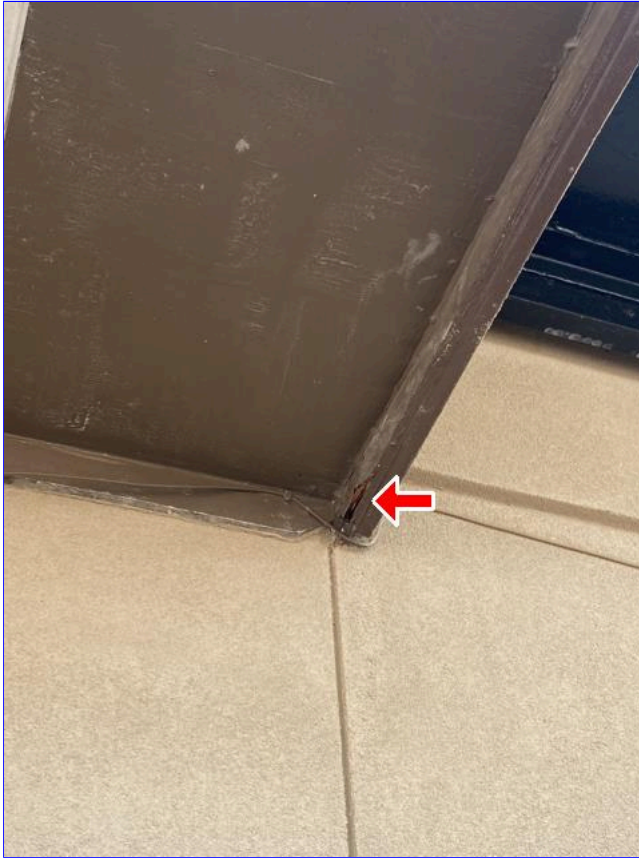
D. Item 3(Picture)

(3) Deteriorated wood observed at fascia and/or soffits.

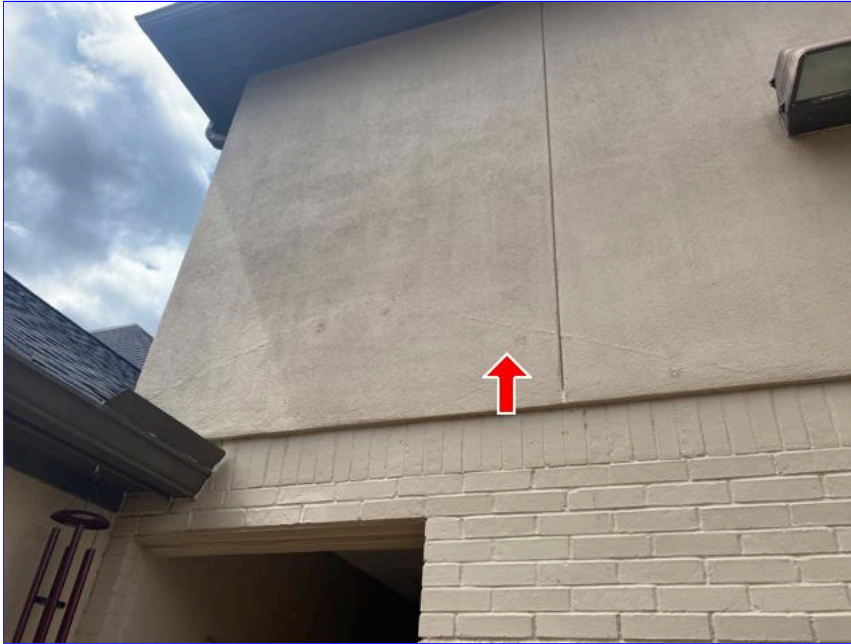
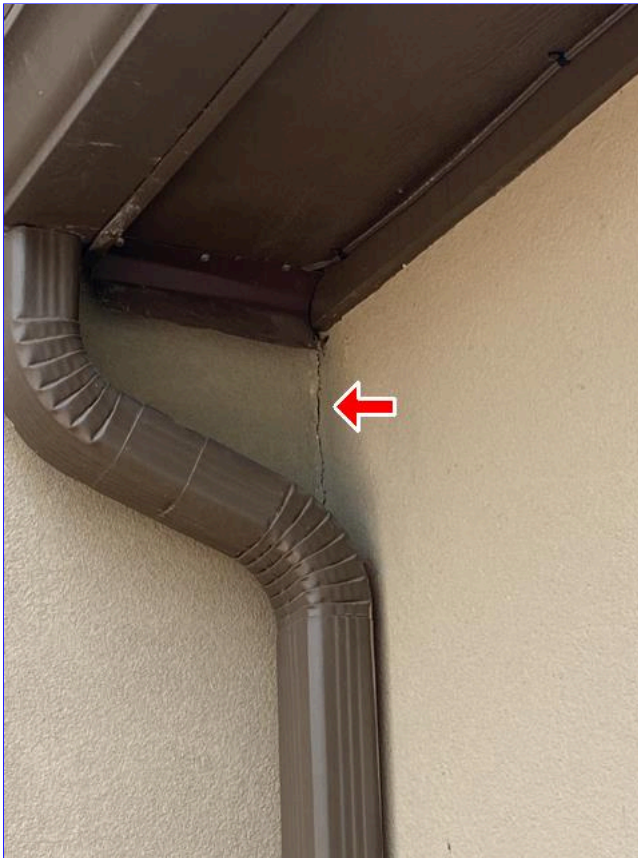
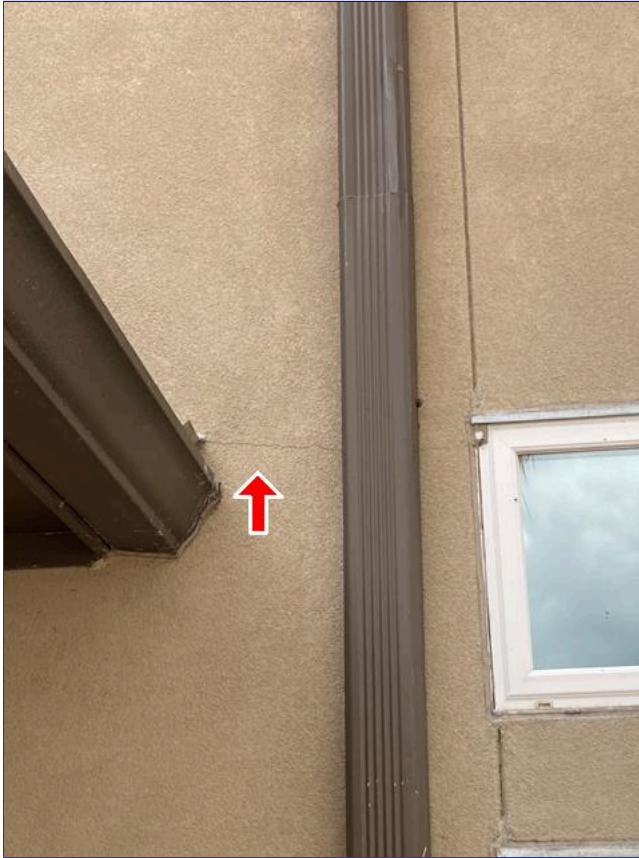
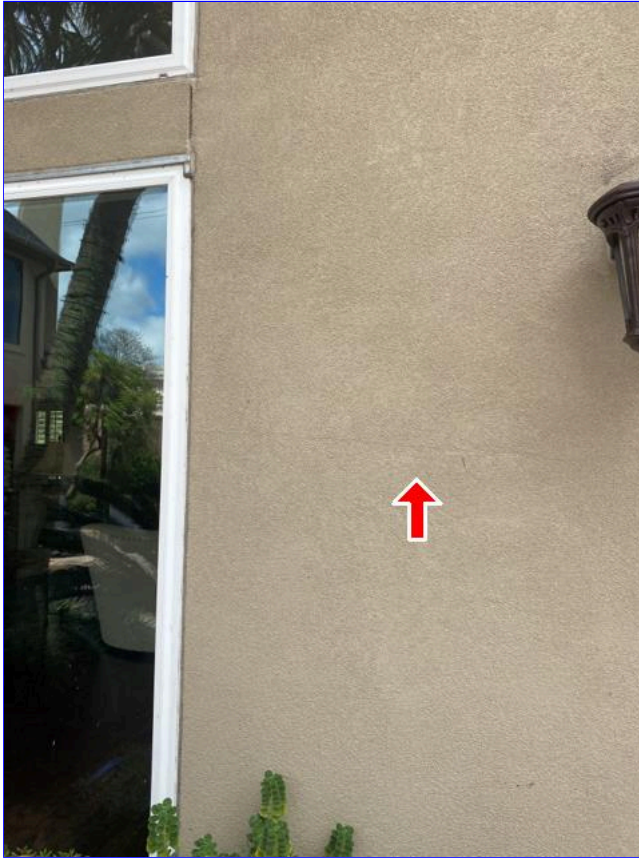
(4) Cracks observed at stucco

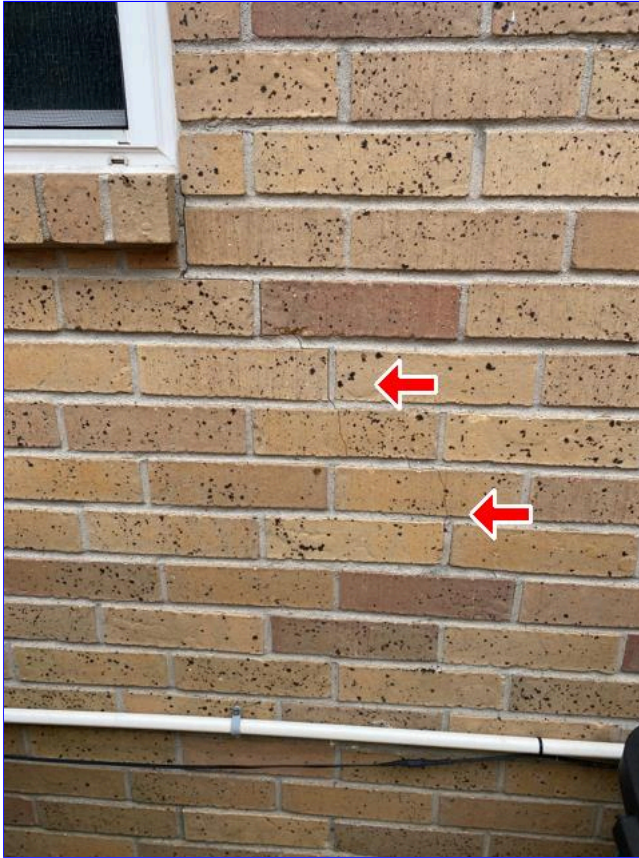
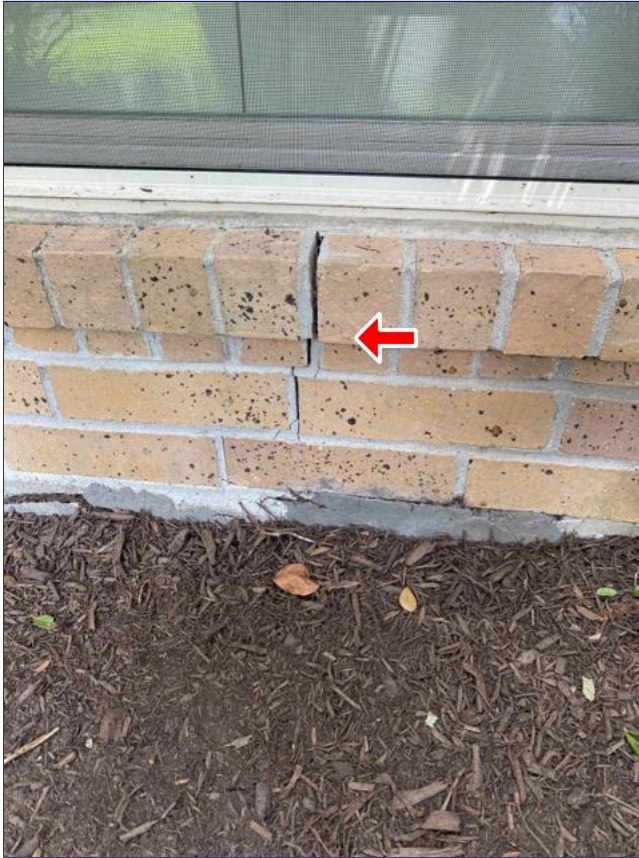
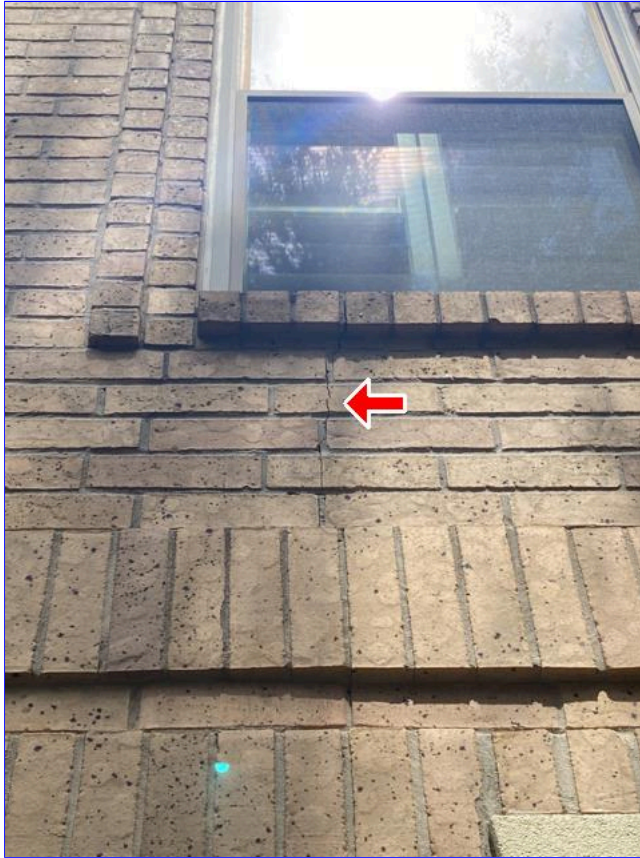
(6) Cracks observed at brick.

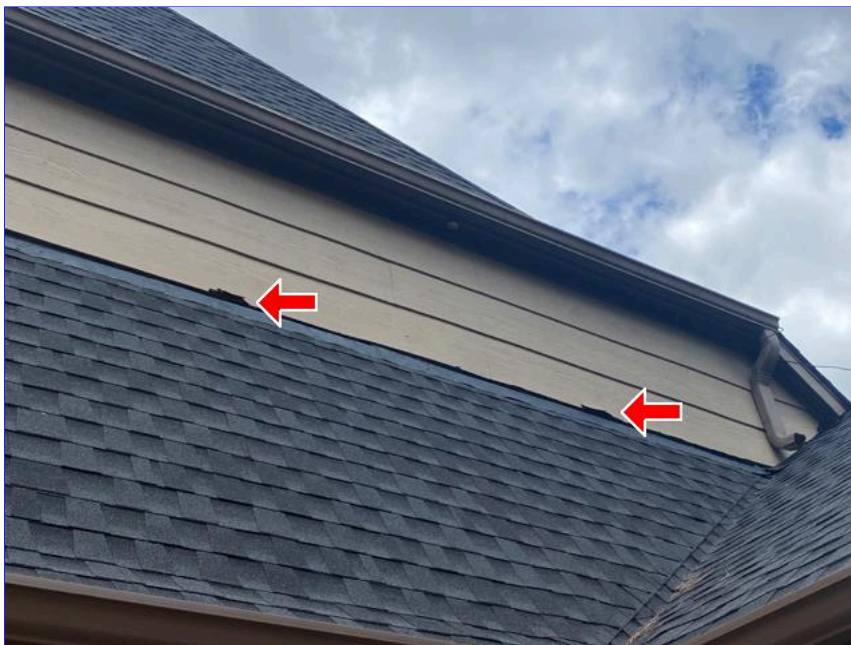
E. Item 14(Picture)

(7) Deteriorated or rotten wood observed at siding

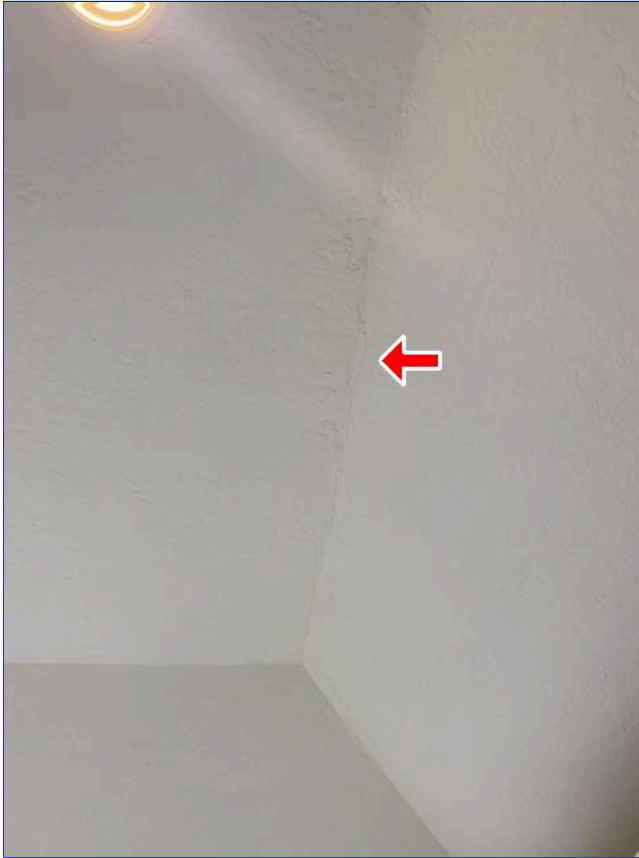
F. Item 2(Picture)

(2) Cracks in sheetrock observed at front entry, upstairs kitchen

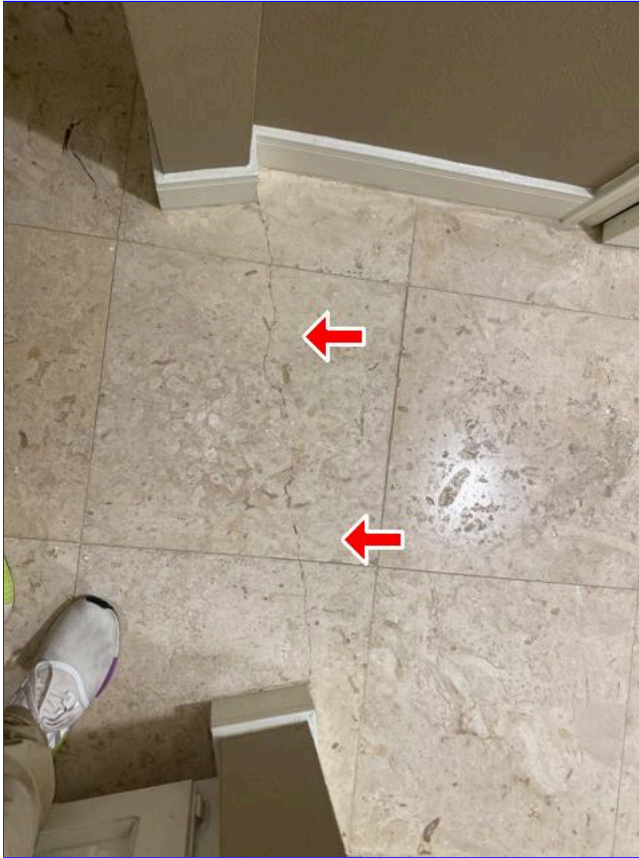
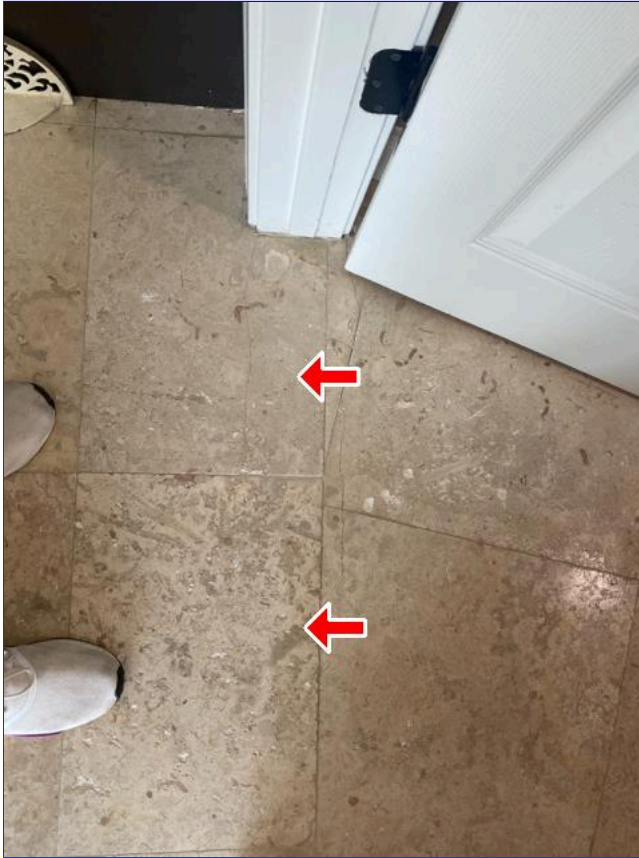
(5) Cracks in tile observed

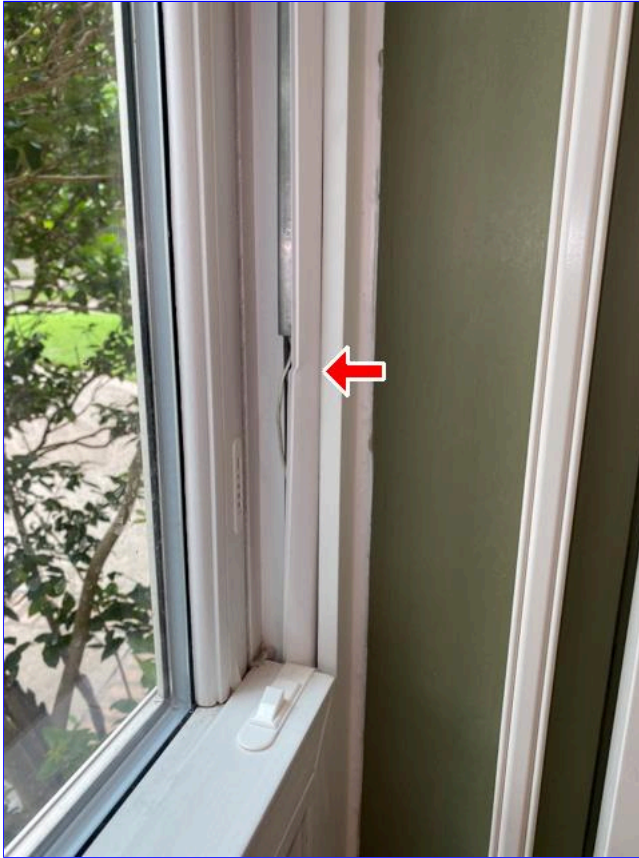
H. Item 3(Picture)

(3) Window lift supports are loose, damaged and/or missing at office

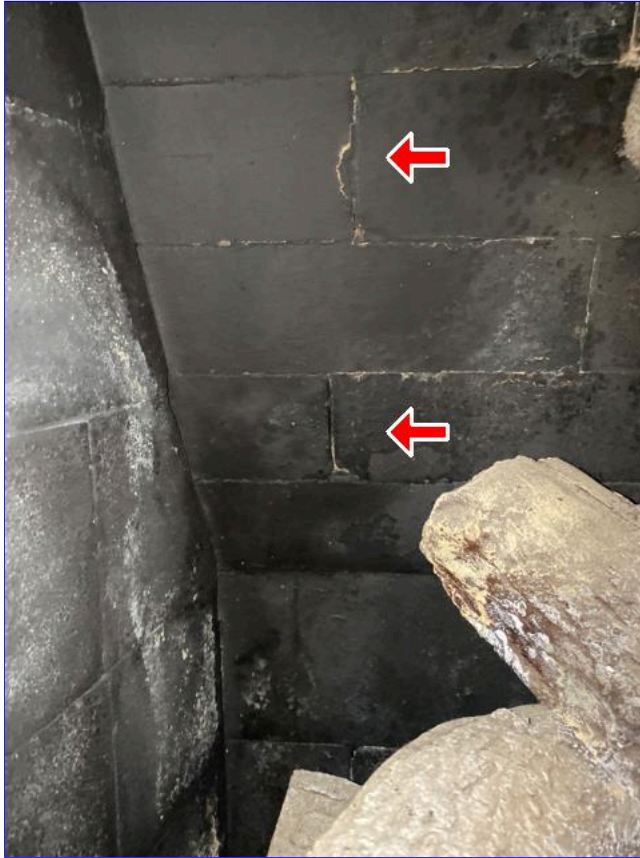
J. Item 5(Picture)

(2) Mortar is missing between firebrick

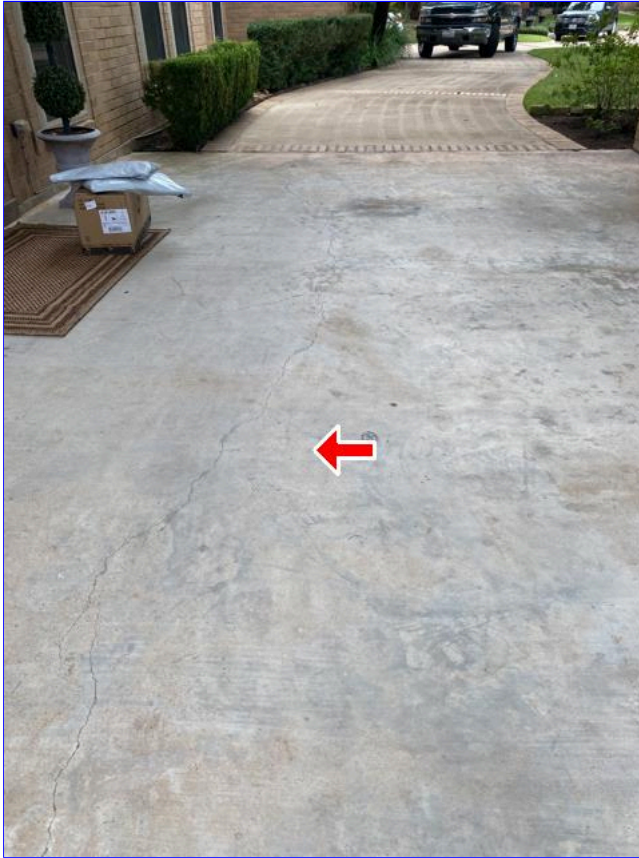
L. Item 1(Picture)

Driveway or sidewalk is cracked at multiple locations

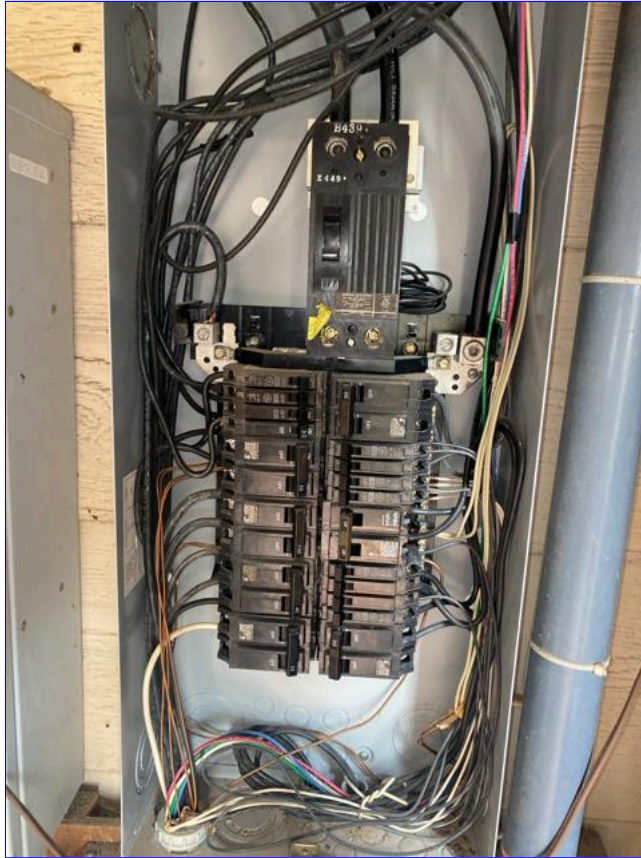
A. Item 4(Picture)

(2) Incorrect sized wires on breakers - 40+ Amp breakers require multi strand wiring

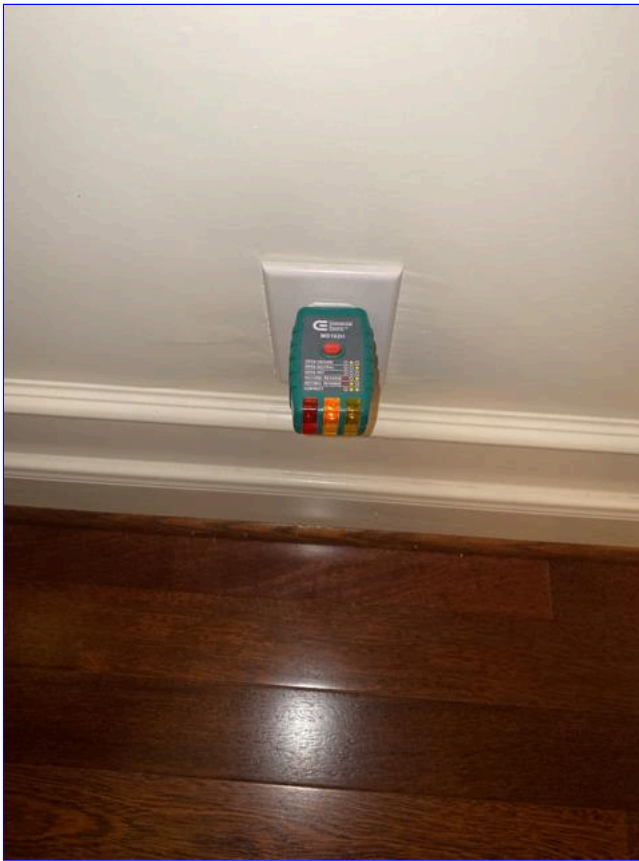
B. Item 1(Picture)

(2) Ungrounded outlets at dining room (3) Piano room (1) upstairs right back bedroom (1)

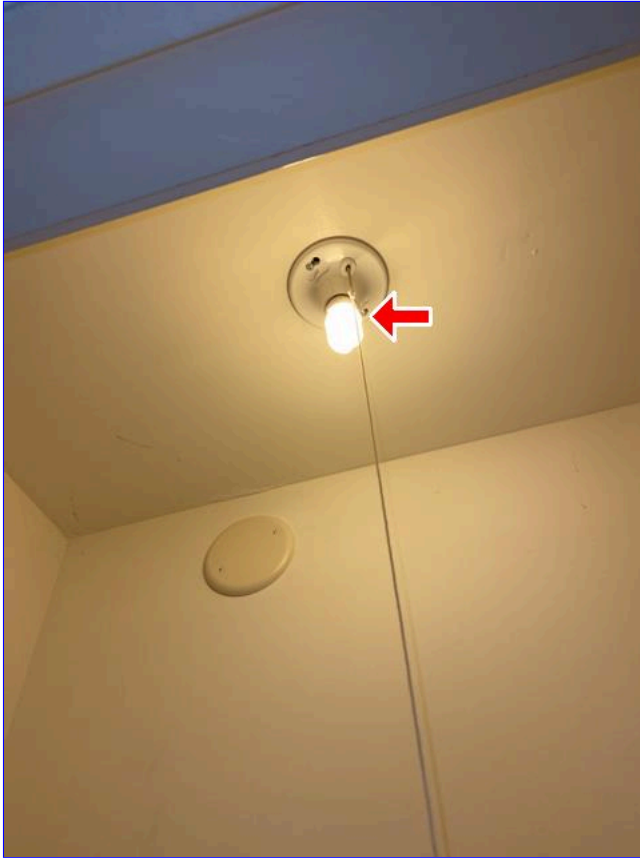
B. Item 2(Picture)

(3) Closet light fixture is not globe protected at bedrooms or hallways

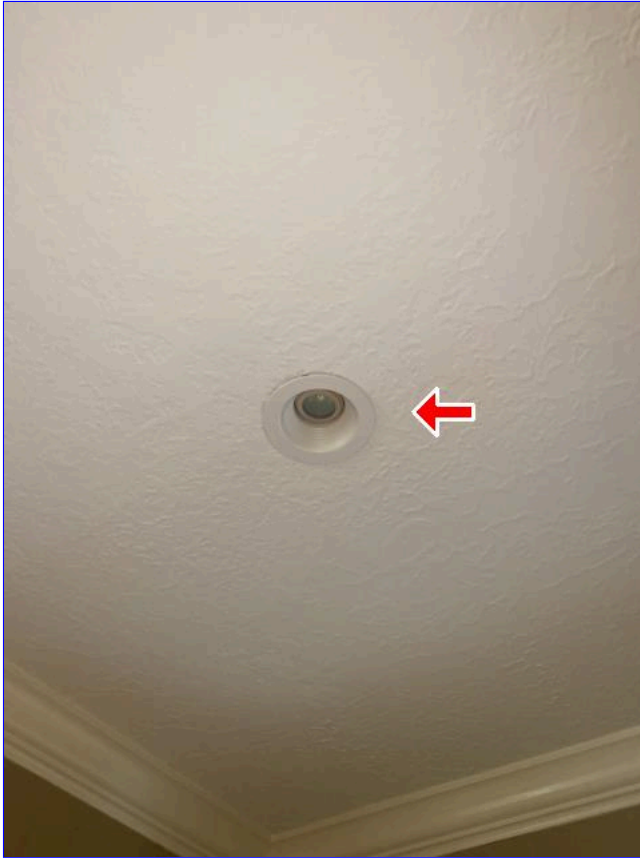
B. Item 3(Picture)

- (4) Lighting or fans are improperly wired into GFCI circuits at master bathroom
- (5) GFCI outlets reset could not be located
- (6) Smoke alarms are not present in all bedrooms
- (7) Light fixtures and/or bulbs did not function at multiple locations

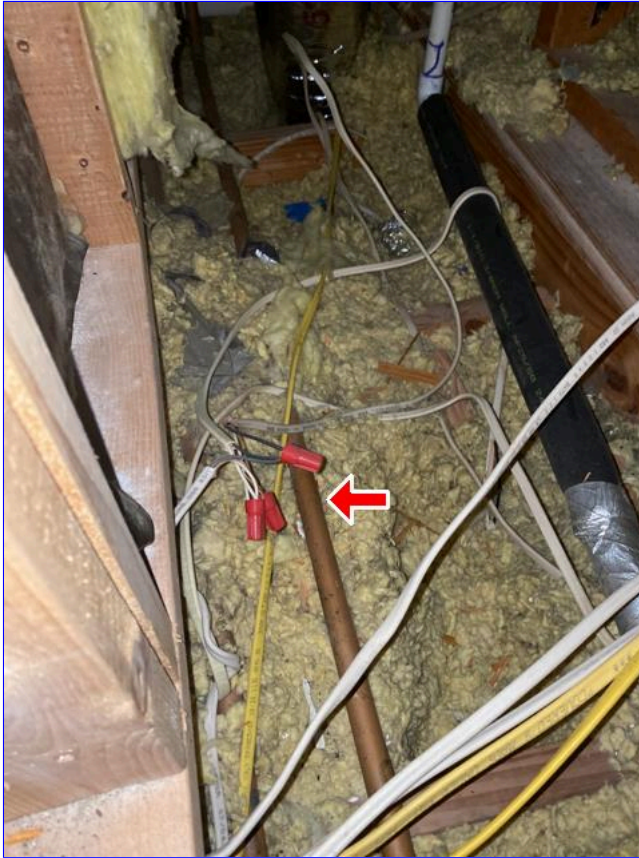
B. Item 5(Picture)

(8) No GFCI protection at one or more locations - This is considered a recognized safety hazard

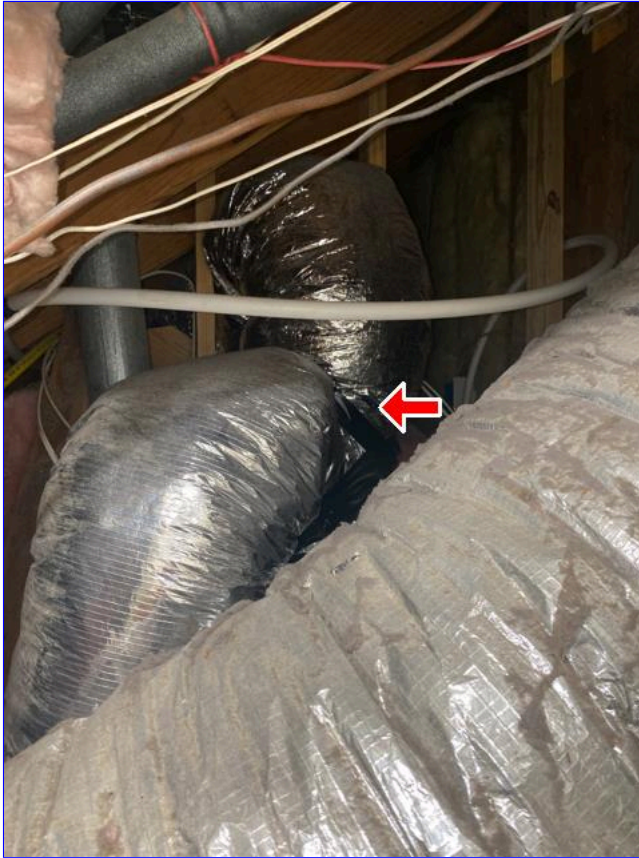
C. Item 1(Picture)

(2) Attic ducting is kinked, restricted or improperly routed in attic

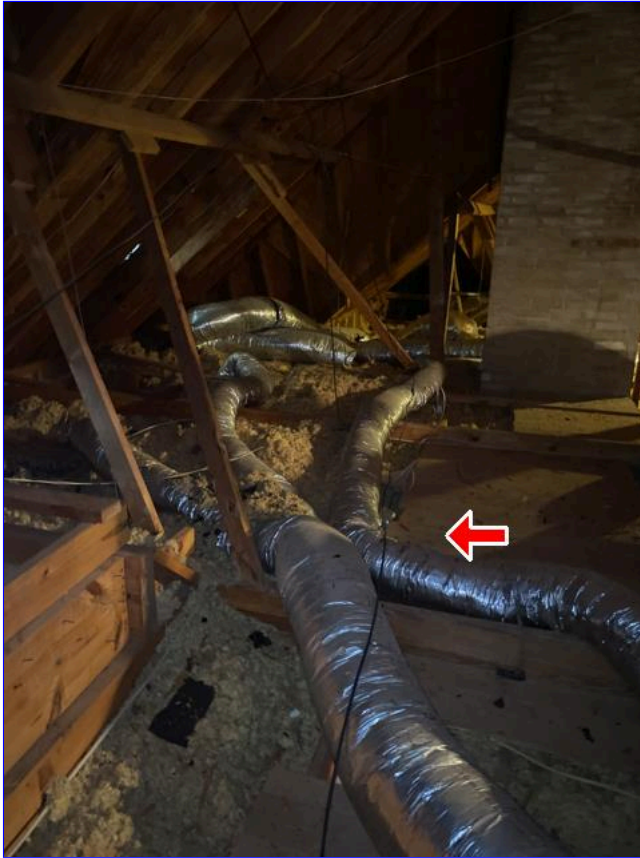
C. Item 2(Picture)

(3) Attic ductwork is not properly strapped above attic insulation at 4' intervals

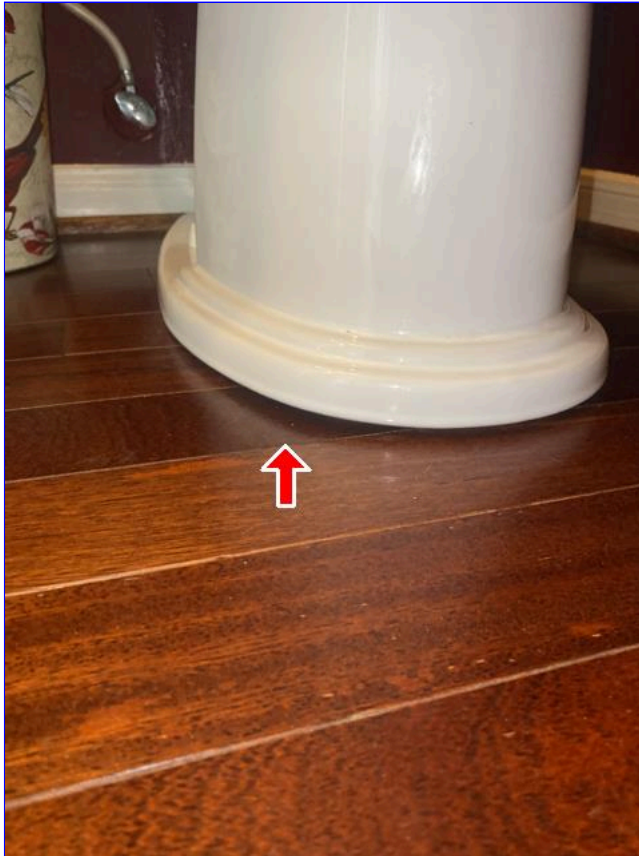
A. Item 1(Picture)

(2) Toilet is not sealed on the base at 1/2 bathroom

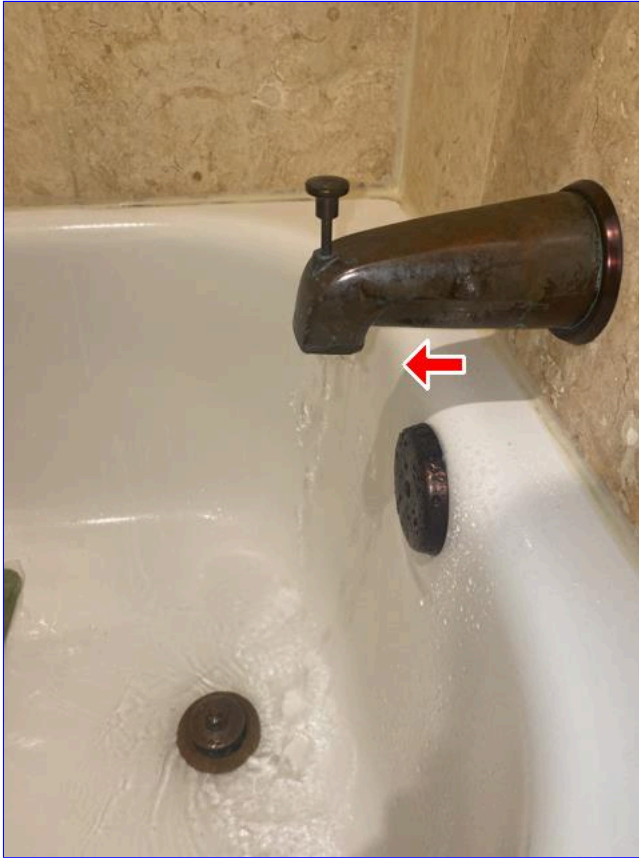
A. Item 2(Picture)

(3) Loud hammer noise when operating master bathroom tub. Further evaluation recommended

(4) Drain stopper is missing or not working properly at master bathroom

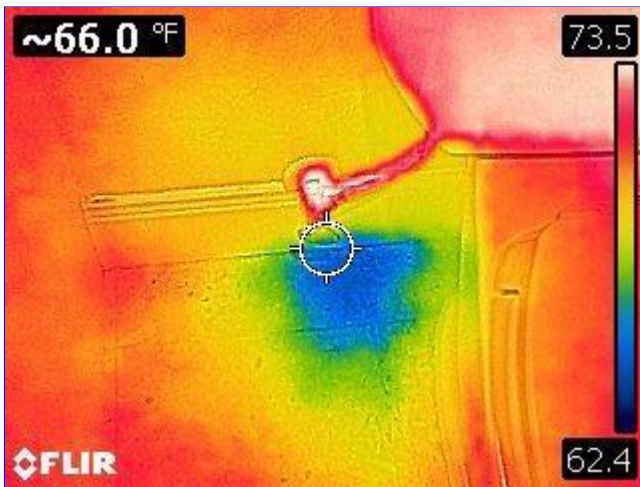
A. Item 5(Picture)

(6) Toilet is leaking at upstairs mother law suite bathroom

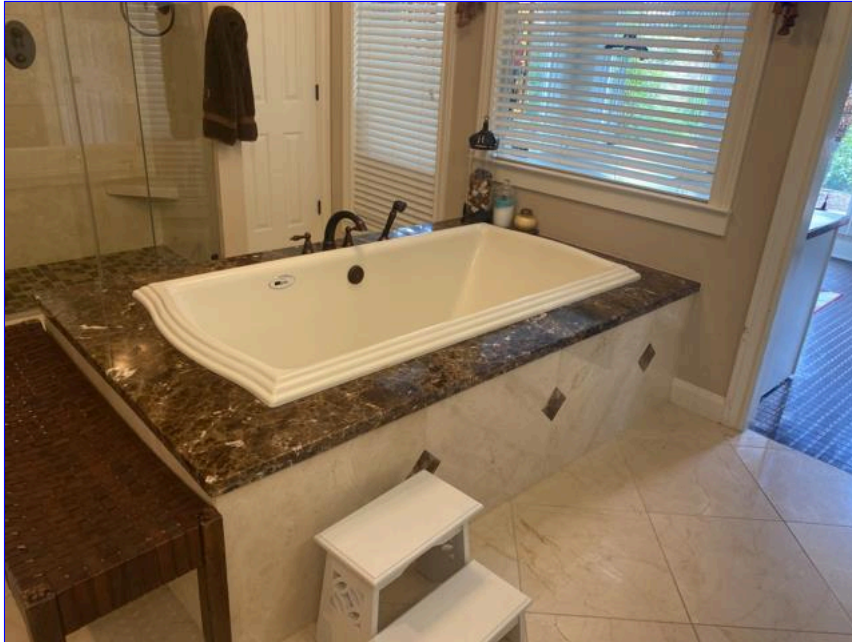
D. Item 1(Picture)

(2) Jacuzzi tub motor GFCI does not test

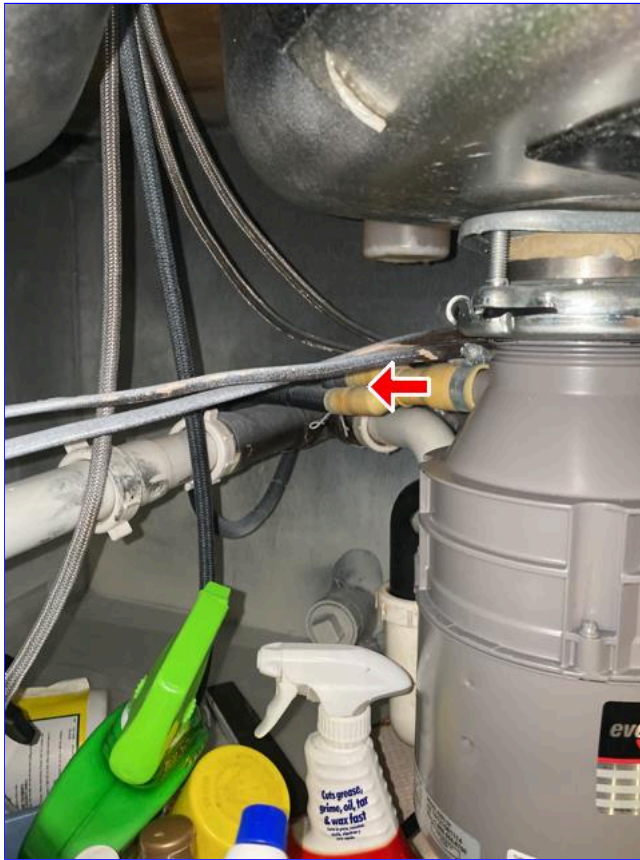
A. Item 2(Picture)

(2) No anti-siphon loop or backflow device installed

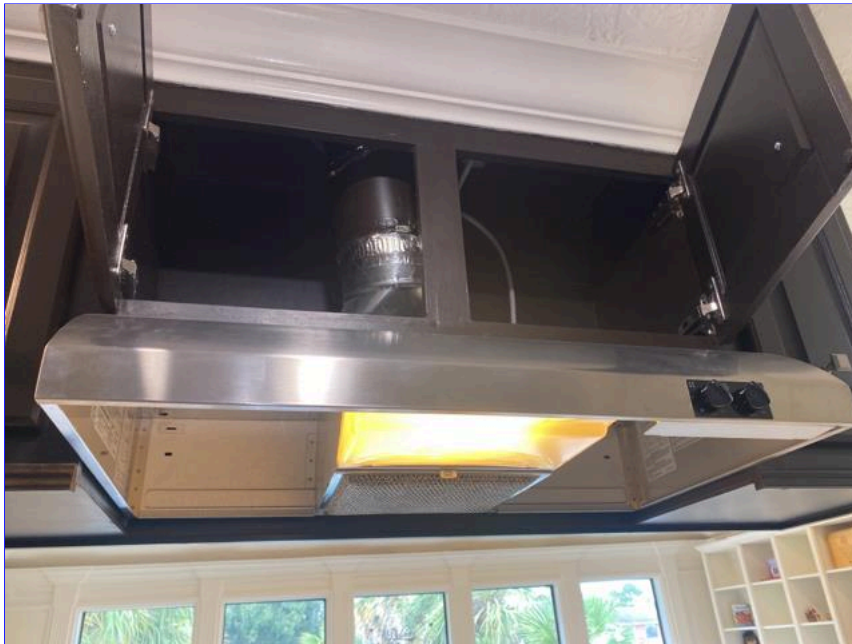
C. Item 2(Picture)

- (2) Unit not functioning - Further evaluation recommended
- (3) Vent pipe is disconnected
