North Star Inspections, Inc.

**13606 Crystal Palace
Pearland, TX 77584**

**Prepared Exclusively For:
John & Diana Derbas**

PROPERTY INSPECTION REPORT FORM

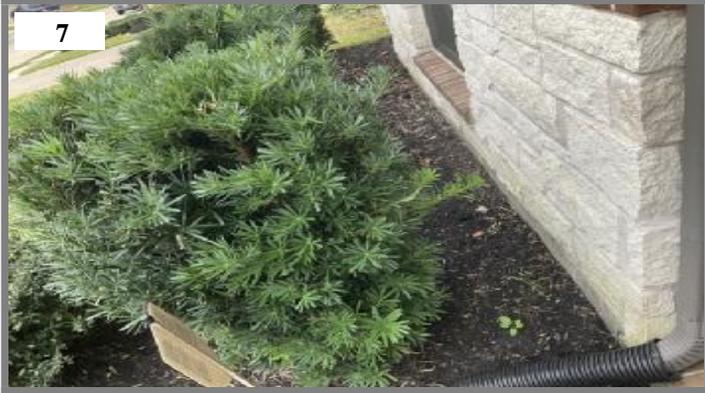
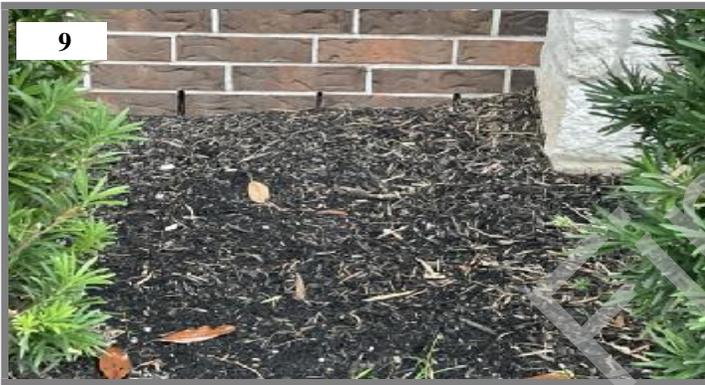
The soil level is high in the front left flower bed and around the back left. (Both minor)
It is recommended that 4 inches of foundation remain in view for masonry siding .(6 inches for wood siding or stucco)
There is a damaged gutter on the left side of the garage.
D - Splash pads or other devices need to be added where missing to direct flow from the gutters away from the foundation. Moisture at the foundation can cause foundation movement in expansive soils .
The swale in the backyard on the right side slightly holds water but we did have a thunderstorm move through this morning .
The drainage and grading are in good overall condition .

High Soil

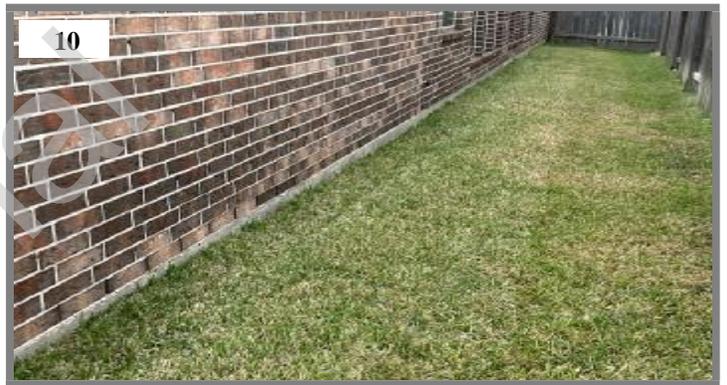
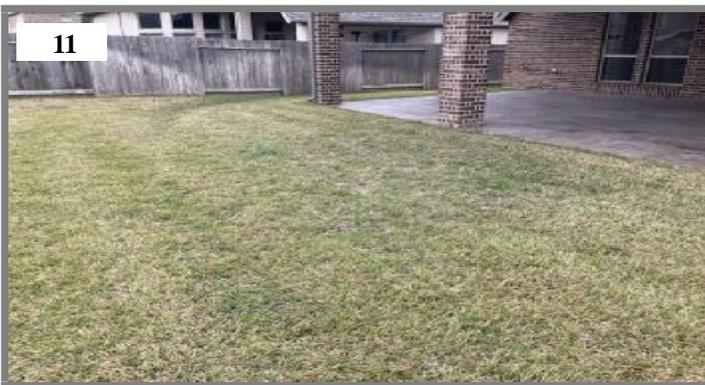
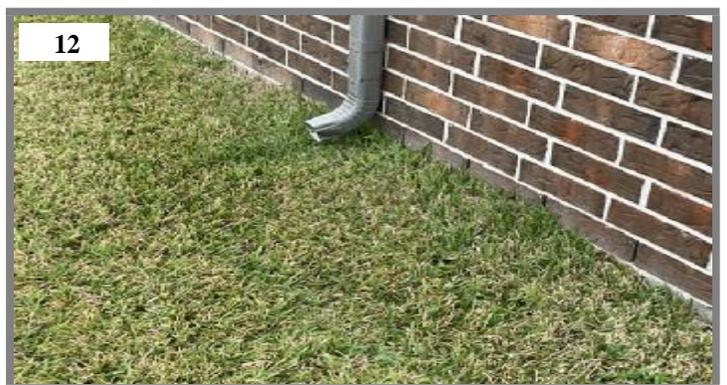
High Soil

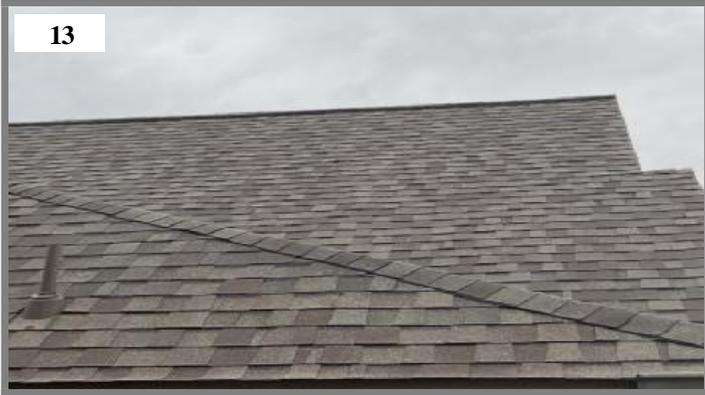
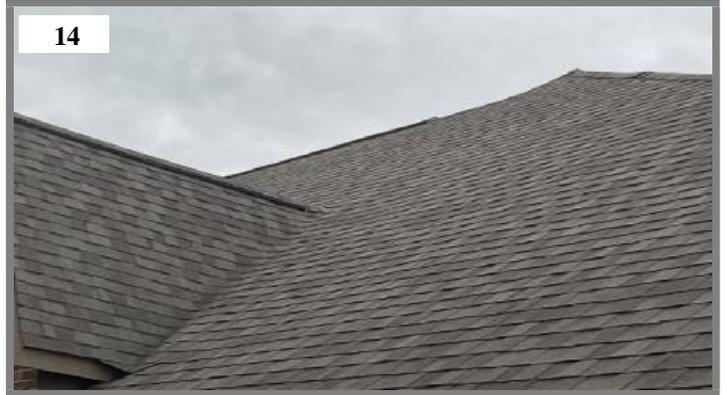
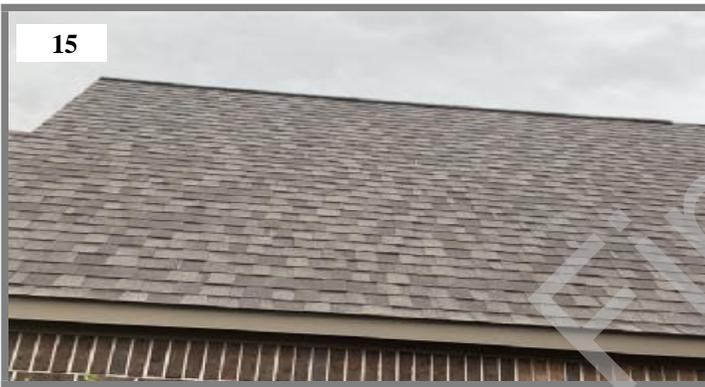
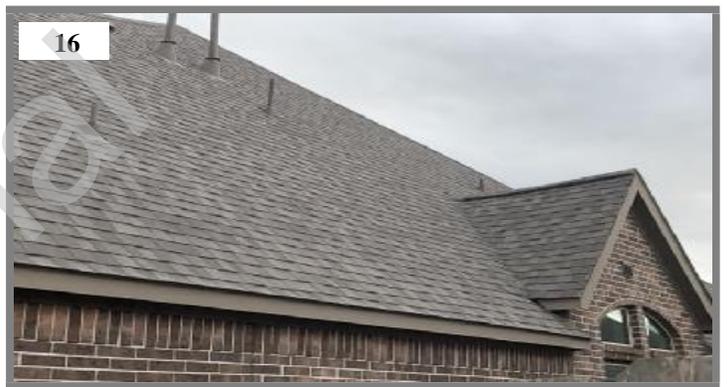
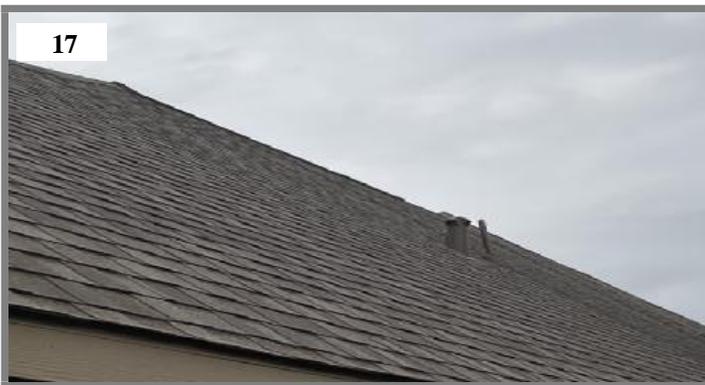
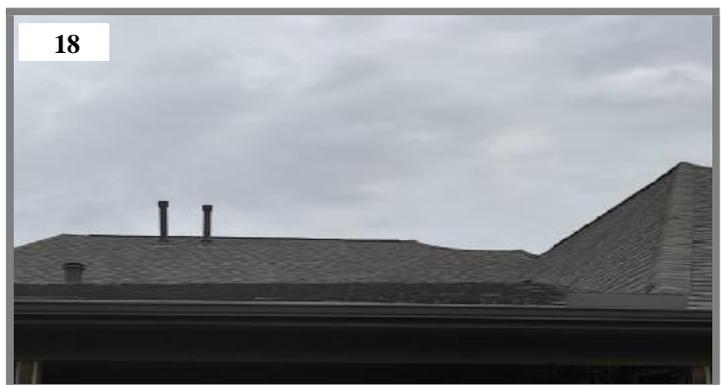
C: Structural: Roof Covering Materials

The roof is in good condition.

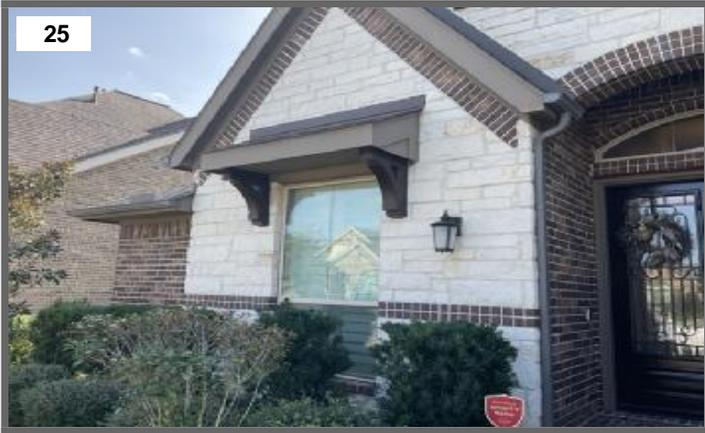
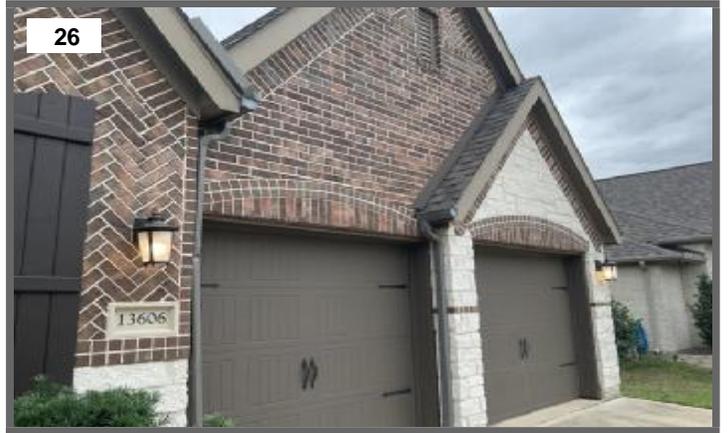
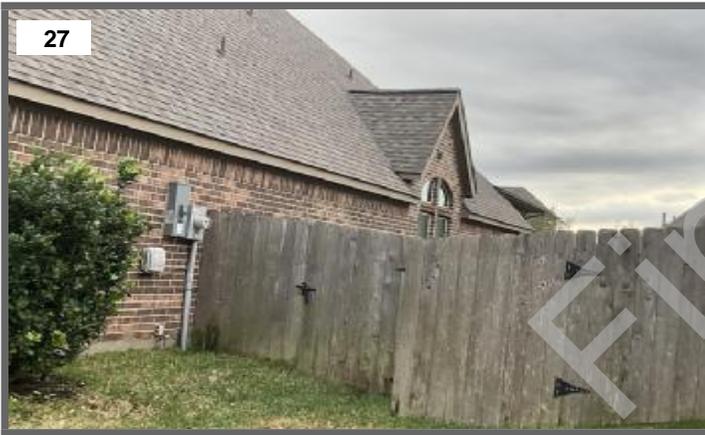
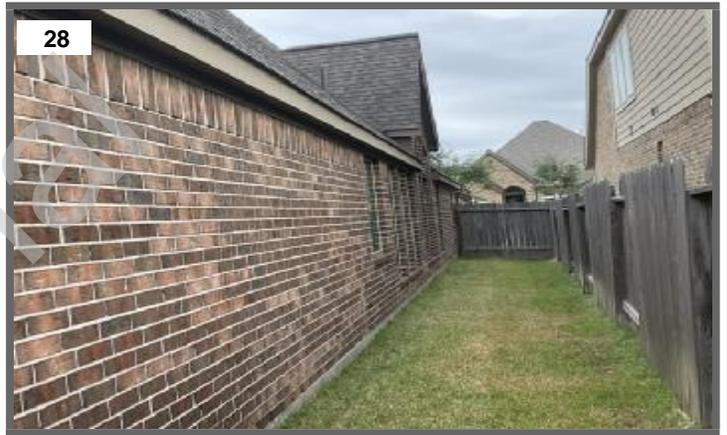
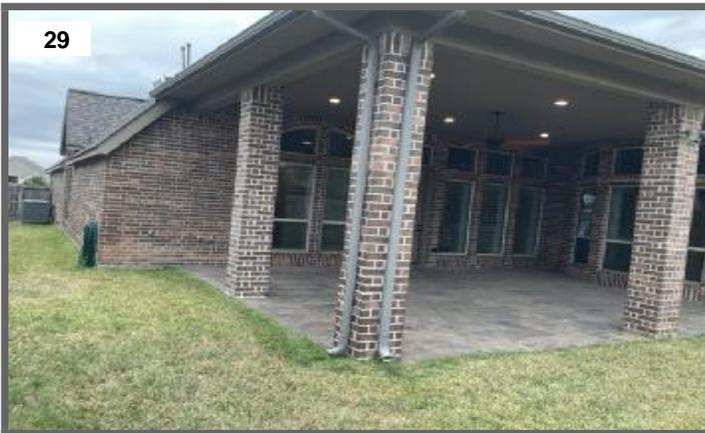
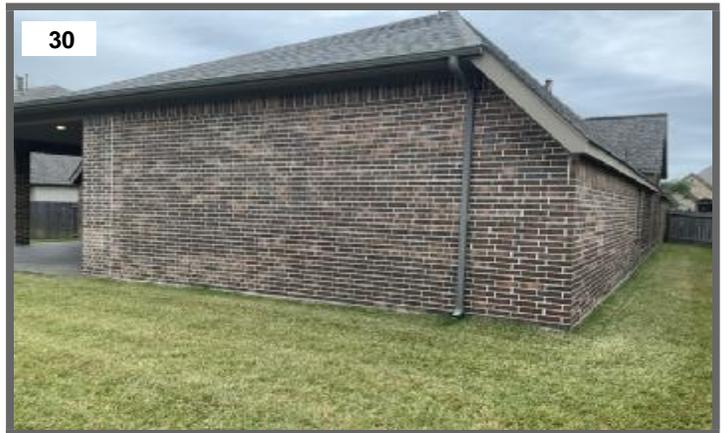
E: Structural: Walls Exterior

On the left side of the home there is paint on the brick under the hose bib from the painters cleaning their paint brushes .
 The exterior walls are in good overall condition .

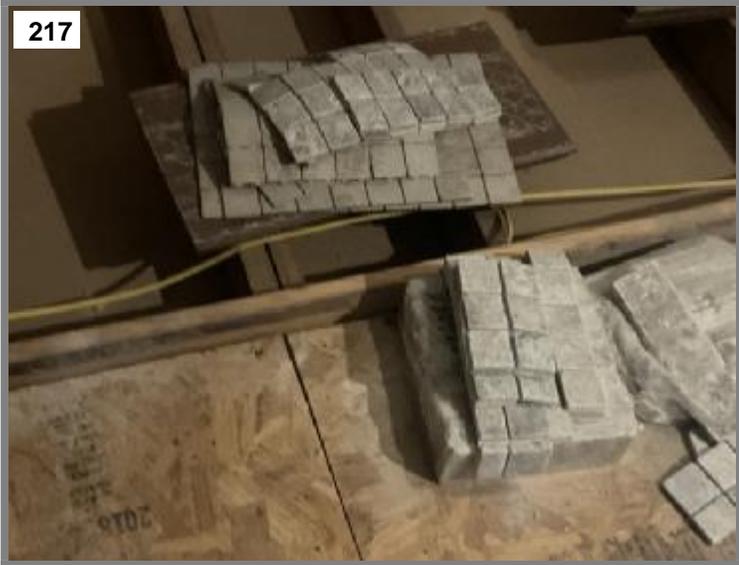
217
spare tiles

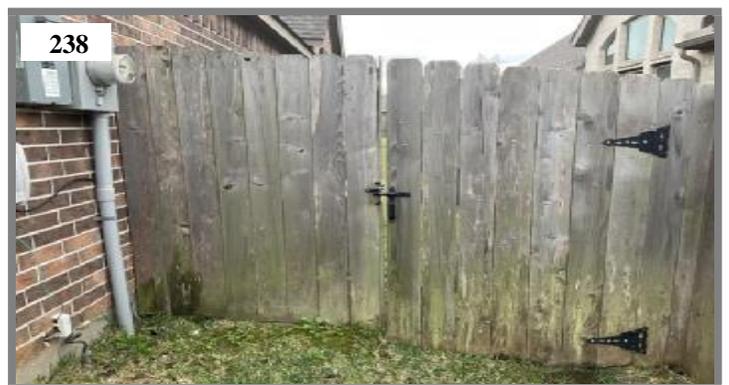
front right
Lock On Gate

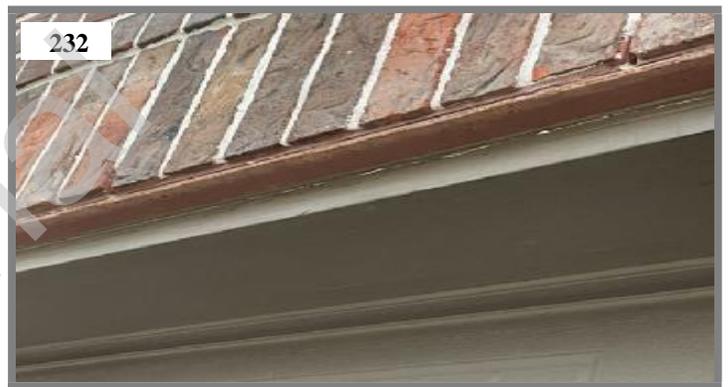
Lintel over both garage doors are primed only not painted

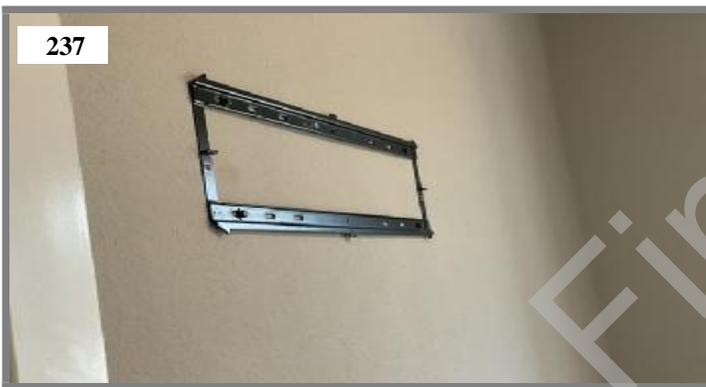
237

TV bracket mounted in front bedroom

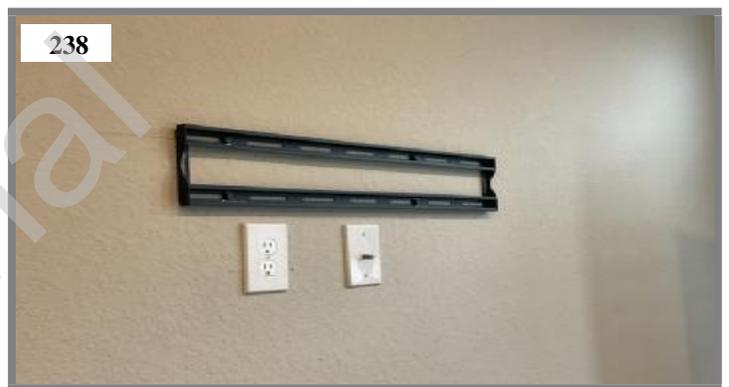
238

TV bracket mounted in the breakfast area

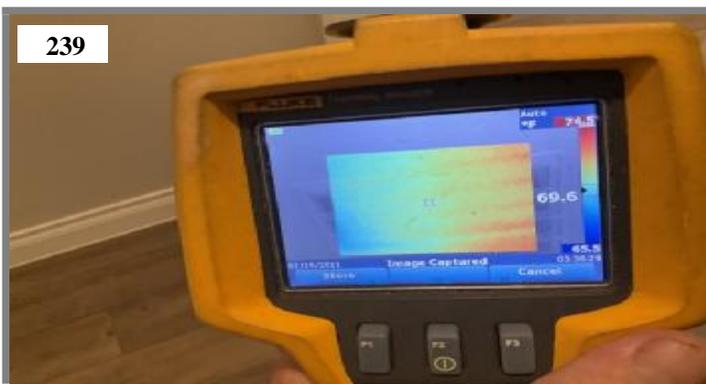
239

return air

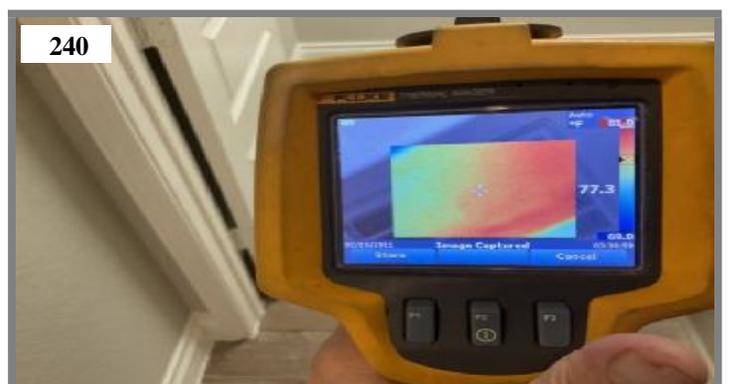
240

return air

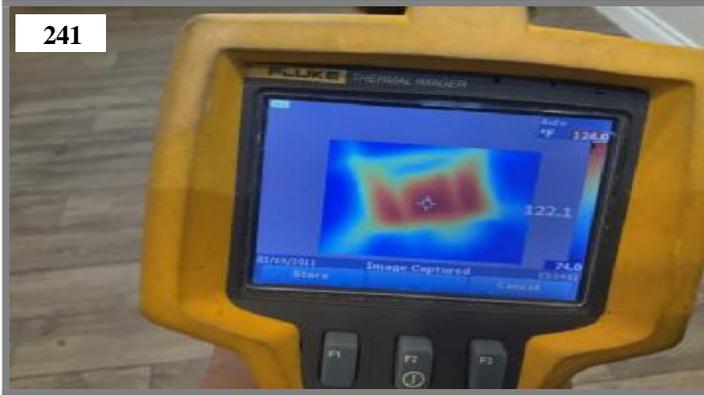
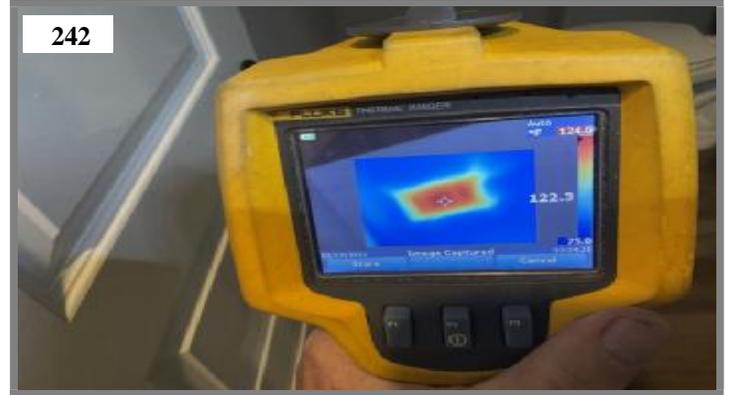
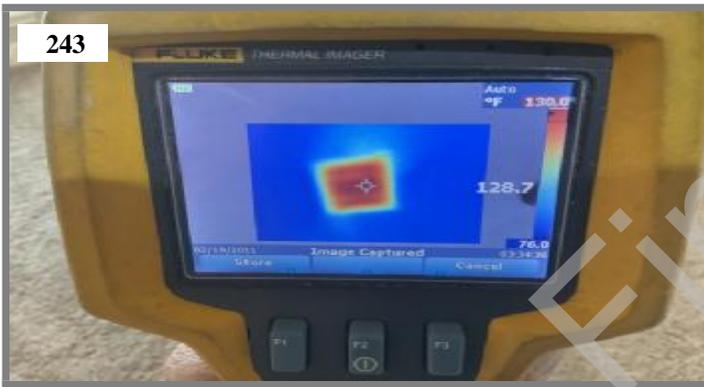
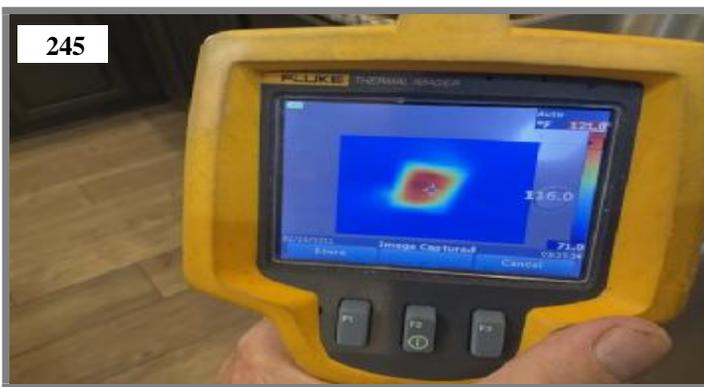
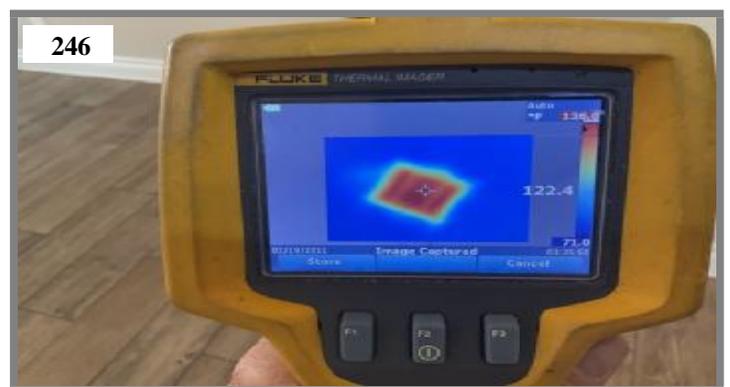
Thermal imaging Heat

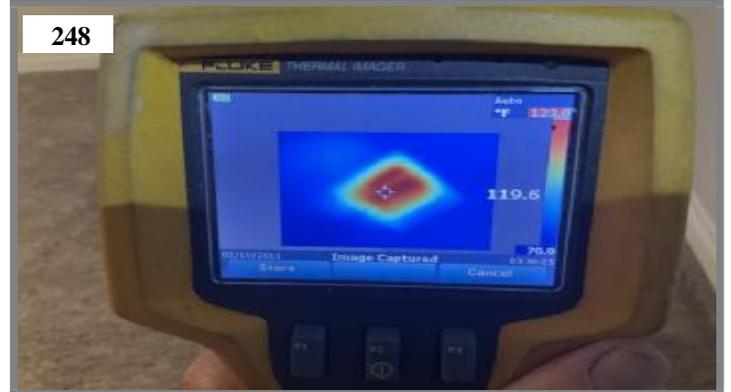
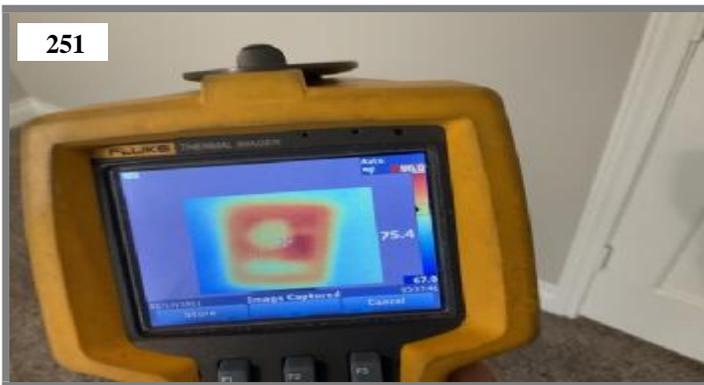
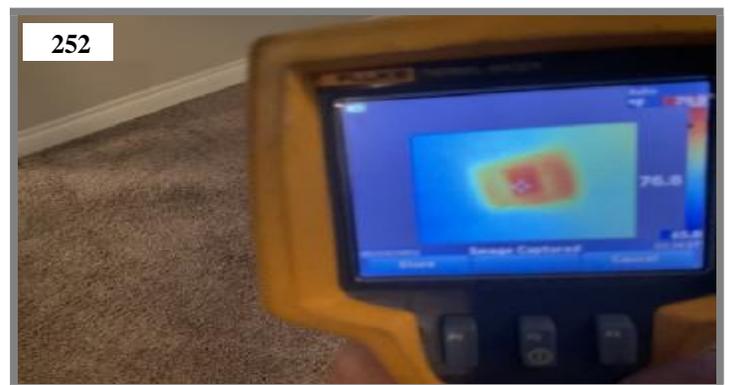
Thermal imaging Heat

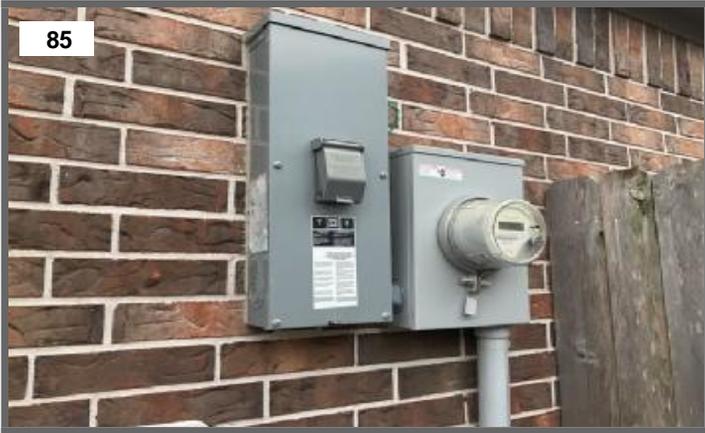
85

Meter

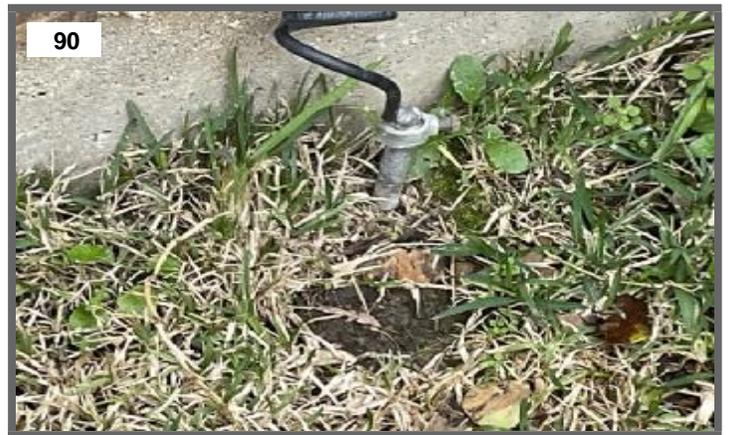
90

Ground rod

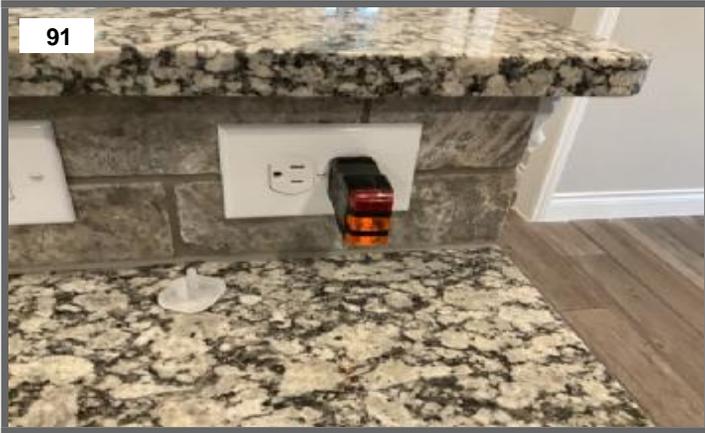
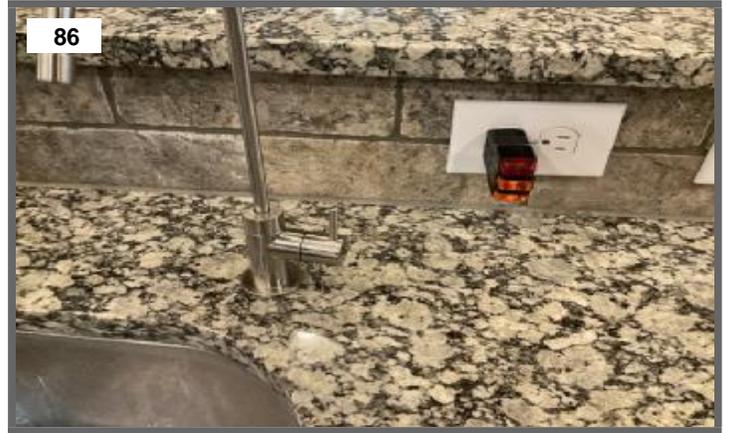
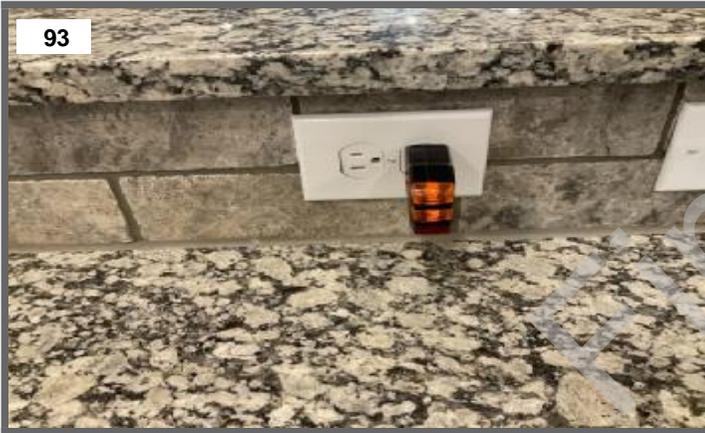
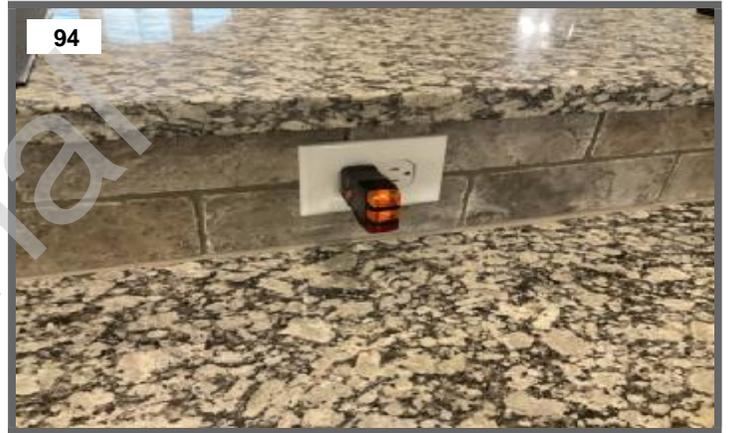
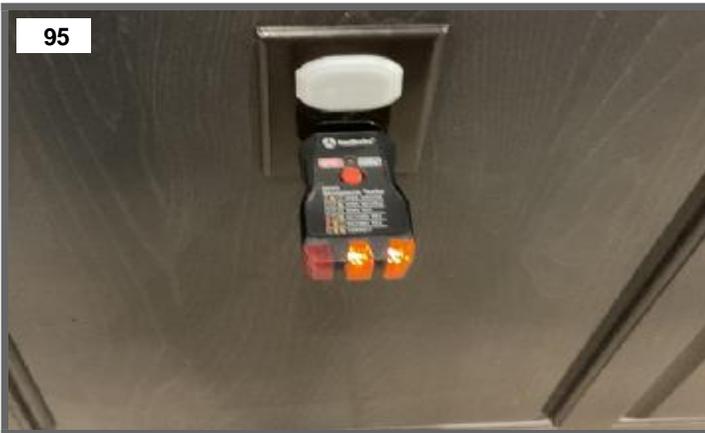
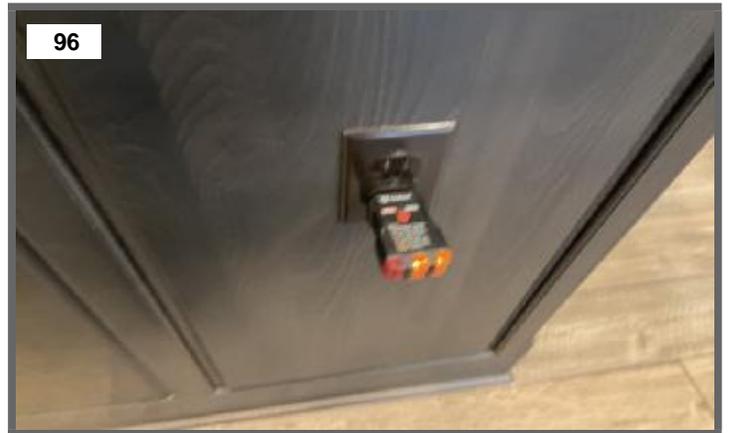
Yes GFCI

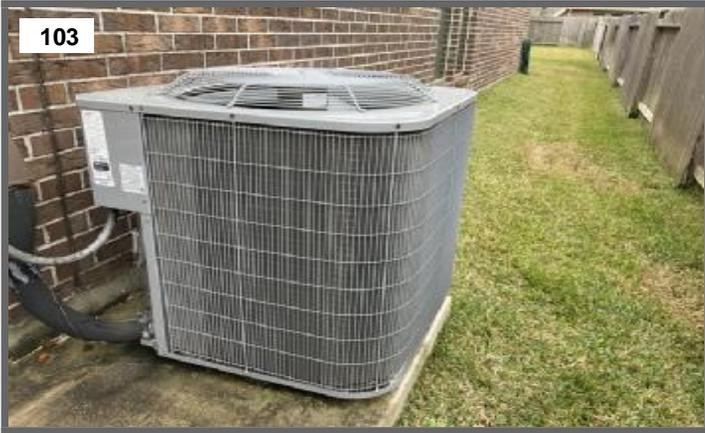
103

3.5 ton
R410A

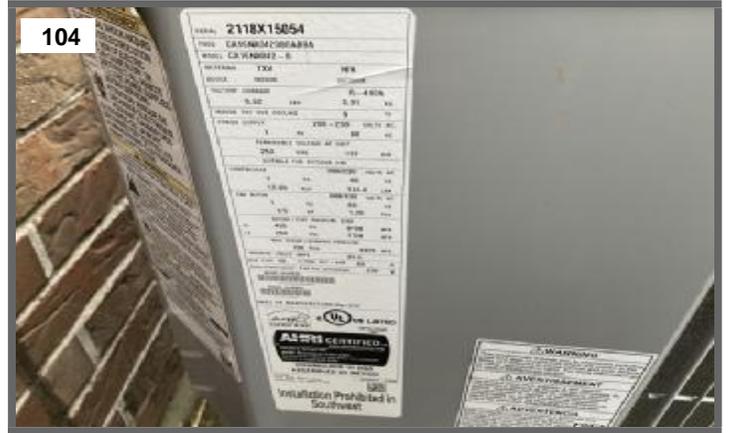
104

CA16NA042

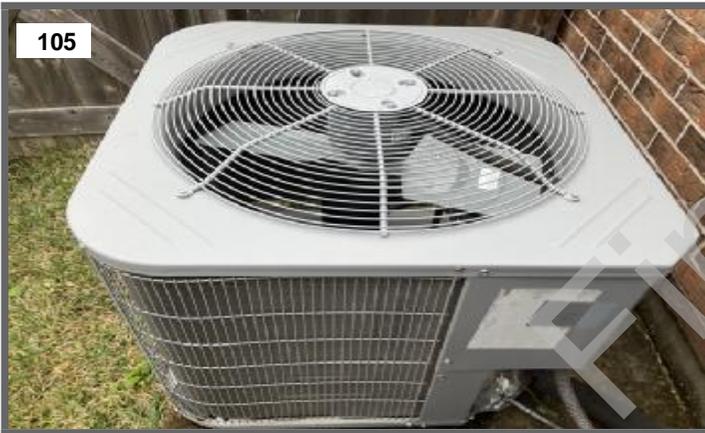
105

2 ton
R410A

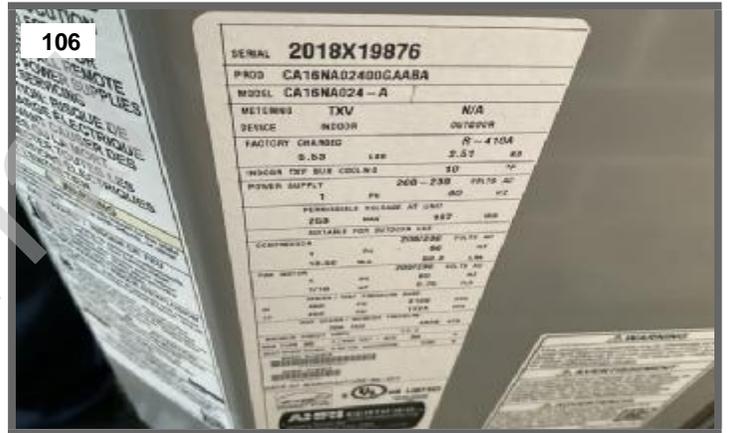
106

CA16NA024

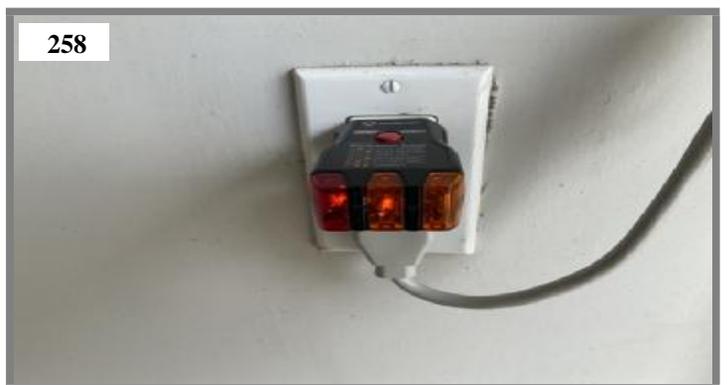
Sprinkler system outlet is hot/neutral reversed

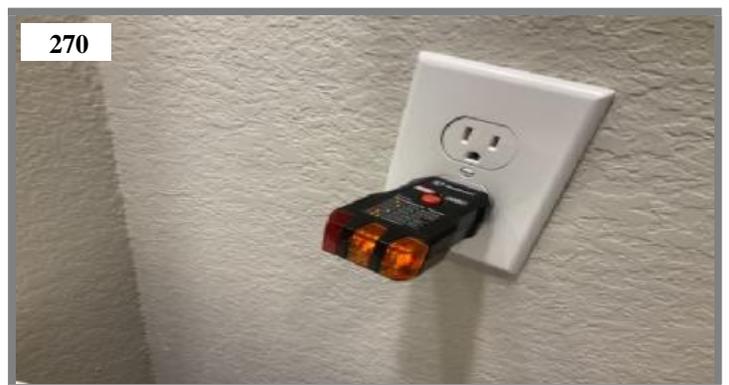
Bathroom outlets

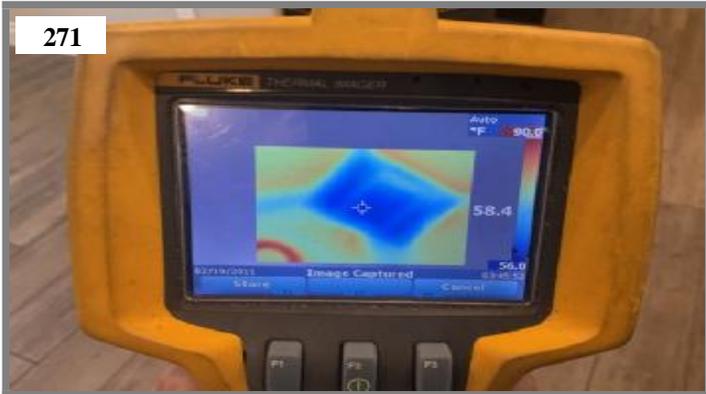
Thermal imaging AC main house

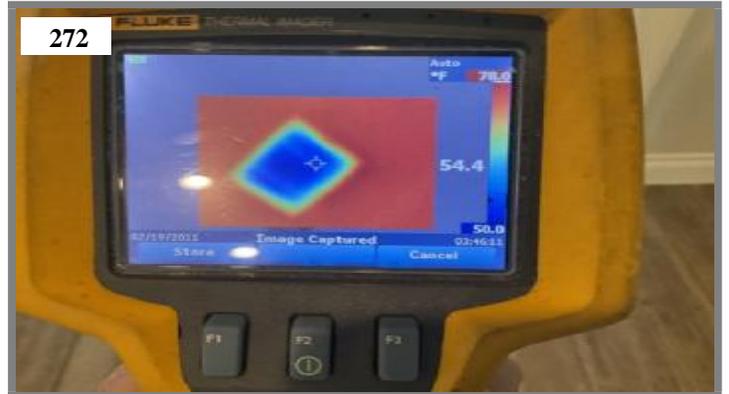
Thermal imaging AC main house

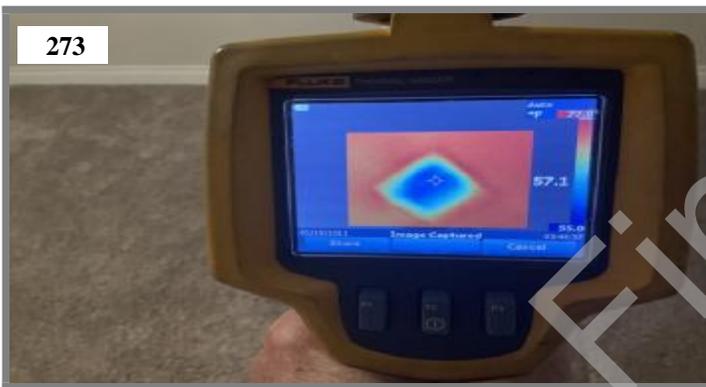
Thermal imaging AC main house

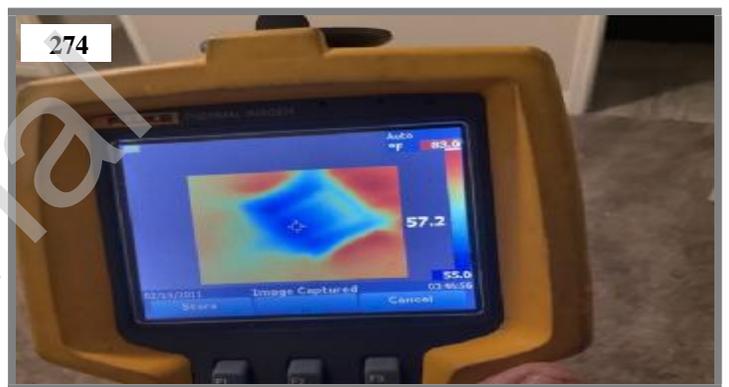
Thermal imaging AC main house

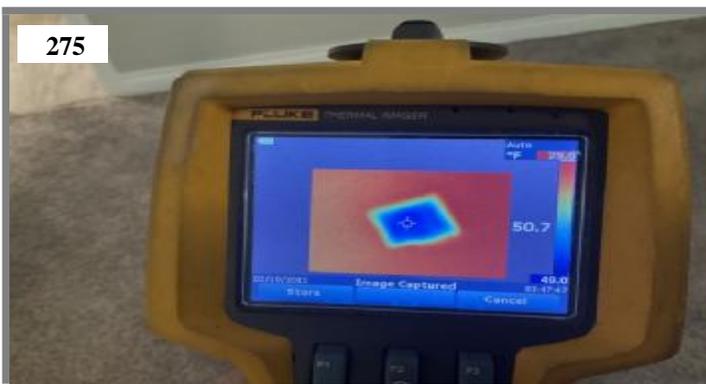
Thermal imaging AC master suite

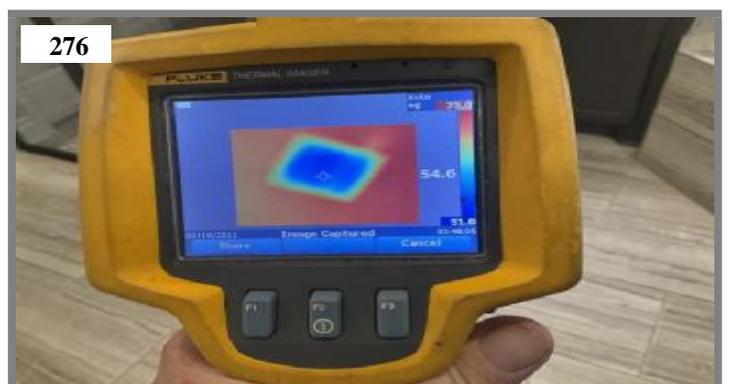
Thermal imaging AC master suite

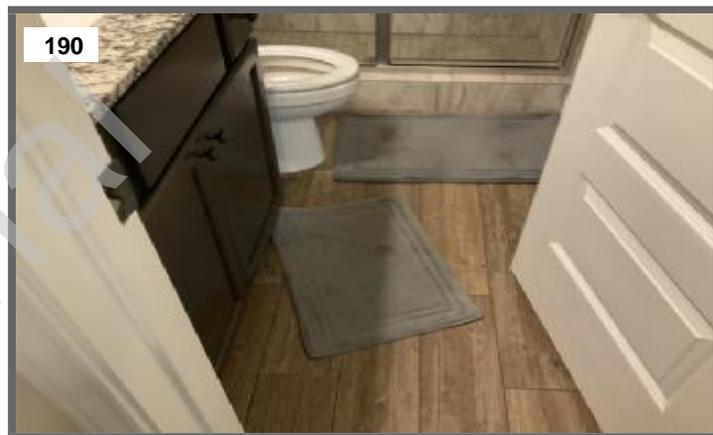
Guest bathroom

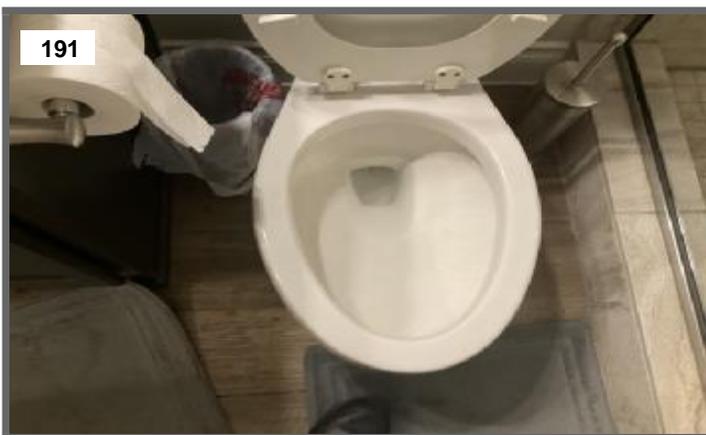
Guest bathroom

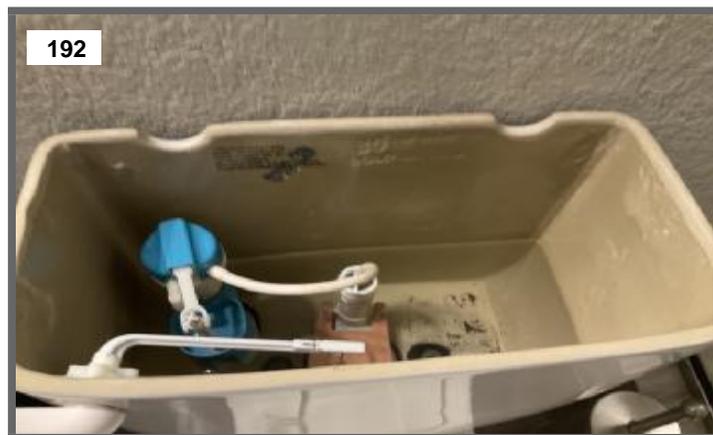
Guest bathroom

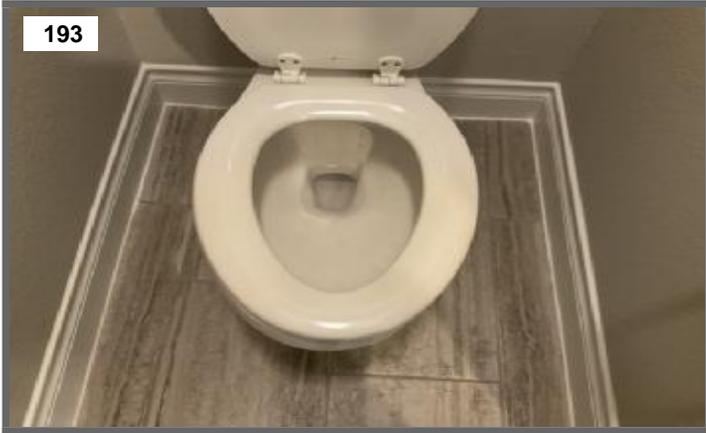
193

Master toilet

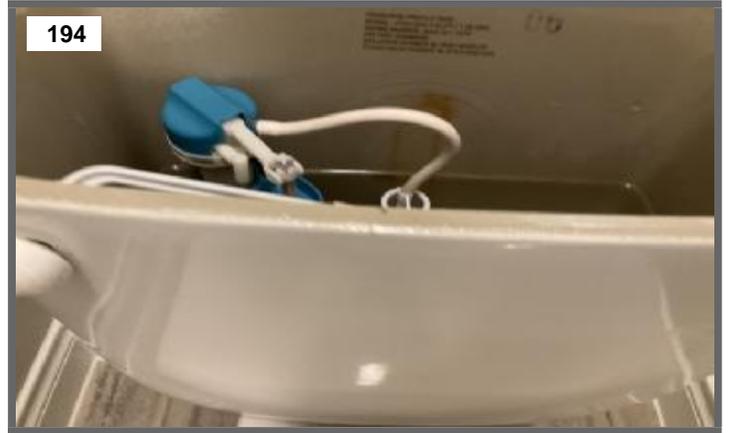
194

Master toilet

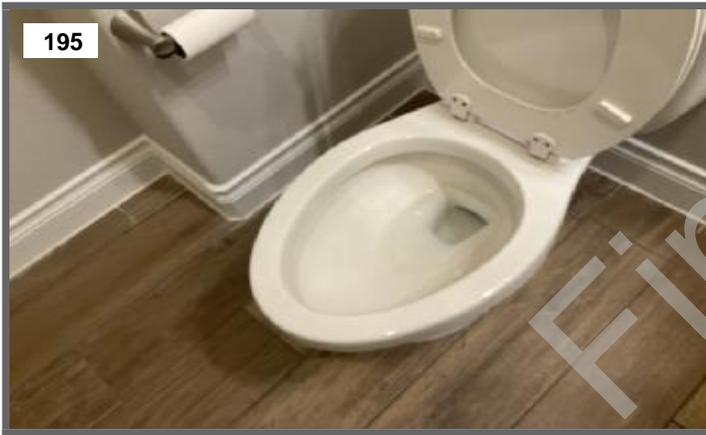
195

Powder room

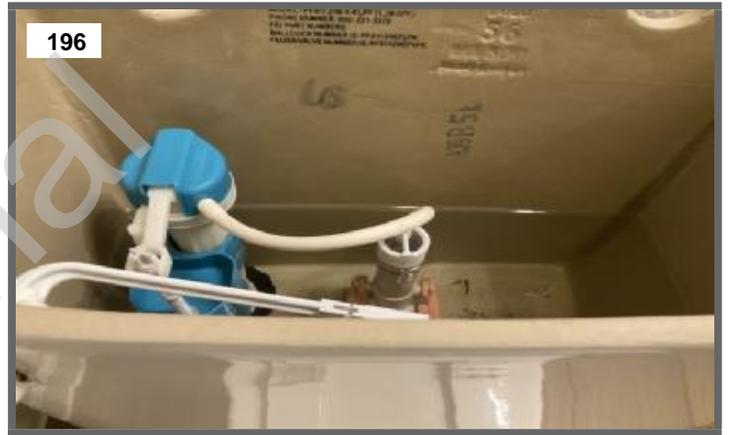
196

Powder room

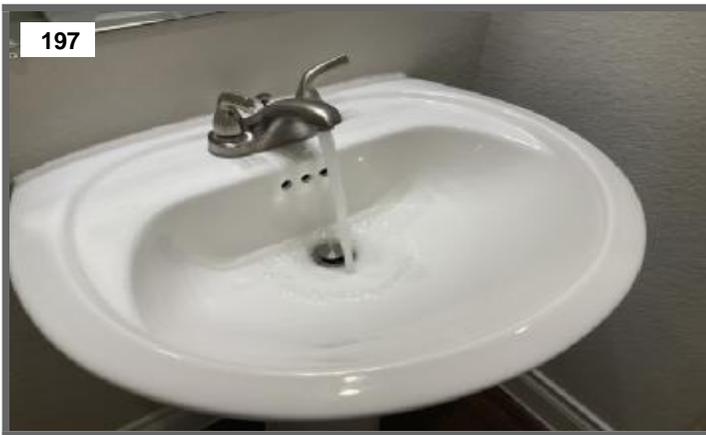
197

Powder room

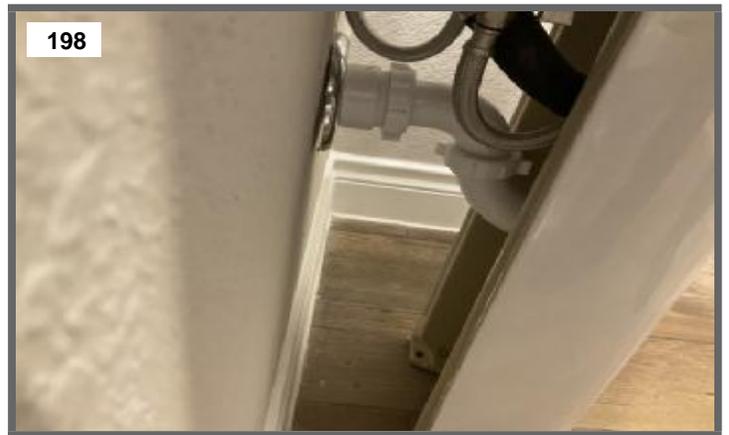
198

Powder room

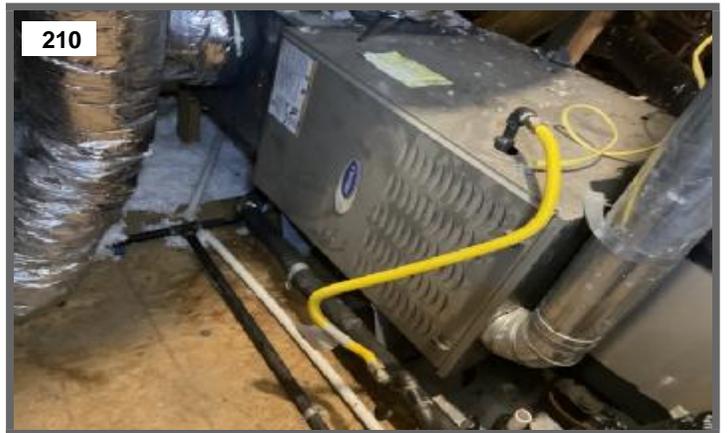
Furnace

The furnace exhaust pipe is in good condition

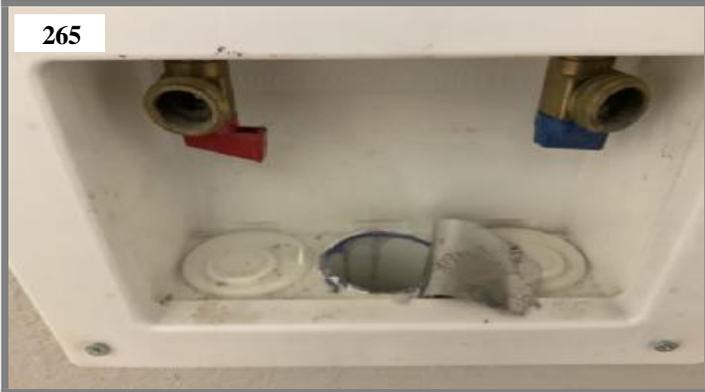
265

washer connection

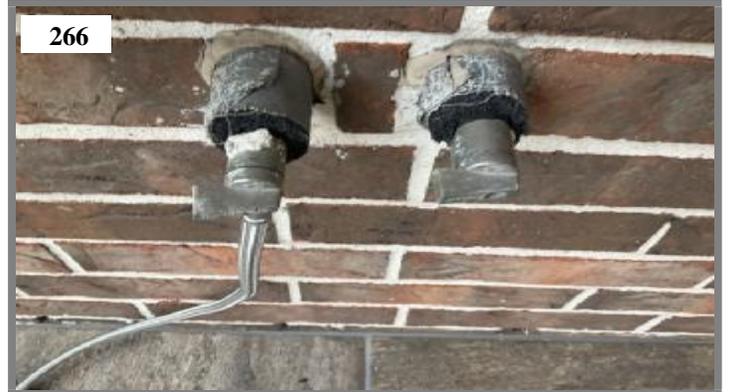
266

Water supply future outdoor kitchen

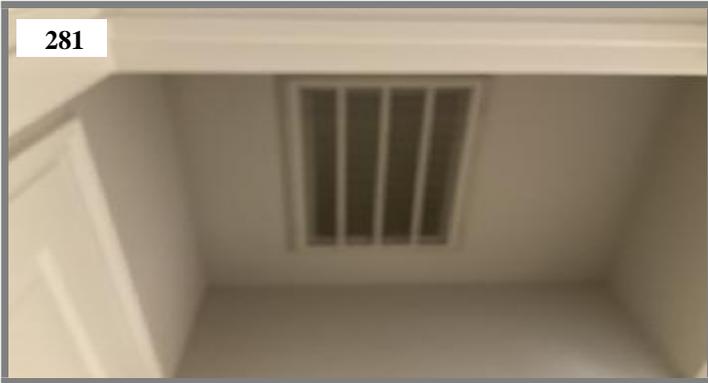
Thermal imaging AC master suite
