5934 Patridge Drive

Property Inspection Report

9/26/2023

**PERFORMANCE
INSPECTIONS, PLLC**

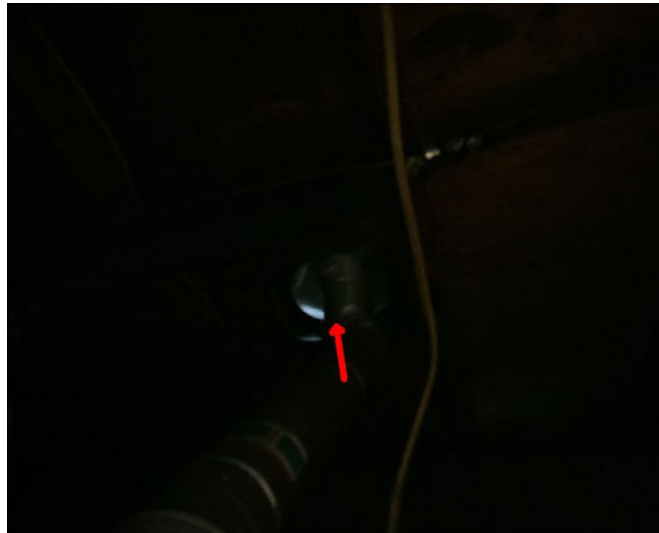
- Vent pipe were observed to be in need of repairs. This may be due to damaged pipes, incorrect termination or gaps in vent pipes which may be exposing daylight which may allow water or pest entry.

Roof jacks and flue pipes need seal improvements

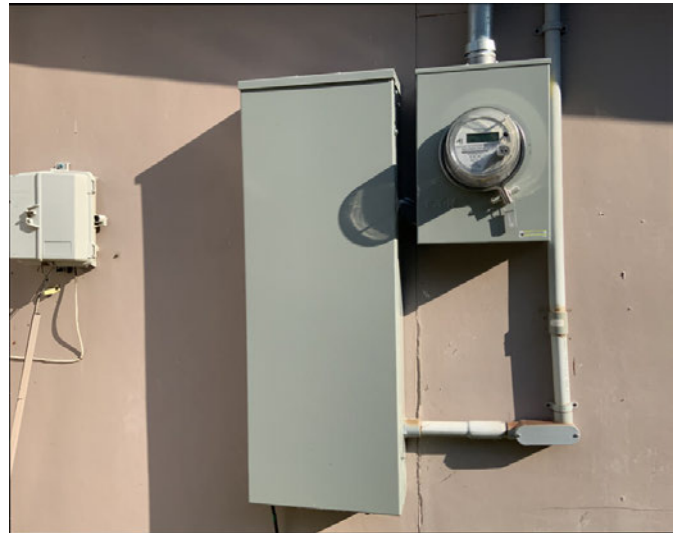
Ref photo

See ground rod requirements

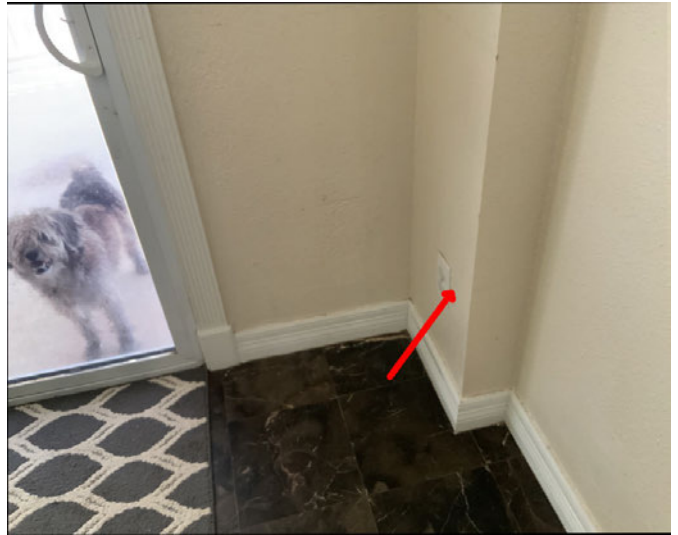
Inoperative outlet

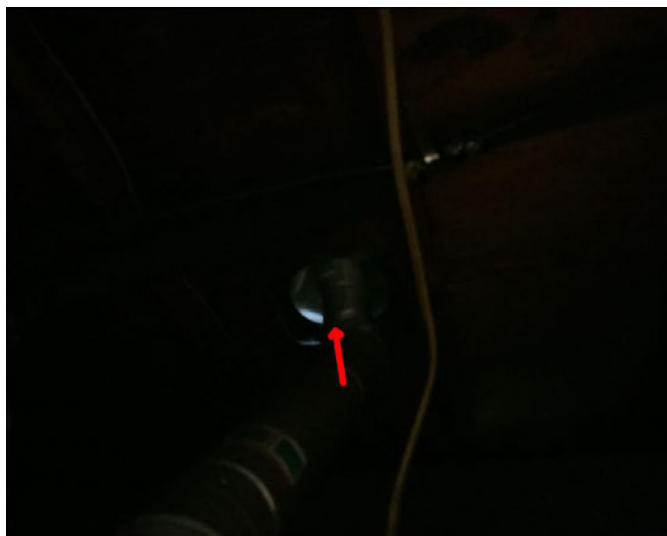
Roof jacks and flue pipes need seal improvements

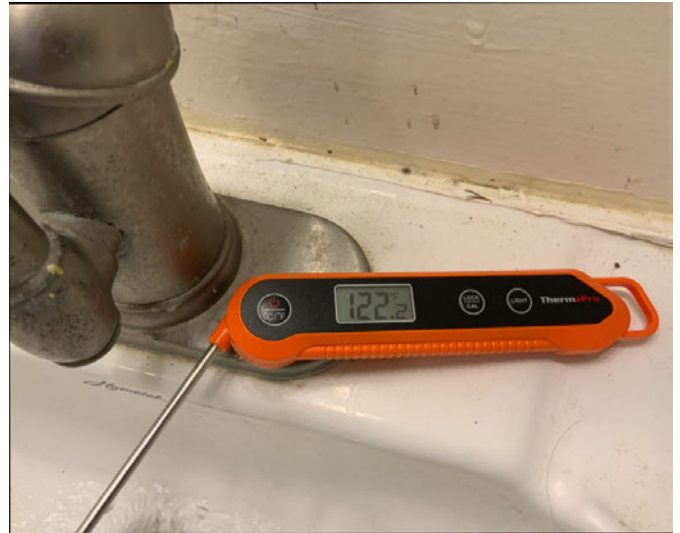
Ref photo

Damaged faucet
