Inspection Report

Property Address:
1200 LANGFORD DR
COLLEGE STATION TX 77840

Tucker Inspections LLC

PROPERTY INSPECTION REPORT FORM

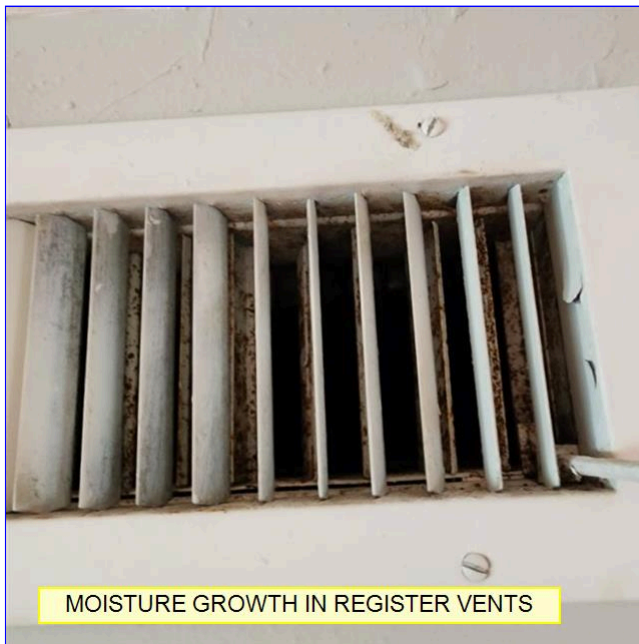
C. Item 2 (Picture)

There was what appears to be moisture growth in the register vents. Recommend further evaluation by a professional HVAC company.

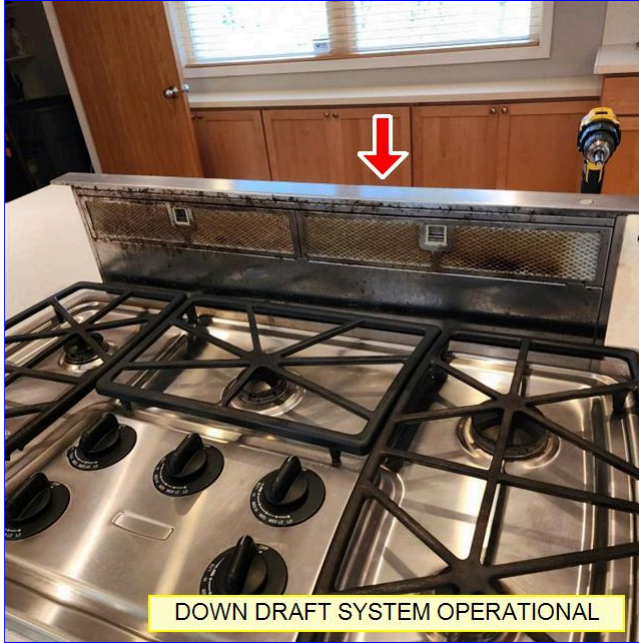
C. Item 1 (Picture)

I was unable to locate where the exhaust vent pipe terminates.

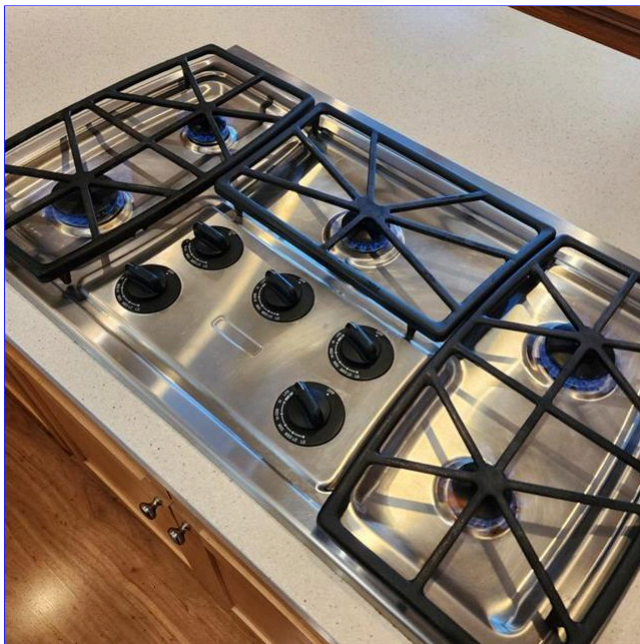
D. Item 2 (Picture)

Note: One of the burner knob trim pieces is melted.
