PROPERTY INSPECTION REPORT

23502 Greenwood Springs Place, Katy Texas 77493

February 23, 2024

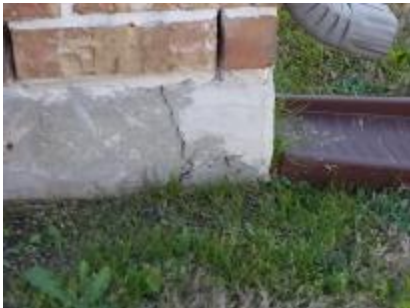
Left rear

Comments: corner pops/cracks at front left, right rear, right rear, rear left. exposed cable ends at rear and left. have contractor seal corner pops and exposed cables.

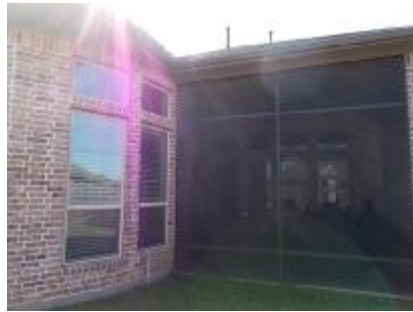
Rear right corner pop

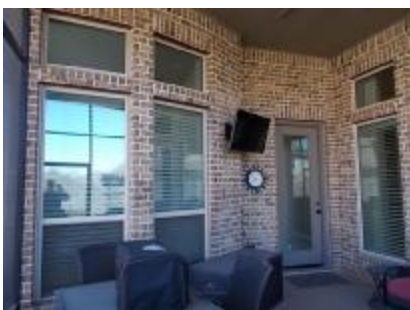
left side exposed cable end
