Total Home Inspection

Property Inspection Report

13322 Southshore Dr, Conroe, TX 77304
Inspection prepared for: Brook Mead
Real Estate Agent: -

Date of Inspection: 3/14/2024 Time: 9:00-11:30AM
Age of Home: 1968 Size: 1792
Weather: 70's clear
Order ID: 3696
Pre listing inspection. Home was occupied.

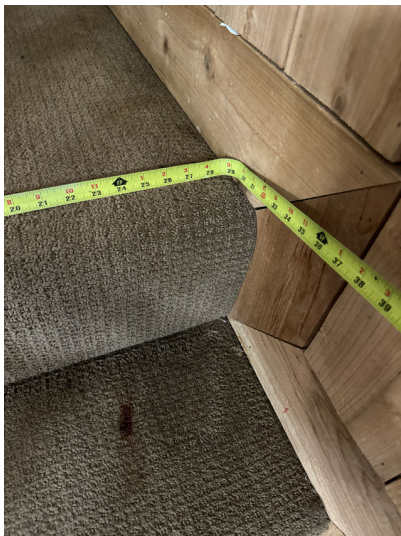
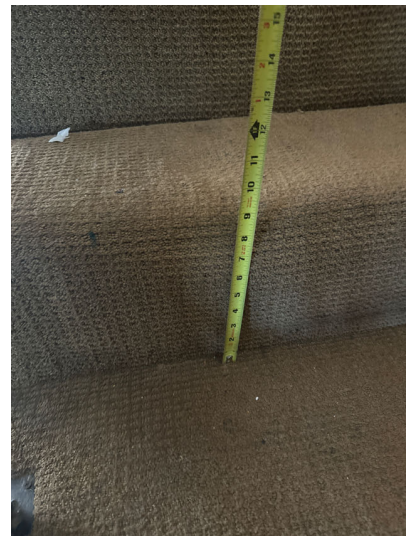
• Stair landing was not 36 x 36 inches on each side.

• Stair risers were taller than the standard 7.5 inch height.

Stair landing was not 36 x 36 inches on each side. Stair risers were taller than the standard 7.5 inch height.

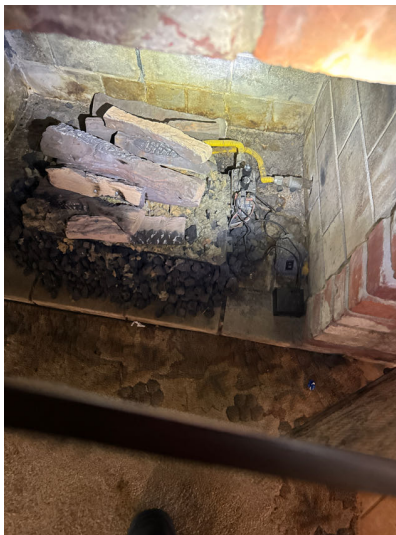
• Gas ceramic logs were present and damper should be blocked open with the presence of gas accessories.

• Ignition was not working. Pilot could not be lit.

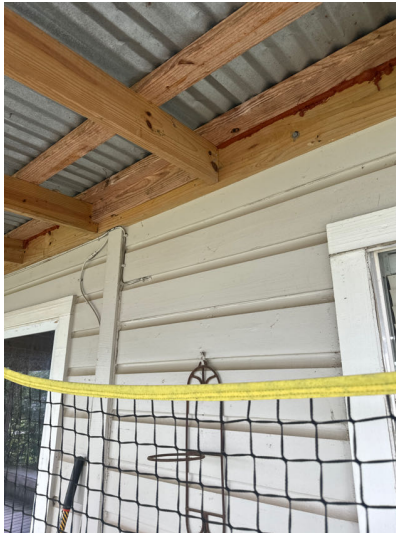
Hangers were not used on ceiling joists at the back patio cover.

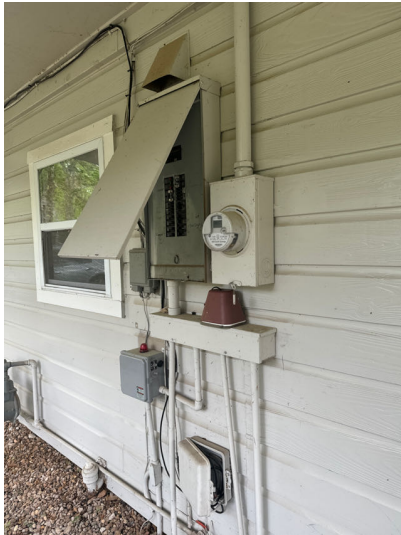
Electrical Systems Service Entrance and Panels All breakers for the panel boxes and/or sub panels must be clearly and permanently labeled for identification of particular circuit.

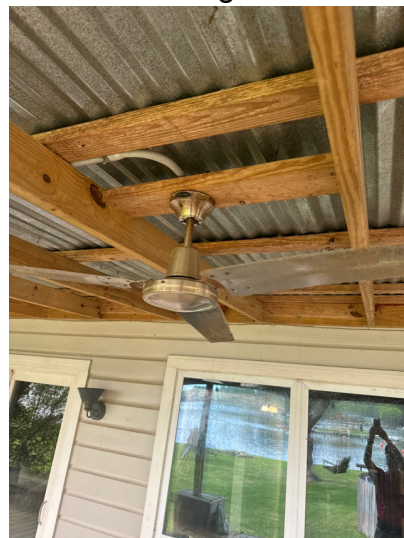
Conduit should continue to the ceiling fan junction boxes.

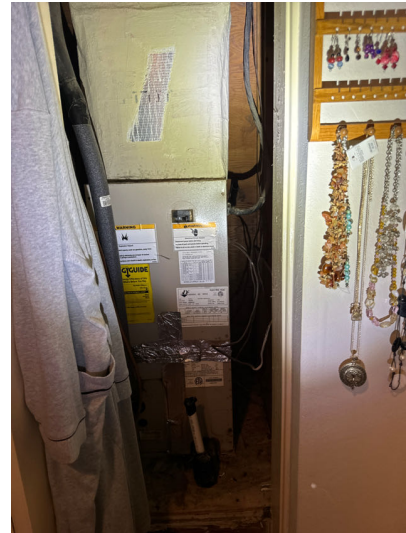
A forced air type, electric furnace was located in the kitchen utility closet and was manufactured by Nordyne in 2001. Furnace serviced the home with 7.5KW's. Furnace was operated, and unit appeared to be functioning as intended.

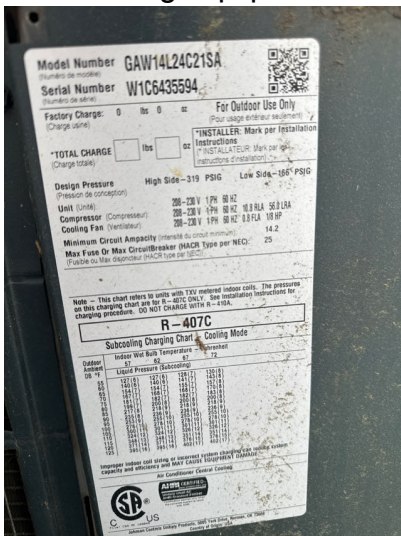
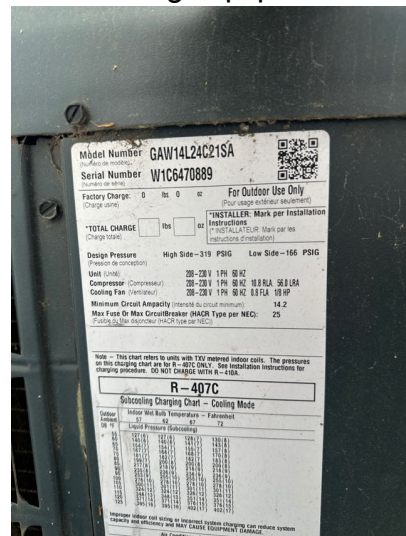
The Condensing units manufactured by York in 2016. Units appeared to be 2 ton each, 14 SEER, using 407C refrigerant. Per the manufacturer's label, max amps on breaker should be 25. Per the labeling on the electrical panel, AC was connected to a 25 amp breakers. 407C is a transition refrigerant that can be used with R22 refrigerant.

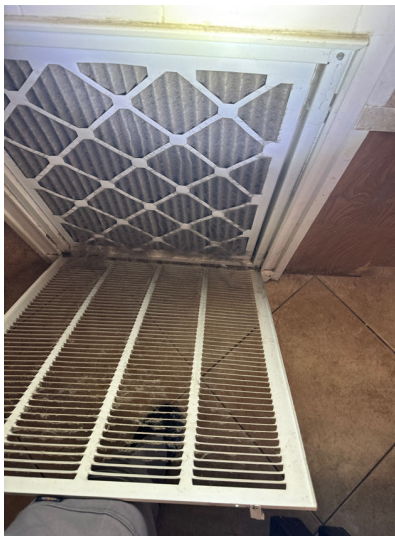
Air filters and chase were dirty. Advise to check records for service of these units. If records are not available we recommend cleaning and service by an HVAC professional.

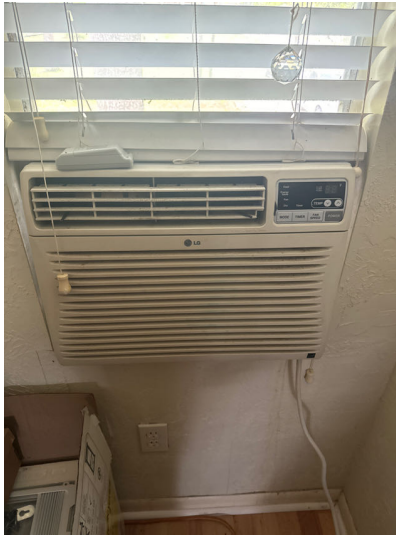
Several rooms had window air conditioning units as well as central air. Parts of the house did not have duct work from the central air system.

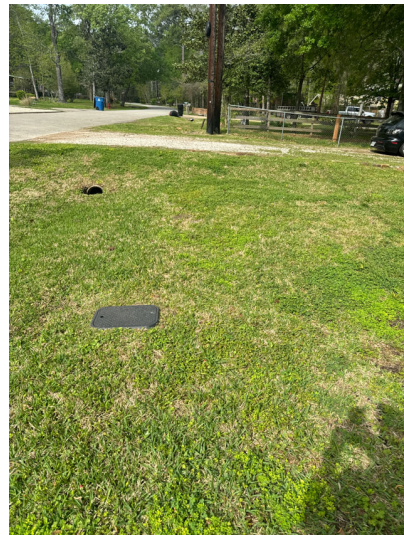
Water at the front of the yard.

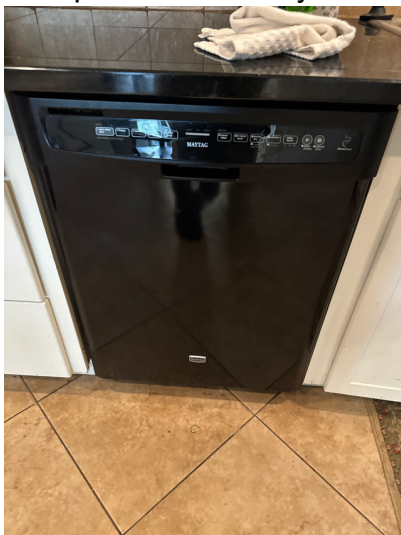
Maytag dishwasher operated normally.

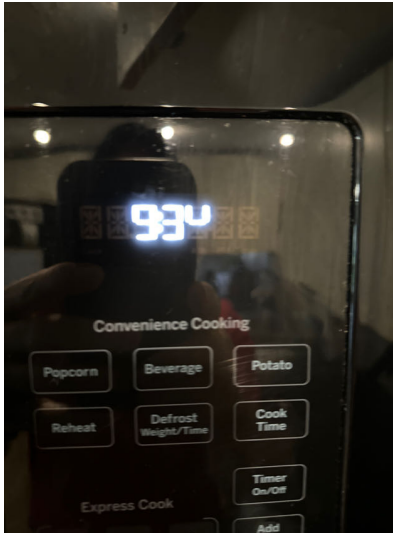
The digital display was missing pixels.
