Lone Star Stucco, LLC

Moisture Assessment Report

1316 Peden Street, Unit B

Houston, TX 77006

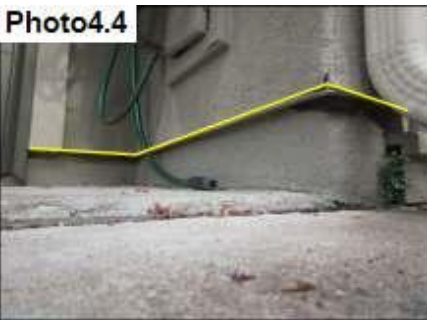
Photo4.4

Proper Grade Termination with Plaster Stop / Positive Detail

- Stucco appears to be typically detailed at grade for the time of this construction. The inspector suggests that this is a positive detail and recommends no modification at this time but to always keep soil away from the structure. Please refer to photos #4.2, #4.3, #4.4, #4.5 and #4.6 for more detail.

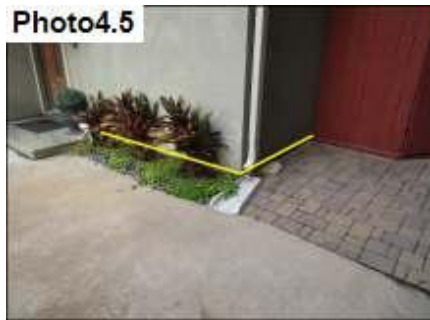
Photo4.5

Proper Grade Termination with Plaster Stop / Positive Detail

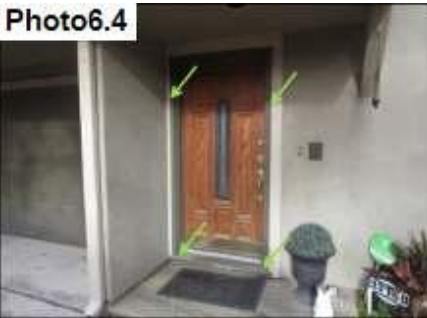
Photo6.4

Door Sealants / Seal

- The door trim and miter sealants are aged or separated at these locations. The inspector suggests to have a qualified waterproofing contractor seal these areas with a low modulus sealant in an effort to prevent moisture intrusion. These types of sealants are of high quality and compatible with stucco and other termination points. Please refer to photos #6.2, #6.3, #6.4, #6.5 and #6.6 for more detail.

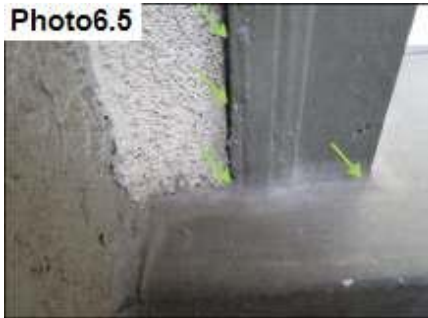
Photo6.5

Door Sealants / Seal

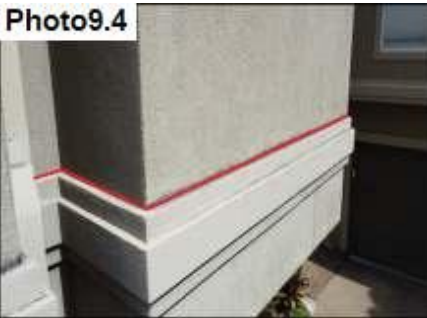
Photo9.4

Foam Accent & Stucco Termination / Seal

- Foam accent/stucco termination sealants are aged at these locations. The inspector suggests to have a qualified waterproofing contractor further assess and seal these areas with a low modulus sealant in an effort to prevent moisture intrusion. These types of sealants are of high quality and compatible with stucco and other termination points. Please refer to photos #9.2, #9.3, #9.4, #9.5 and #9.6 for more detail.

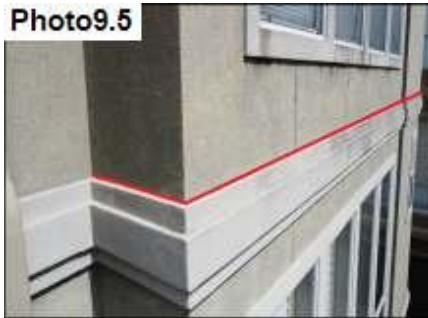
Photo9.5

Foam Accent & Stucco Termination / Seal

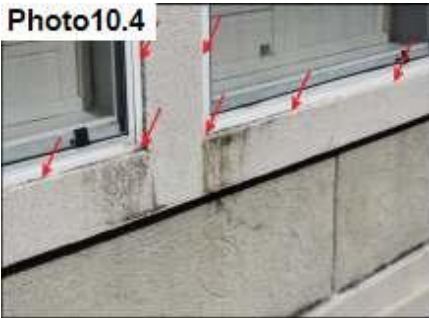
Photo10.4

Window Sealants / Seal

- The window sealants are aged or separated. The inspector suggests to have a qualified waterproofing contractor further assess and seal these areas with a low modulus sealant in an effort to prevent moisture intrusion. These types of sealants are of high quality and compatible with stucco and other termination points. Please refer to photos #10.2, #10.3, #10.4, #10.5 and #10.6 for more detail.

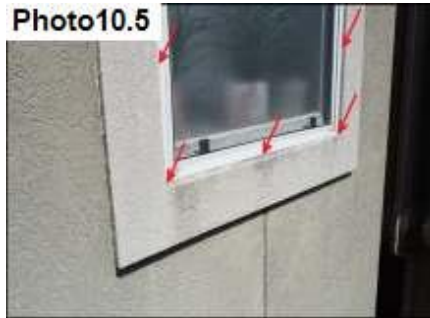
Photo10.5

Window Sealants / Seal

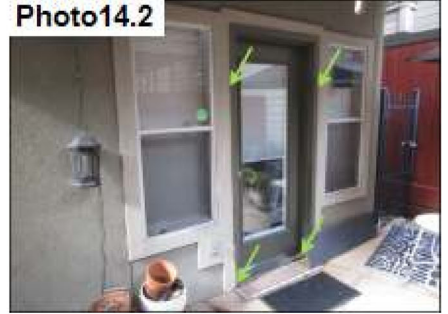
Photo14.2

Door Sealants / Seal

- The door trim and miter sealants are aged, separated or missing at these locations. The inspector suggests to have a qualified waterproofing contractor seal these areas with a low modulus sealant in an effort to prevent moisture intrusion. These types of sealants are of high quality and compatible with stucco and other termination points. Please refer to photos #14.2, #14.3 and #14.4 for more detail.

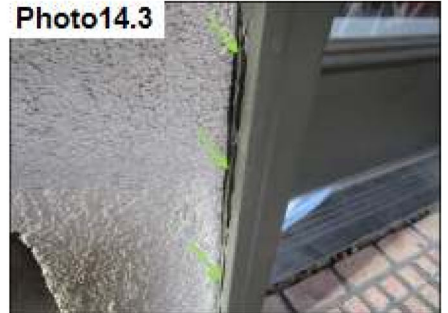
Photo14.3

Door Sealants / Seal

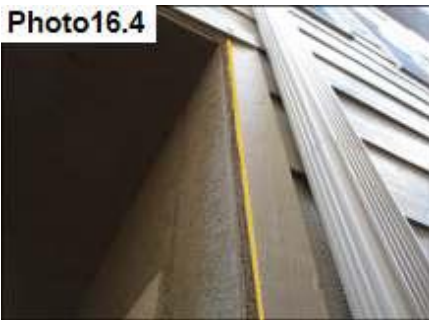
Photo16.4

Trim & Stucco Termination / Seal

- Trim/stucco termination sealants are aged or separated at this location. The inspector suggests to have a qualified waterproofing contractor further assess and seal this area with a low modulus sealant in an effort to prevent moisture intrusion. These types of sealants are of high quality and compatible with stucco and other termination points. Please refer to photos #16.2, #16.3, #16.4, #16.5 and #16.6 for more detail.

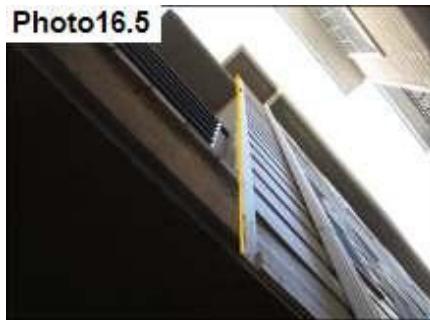
Photo16.5

Trim & Stucco Termination / Seal

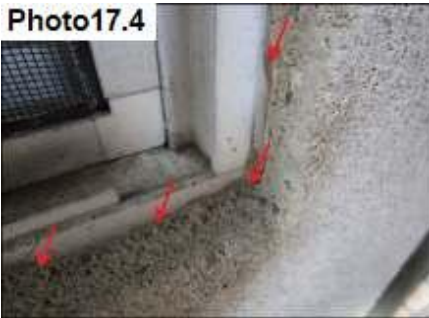
Photo17.4

Window Sealants / Seal

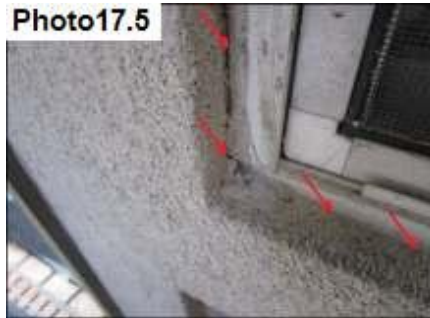
Photo17.5

Window Sealants / Seal

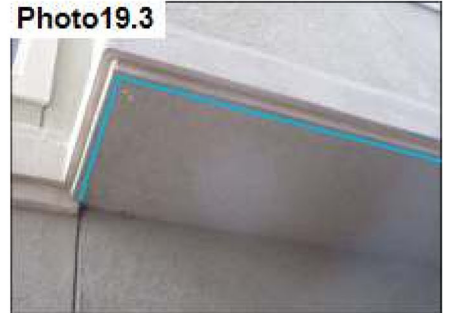
Photo19.3

No Relief / No Modification but Maintain Sealants Above

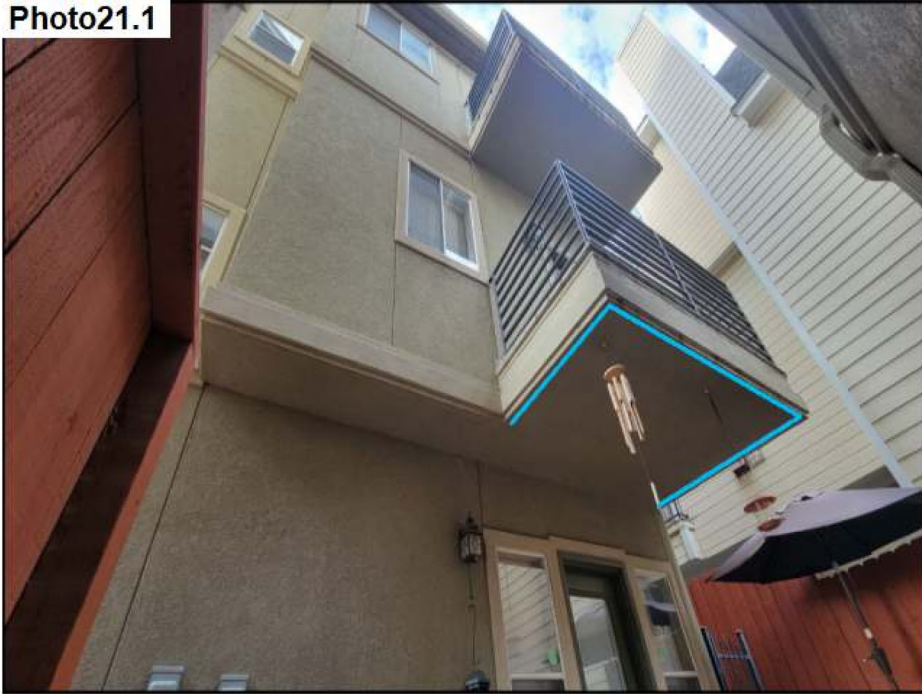
Photo21.1

Grid Location	Item Description	Moisture Readings	Substrate Condition	Observations
Blue Line	Relief			Although the bottom of the second floor balcony does not have a proper relief, this was a proper detail at the time of construction. Upon invasive testing at this location, the substrate was semi-firm with elevated moisture readings. The inspector recommends a qualified waterproofing contractor assess this area. No damage was noted at this time, however, it is recommended to maintain all sealants above. Please refer to photos #21.2, #21.3 and #21.4 for more detail.

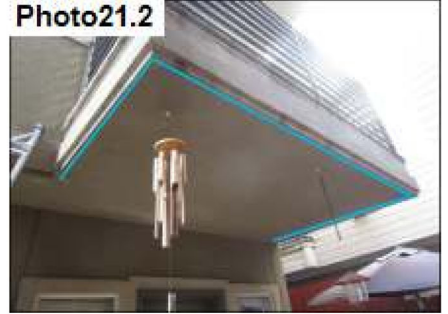
Photo21.2

- Although the bottom of the second floor balcony does not have a proper relief, this was a proper detail at the time of construction. Upon invasive testing at this location, the substrate was semi-firm with elevated moisture readings. The inspector recommends a qualified waterproofing contractor assess this area. No damage was noted at this time, however, it is recommended to maintain all sealants above. Please refer to photos #21.2, #21.3 and #21.4 for more detail.

No Relief / No Modification but Maintain Sealants Above

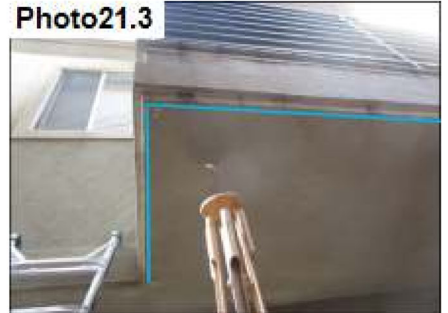
Photo21.3

No Relief / No Modification but Maintain Sealants Above

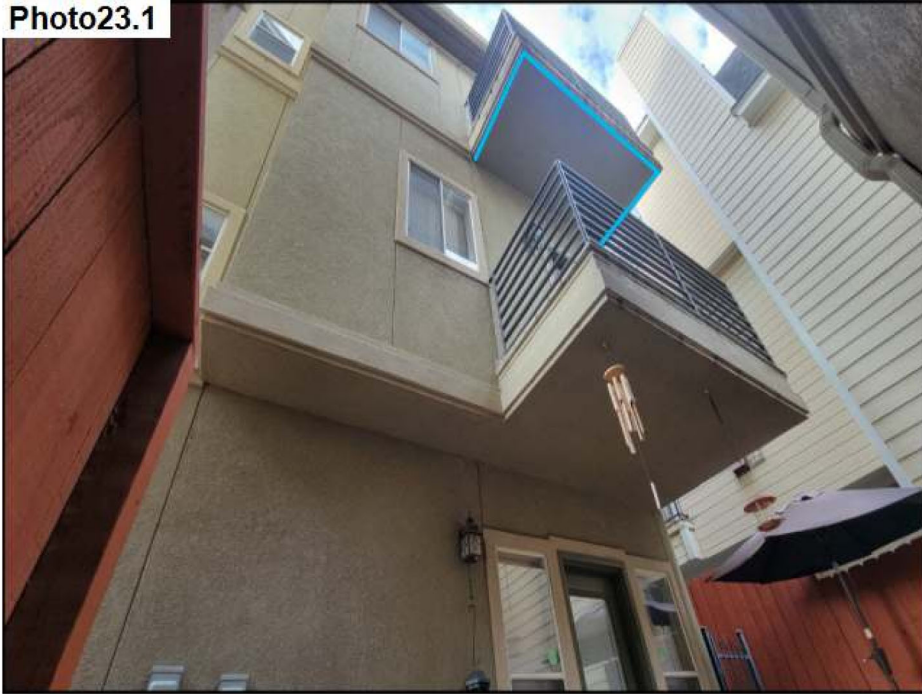
Photo23.1

Grid Location	Item Description	Moisture Readings	Substrate Condition	Observations
Blue Line	Relief			Although the bottom of the third floor balcony does not have a proper relief, this was a proper detail at the time of construction. Upon invasive testing at this location, the substrate was firm with acceptable moisture readings. The inspector recommends no modification at this point in time but recommends to maintain all sealants above this location to prevent potential moisture intrusion. Please refer to photos #23.2, #23.3 and #23.4 for more detail.

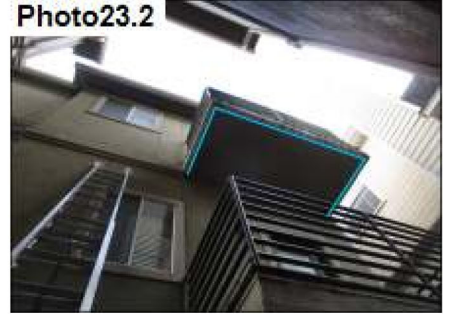
Photo23.2

- Although the bottom of the third floor balcony does not have a proper relief, this was a proper detail at the time of construction. Upon invasive testing at this location, the substrate was firm with acceptable moisture readings. The inspector recommends no modification at this point in time but recommends to maintain all sealants above this location to prevent potential moisture intrusion. Please refer to photos #23.2, #23.3 and #23.4 for more detail.

No Relief / No Modification

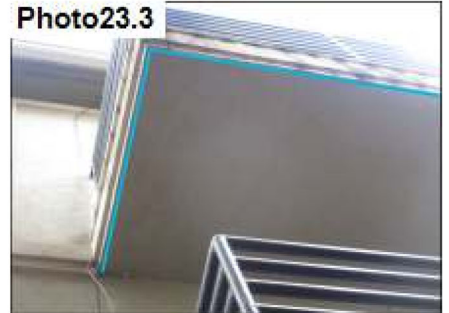
Photo23.3

No Relief / No Modification
