Inspection for Property located at 20259 Beechview Ln
04/23/2024
Prepared for : Jose R Peniche

PROPERTY INSPECTION REPORT FORM

20259 Beechview Ln, Katy, TX 77449

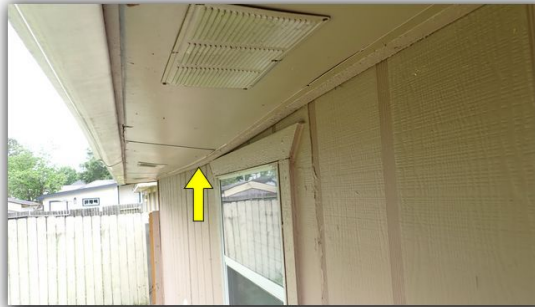
Stairway to attic is missing insulation on stairway and weatherstrip at the frame.

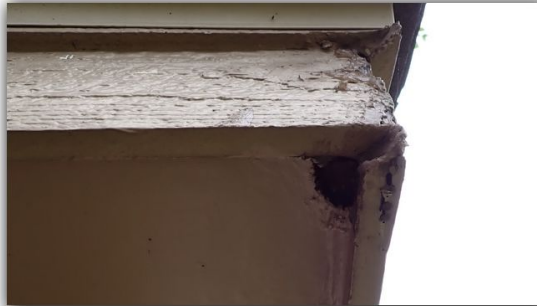
Wood rot observed on areas of house / garage.

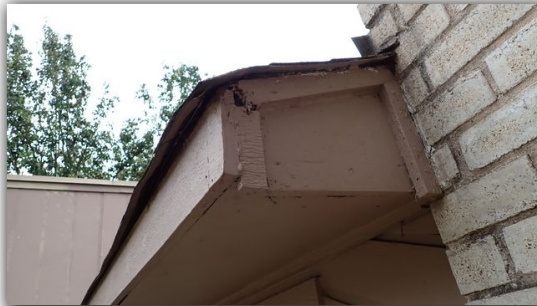
Damaged siding and/or trim at one or more locations.

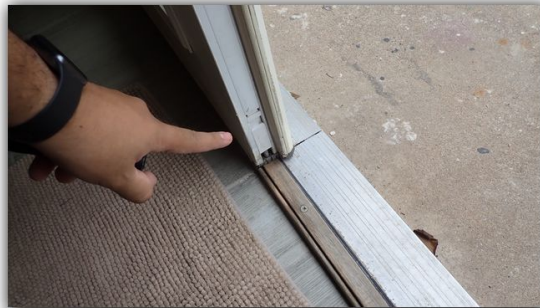
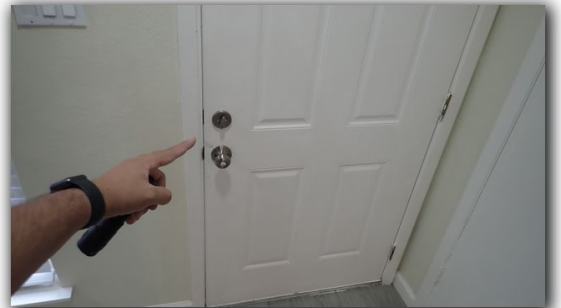
One or more door(s) have sticky hardware.

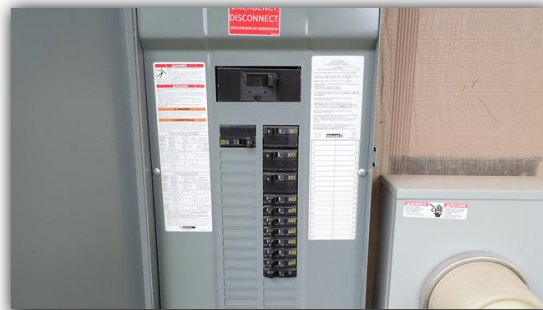
Not all breakers are properly and uniquely identified.

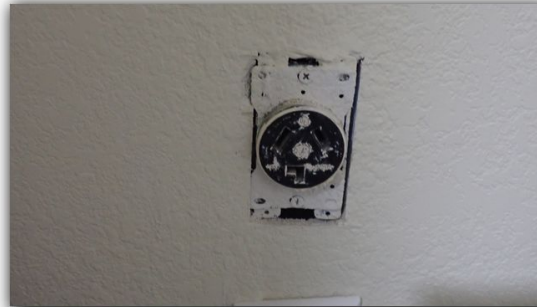
One or more cover plates were either missing or damaged.

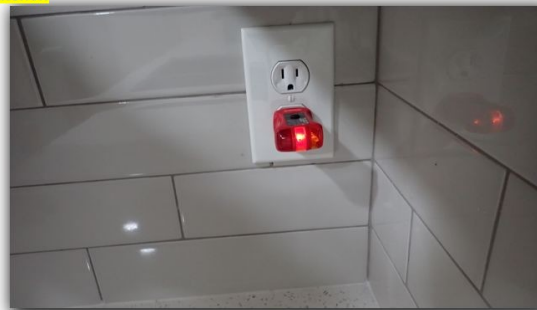
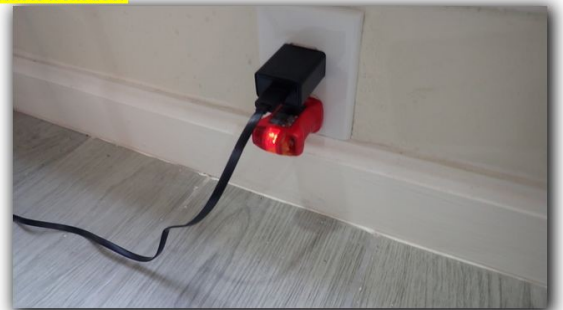
3-prong outlet not grounded, including but not limited to:

Kitchen

next to front door

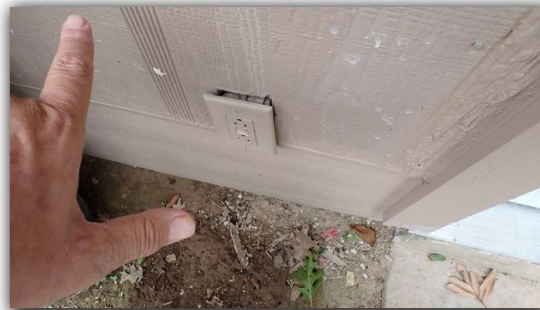
One or more outlets are not secured well in wall.

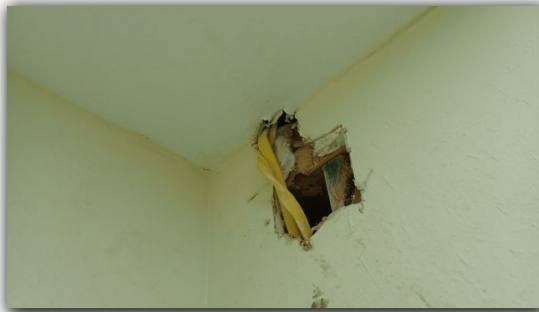
Exposed wiring in the drywall of the foyer closet.

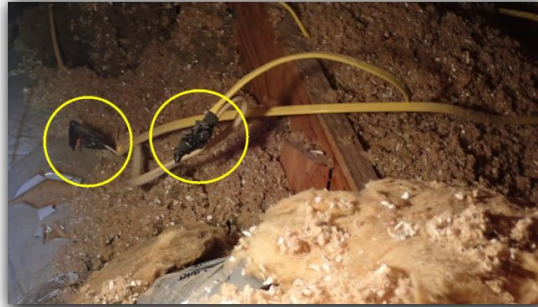
Wire connections are not enclosed in proper electrical junction box(s), or electrical junction box(s) do not have covers in place, including but not limited to the following location; Attic

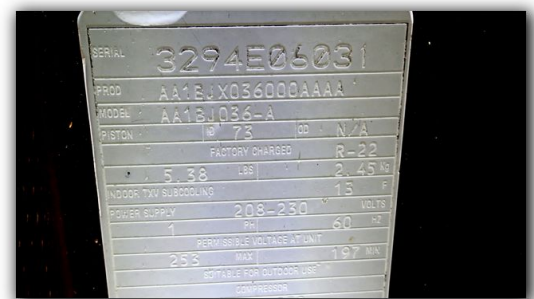
The air conditioner produces a differential temperature of 23.6 degrees F. Temperature differential is too great, indication of possible air flow restriction across coil and/or low Freon charge, needs service.

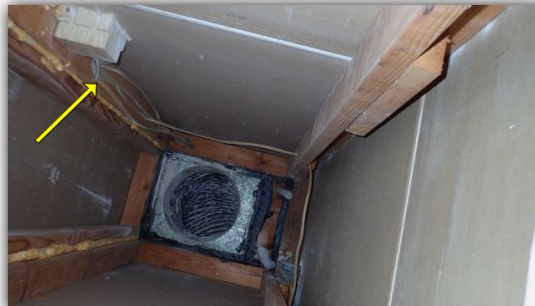
120 Volt electrical wiring improperly located in return air chase. Does not comply with current industry standard/code. Ref. NEC 300-22(c).

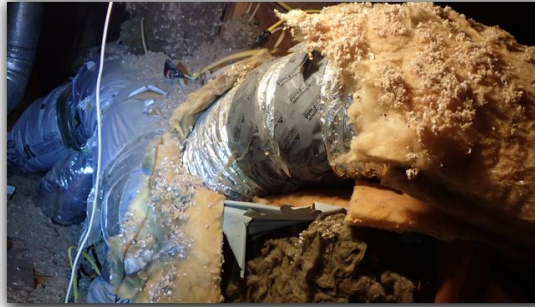
Some gray duct wrapping damaged on ducts in attic needs to be repaired. This product appears to be type that was recalled many years ago due to deterioration of exterior vapor barrier when exposed to light.

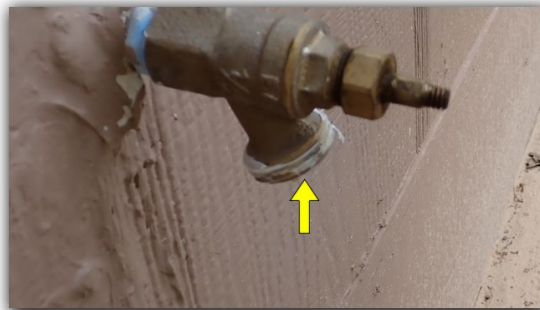
Exterior hose spigot(s) do not have code approved anti-back flow devices installed.

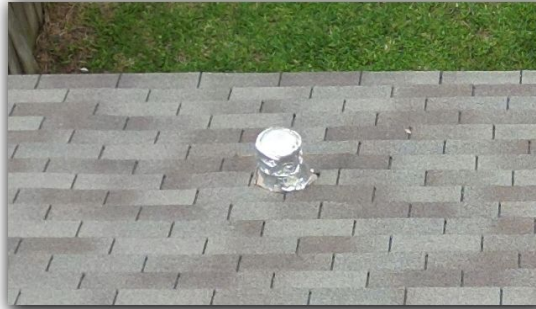
Roof vent has been blocked with tape.

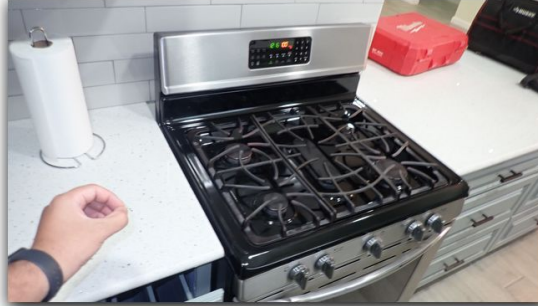
Comments: Gas valve improperly located more than 3 feet from unit and/or on opposite side of unit.

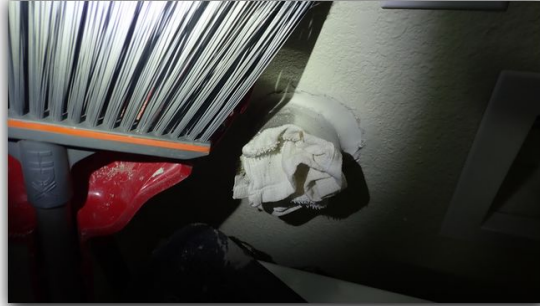
Comments: Dryer vent was covered with a rag, could not properly inspect.
