21418 Park Rock Ln
Katy, TX 77450
Kachi Osuorji

06/27/2024

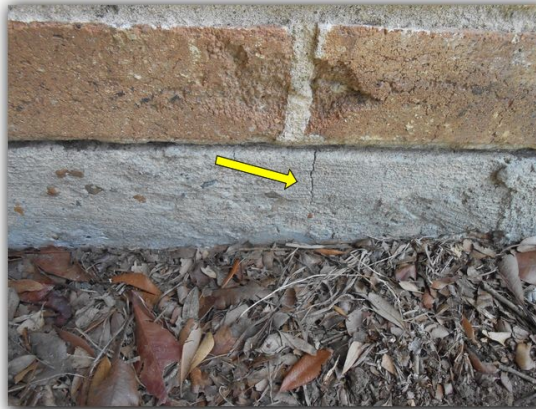
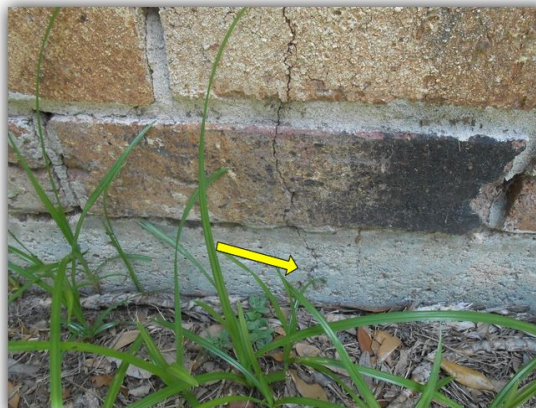
There is a hairline crack in the foundation on the at multiple locations around the home.

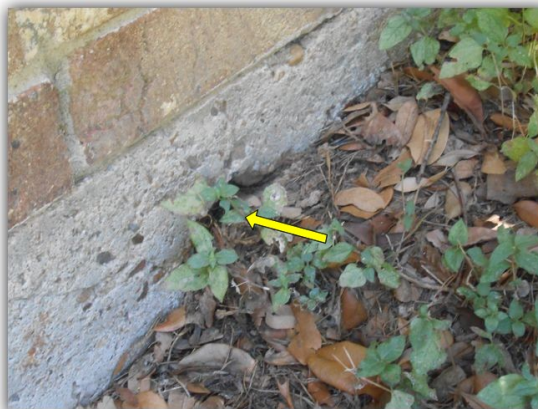
There are exposed cable ends on the left side of the home. These cable ends should be sealed to help prevent oxidation/rusting of the cable into the foundation.

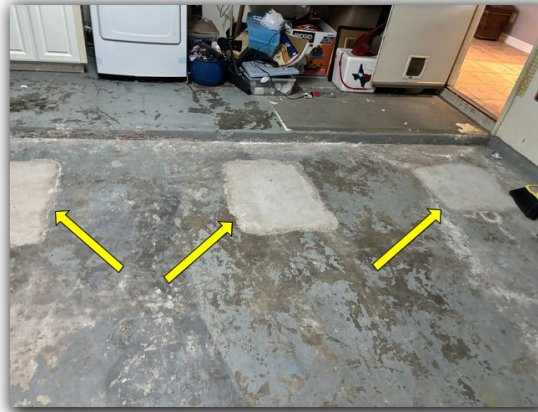
There is evidence of prior foundation repair. I recommend asking for any additional information regarding prior review and repair of the foundation, including who performed the repairs, when the repairs were completed, and where the repairs were made. I recommend asking the seller if there is a transferable warranty, and ask that all relevant forms be provided so that proper and timely transfer of any warranty may be completed accordingly.

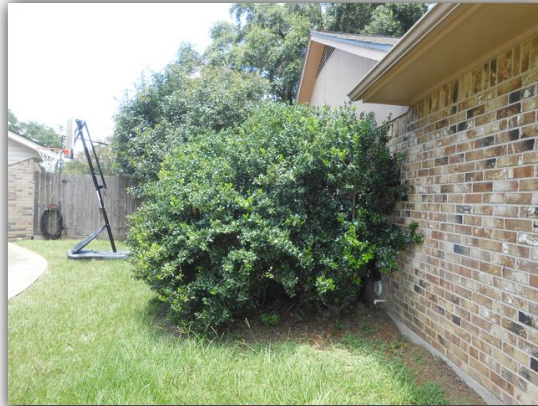
There is high soil and heavy foliage at the left side of the home. This is conducive to water and pest penetration into the home.

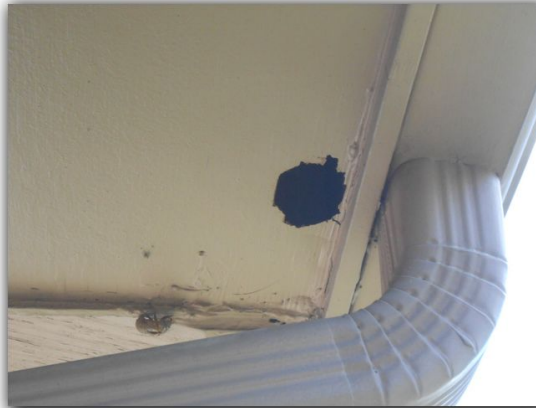
There is rot/deterioration on the soffit at the front left corner of the home.

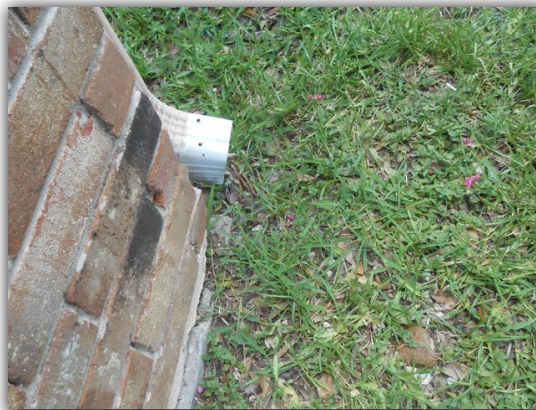
There are splash blocks missing at the base of the down spouts around the home.

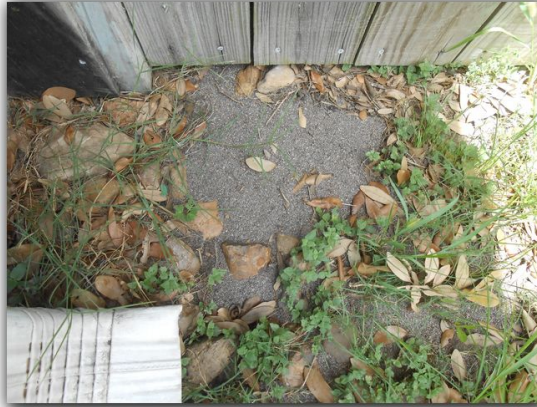
There is an excessive amount of granules at the front right corner of the home.

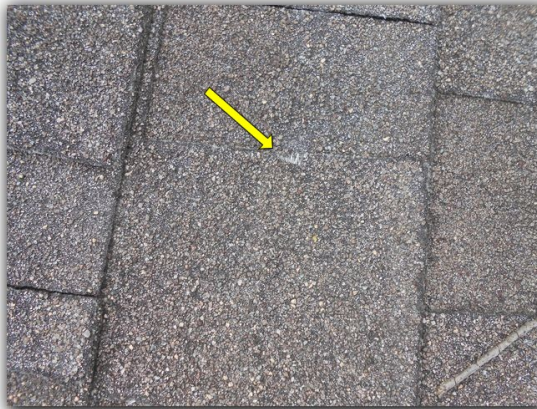
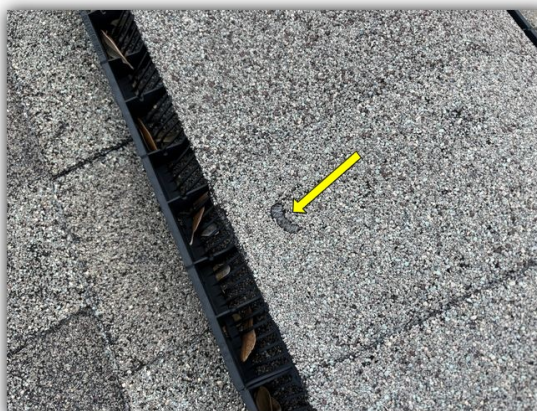
There are torn, worn, damaged shingles on multiple sides of the roof in more than one location.

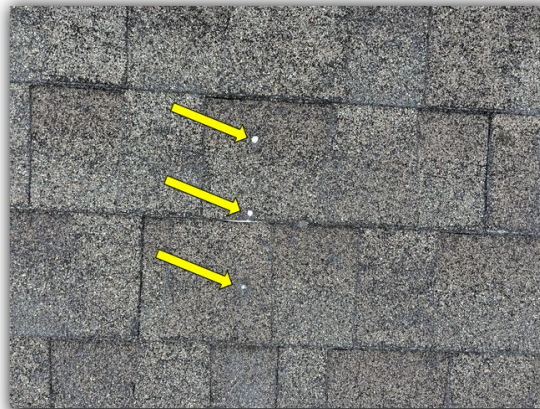
There are exposed nail heads on the roof. Nail heads should be sealed with roof caulking material. Over time, water may penetrate the roof around a rusted nail if they are not properly sealed.

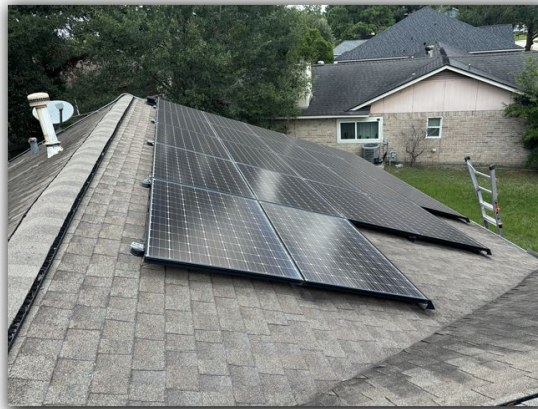
NOTE: There are solar panels on the left side of the roof. I'm unable to verify all penetration points under the solar panels. I recommend monitoring as these may become water penetration points. If there is any concerns with the roof connections for the solar panels I recommend having a qualified roofer review the roof at the solar panels.

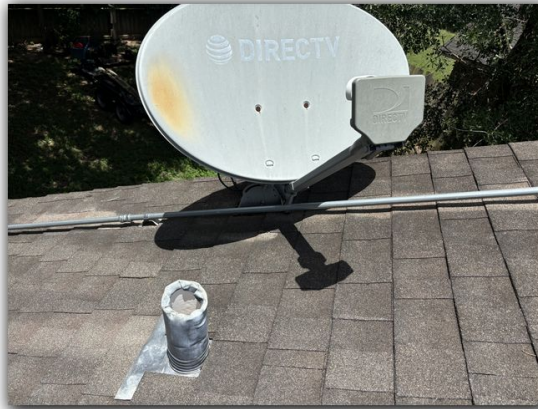
NOTE: There is a satellite dish on the roof. I recommend monitoring as these may become water penetration points.

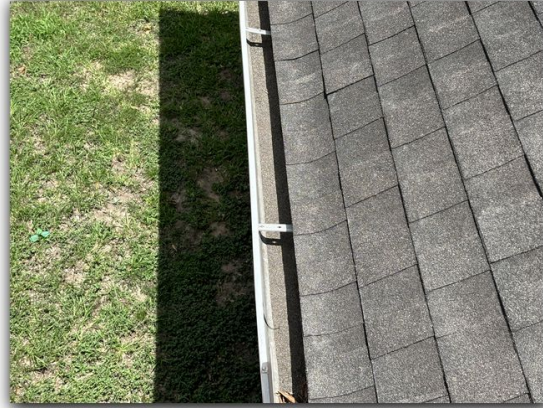
There is an excess of shingles granules accumulating in the gutters at multiple side of the home. This is an indication that the shingles have lost effectiveness of protection against the elements.

I recommend that the roof be evaluated by a qualified roofing contractor.

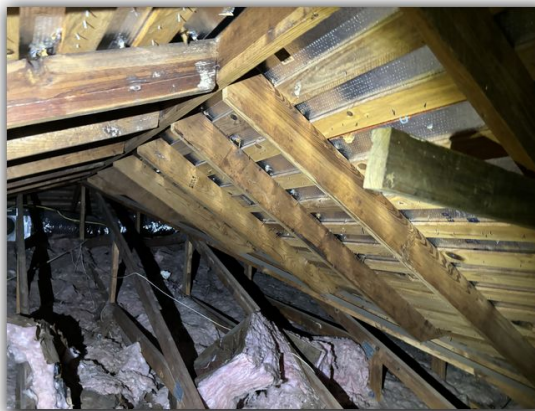
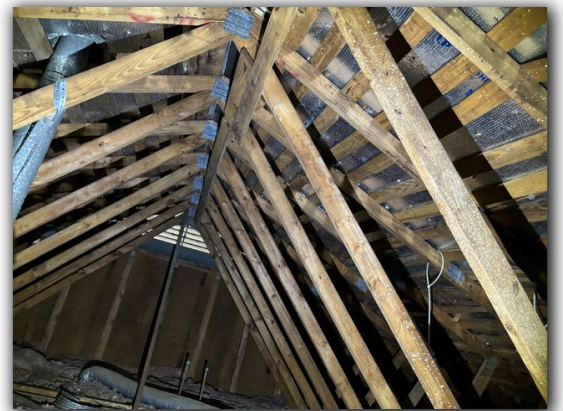
Collar ties are required on the upper third of the rafters and placed no more than four feet apart in the attic. There are no collar ties in the attic.

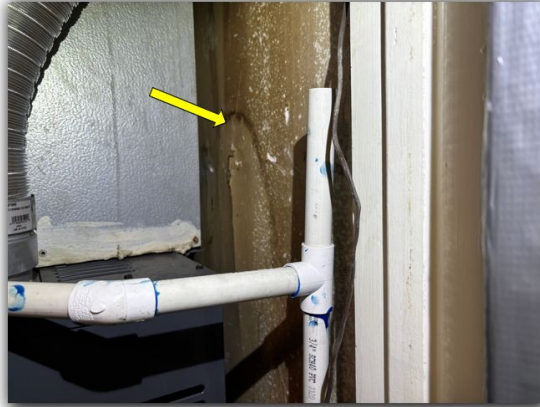
There is water staining in the HVAC closet.

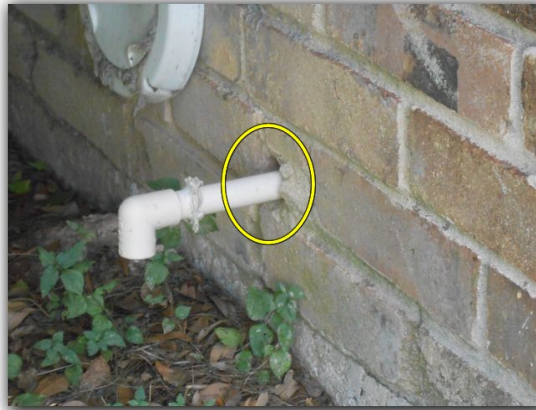
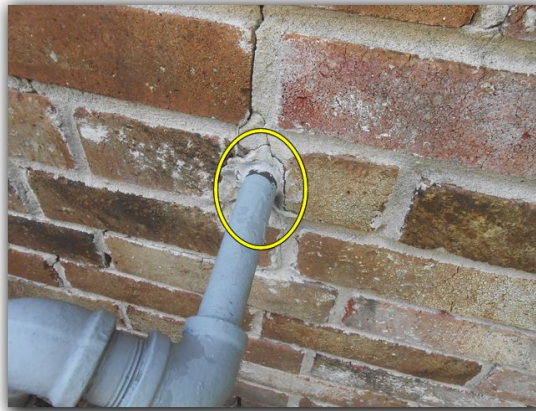
All wall penetrations and exposed openings should be sealed to help prevent pest and moisture penetration into the wall cavity including areas such as electrical outlets, exterior light fixtures, window and door frames, and water and gas supply lines.

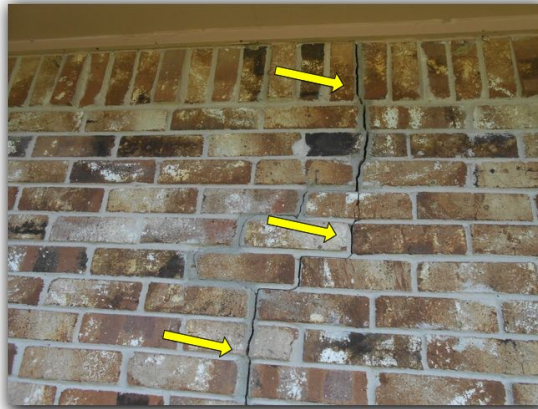
There are mortar joint/brick cracks on the exterior walls at multiple locations.

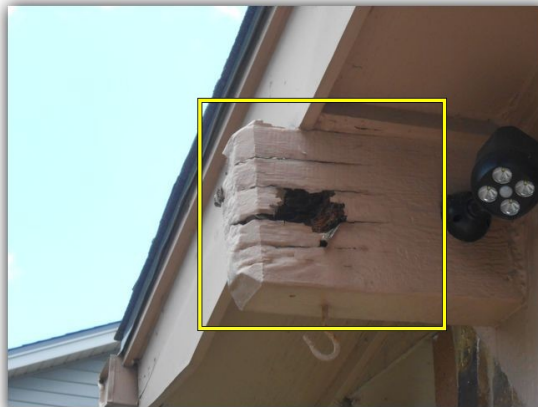
There is rot/deterioration at the decorative beams at the front of the home at multiple locations.

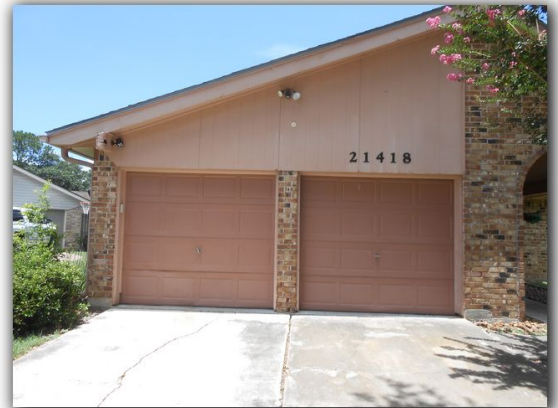
The mortar at the bottom of the front left column/wall has deteriorated/caulked loose from the bricks.

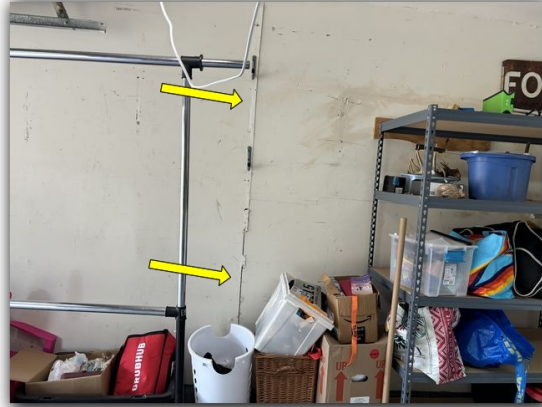
There are signs of rot/deterioration on the exterior siding at multiple locations around the home.

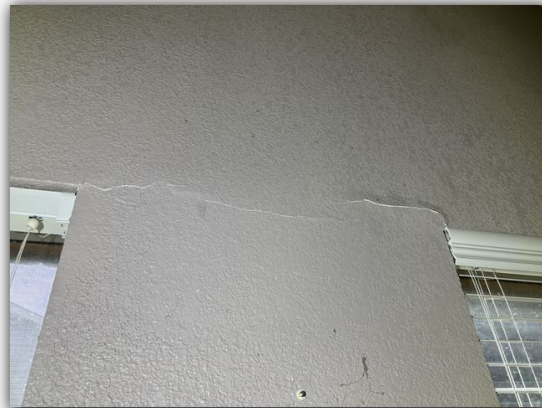
There are cracks on the walls at multiple locations throughout the home.

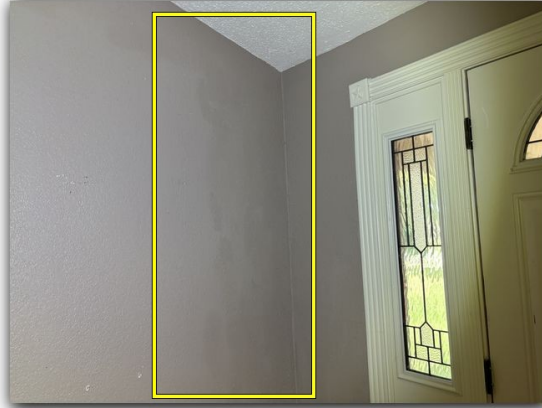
NOTE: I recommend further investigation at areas where moisture stains are present as I cannot see into the wall or behind the sheet rock. I cannot determine what may be present inside the wall.

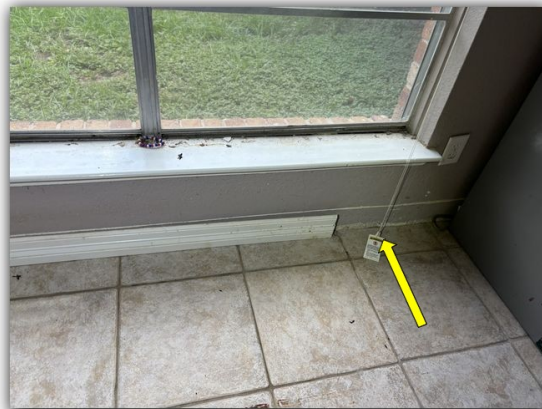
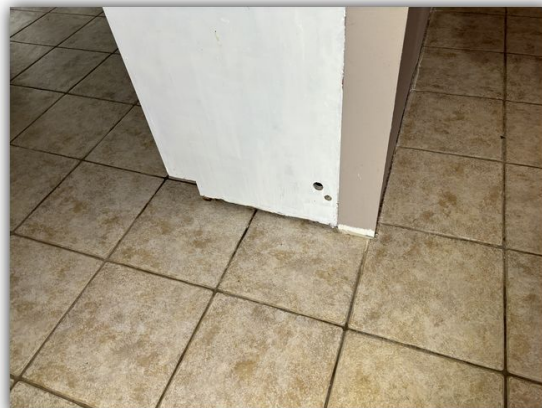
There is missing base boards in the kitchen and living room at multiple locations.

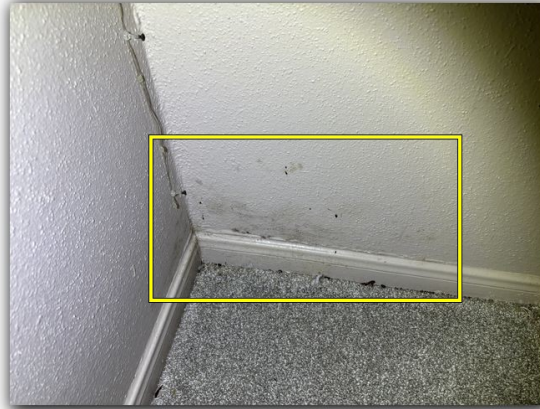
There is organic growth/mildew at the right side of the front right bedroom closet. NOTE: I recommend further investigation at areas where moisture stains are present as I cannot see into the wall or behind the sheet rock. I cannot determine what may be present inside the wall.

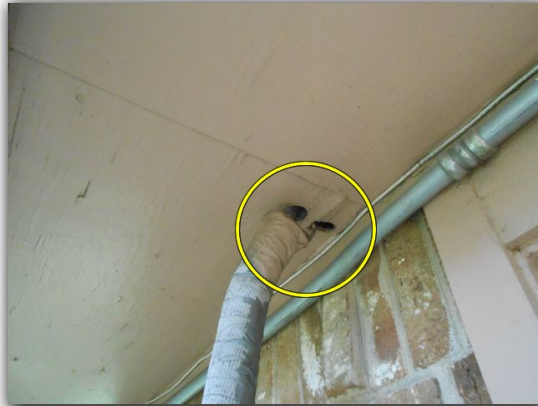
There is an exposed opening where the A/C supply lines penetrate the ceiling/soffit.

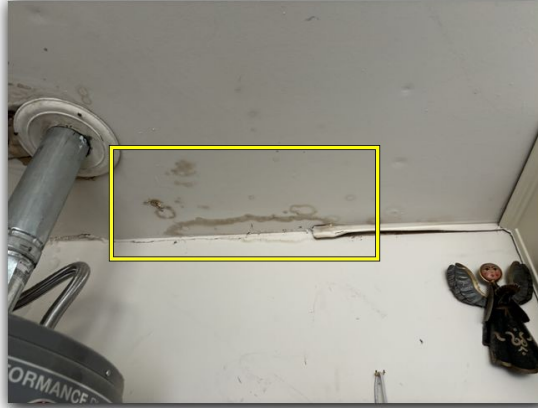
There is a stain on the ceiling in the garage at multiple locations. NOTE: I recommend further investigation at areas where moisture stains are present. I cannot determine what may be present.

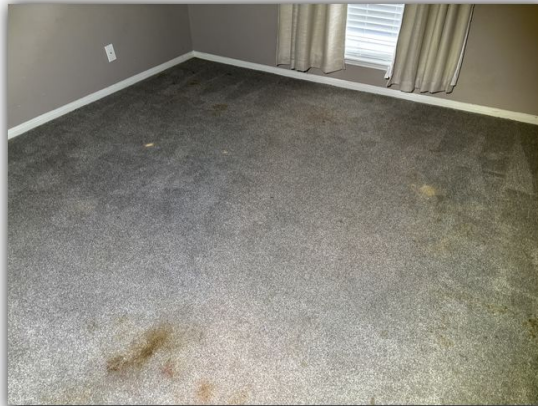
There is staining on the carpet in the front left bedroom and hallway.

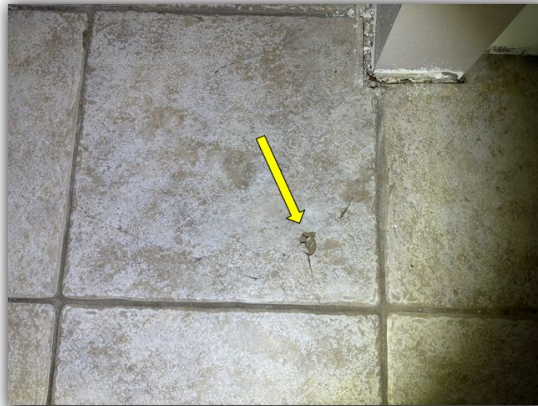
There are cracked tiles in the living room and master bathroom.

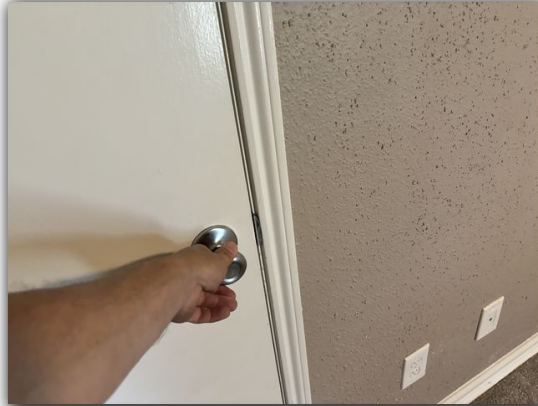
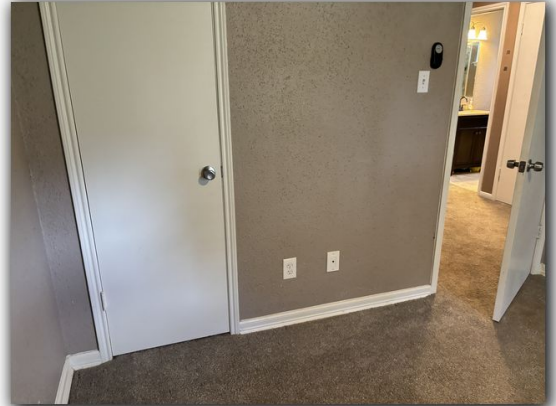
There are doors that do not latch properly at more than one location around the home.

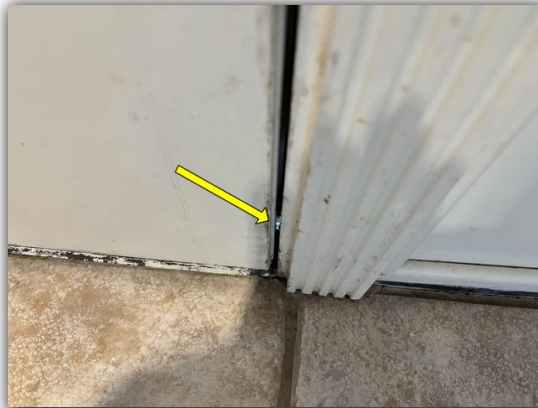
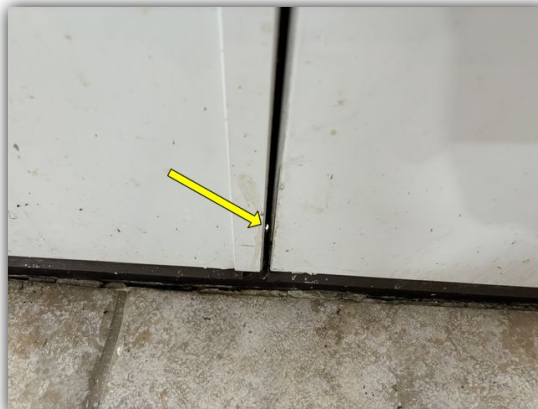
There is daylight showing through the jamb at the front and back doors. This is indicative that the door is not fully weather sealed.

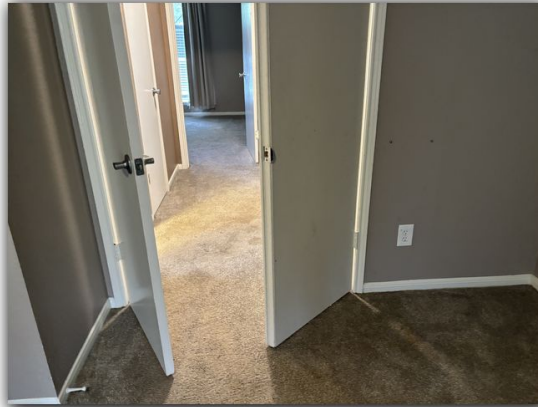
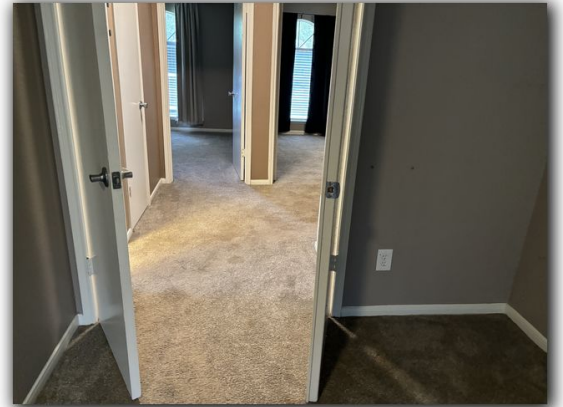
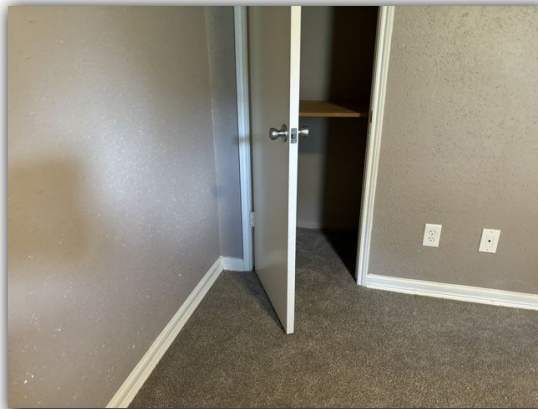
There are doors that open / close on their own in more than one location including the left master bedroom door and the front left bedroom closet door.

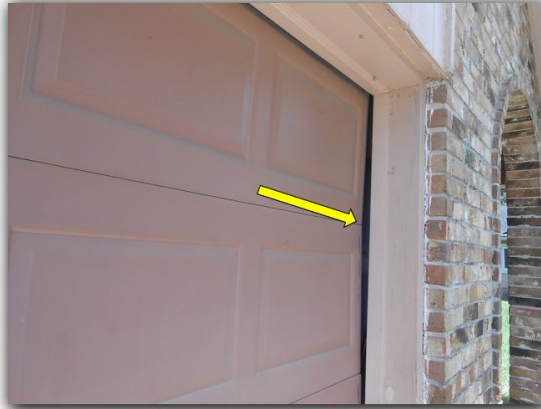
There is a gap between the garage door and garage door trim at the right side of the garage door. This is a potential entry point for water and pests.

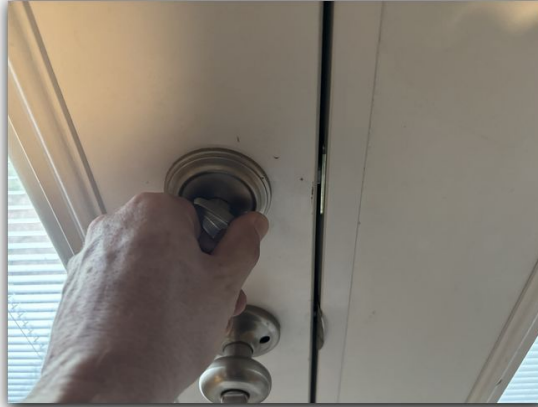
The front door deadbolt is not latching properly. The latch is hitting the strike plate causing the latch to not latch into the door frame. The door must be push against to get the latch to work. I recommend adjust the strike position to allow the deadbolt to latch properly.

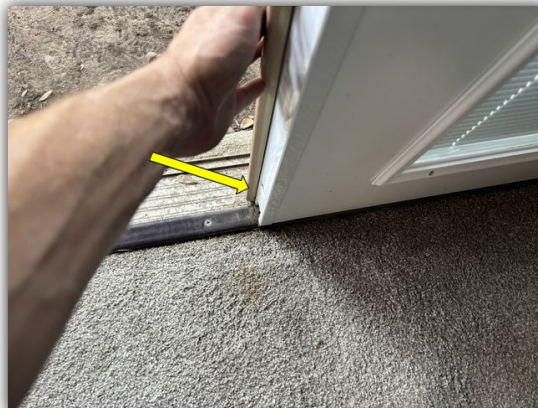
The bottom latch at the master bedroom double door is stuck. I was unable to open the stationary door.

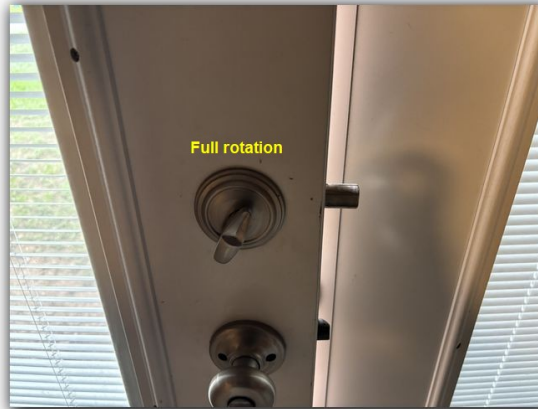
The deadbolt at the front is not locking properly. The deadbolt latch does not complete a full rotation locking the latch in place. The latch is hitting the door frame preventing the latch from locking. I recommend having the latch opening extended to allow for the latch to extend fully.

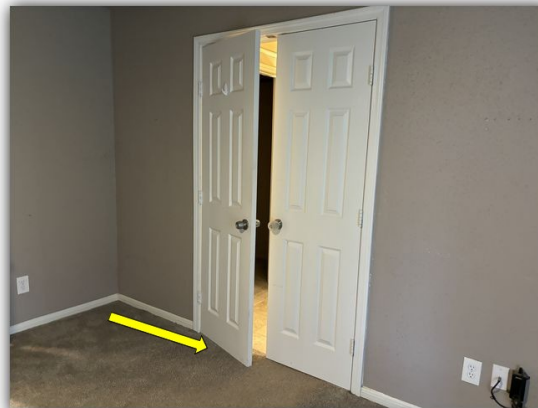
There are door rubbing the carpet at multiple locations in the home.

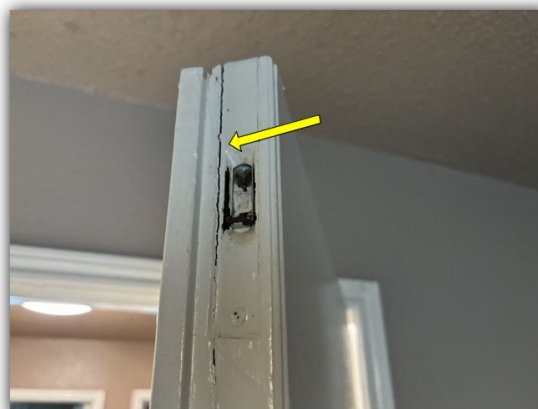
There is damage to the left master bedroom door.

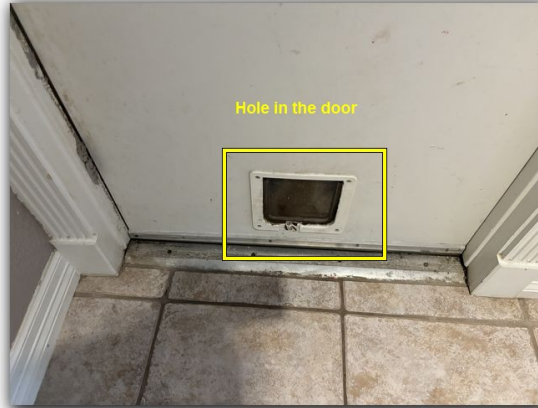
The garage entry door is required to be solid core to maintain the fire stop between the garage and living space as well as help prevent exhaust gases from entering the home. The garage entry door does not meet this minimum requirement.

The house to garage door and the furnace room door do not have self closing hinges. R302.5.1 Opening protection.

Openings from a private garage directly into a room used for sleeping purposes shall not be permitted. Other openings between the garage and residence shall be equipped with solid wood doors not less than 1³/₈ inches (35 mm) in thickness, solid or honeycomb-core steel doors not less than 1³/₈ inches (35 mm) thick, or 20-minute fire-rated doors, equipped with a self-closing device.

I recommend having any deficiencies reviewed and corrected by a qualified door specialist.

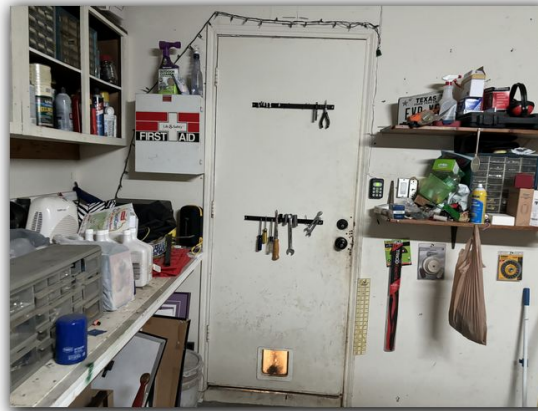
The garage entry door is not on self closing hinges.

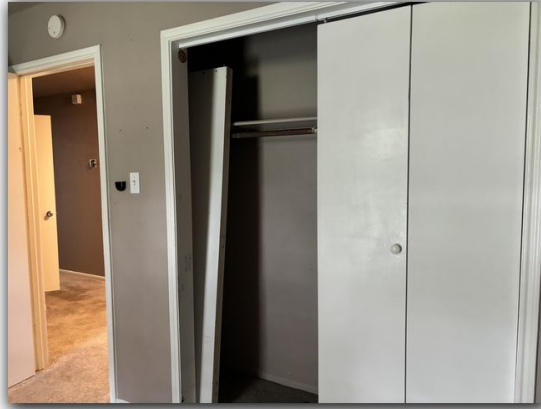
The left closet door in the front right bedroom is off the tracks.

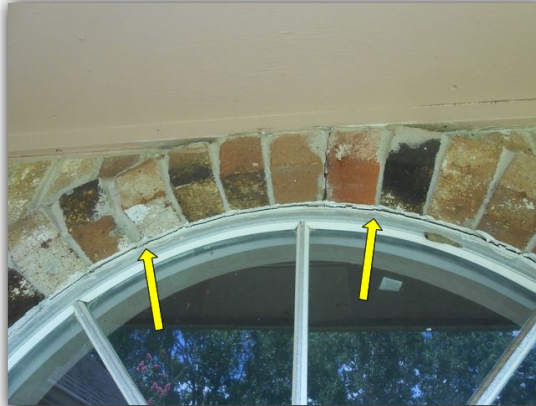
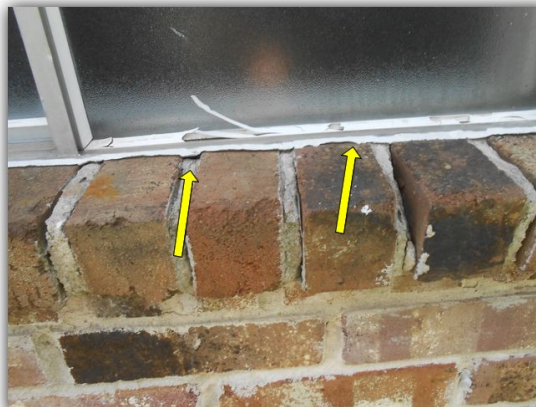
The caulking around the windows is showing signs of deterioration and may need to be replaced.

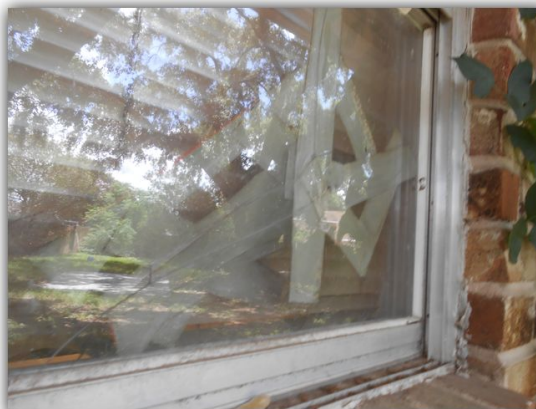
There is a cracked / broken window pane in the kitchen window and back living room window.

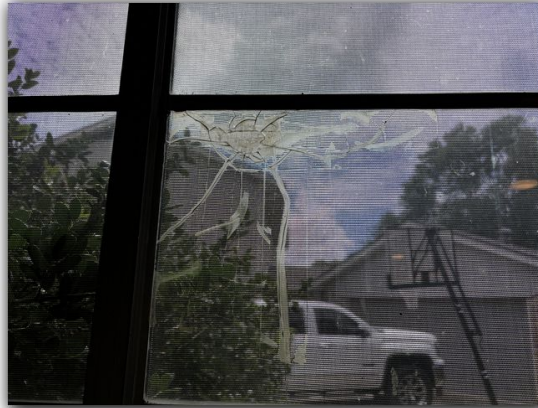
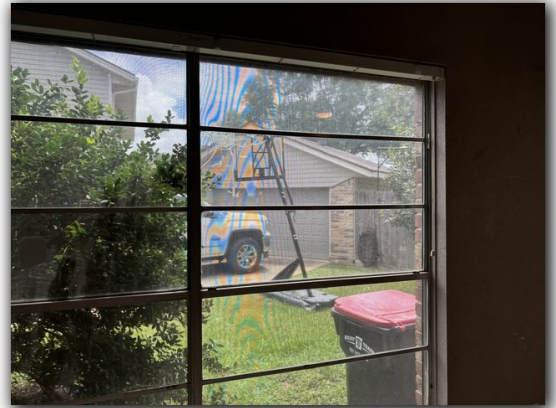
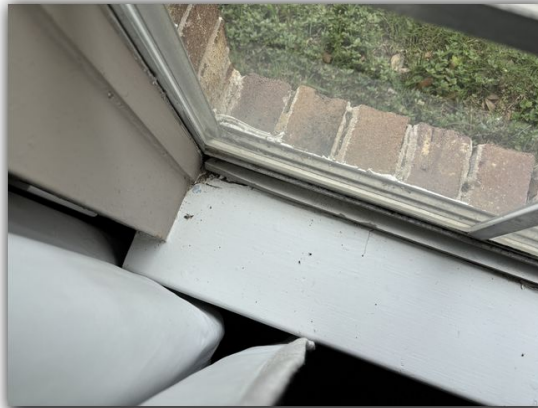
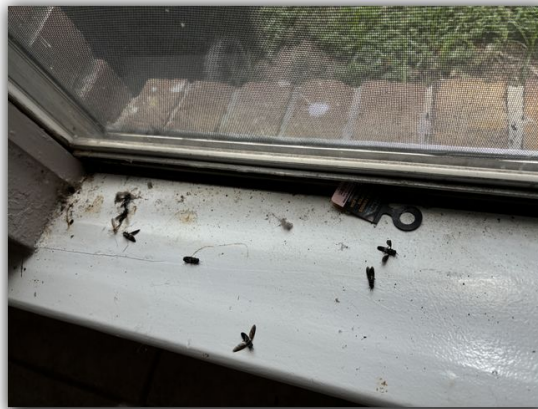
There is water/moisture damage at the window sills at multiple locations in the home. This is an indication that the windows are not properly sealed.

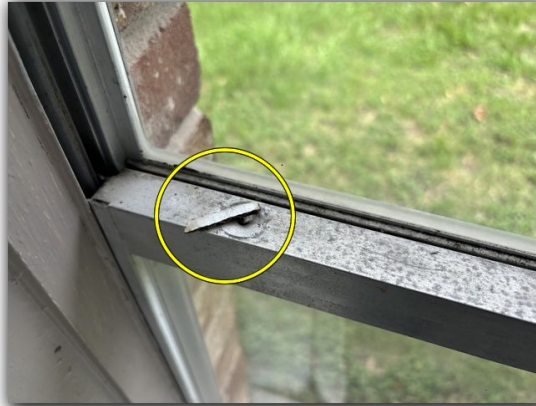
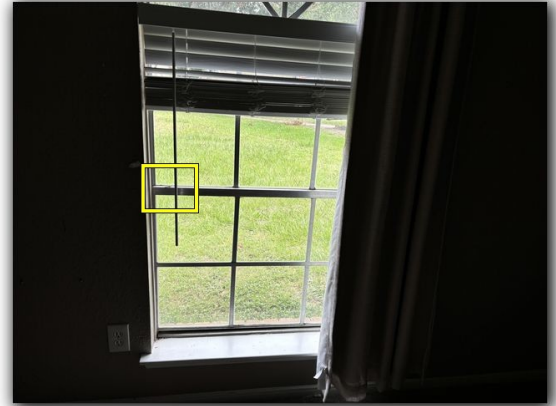
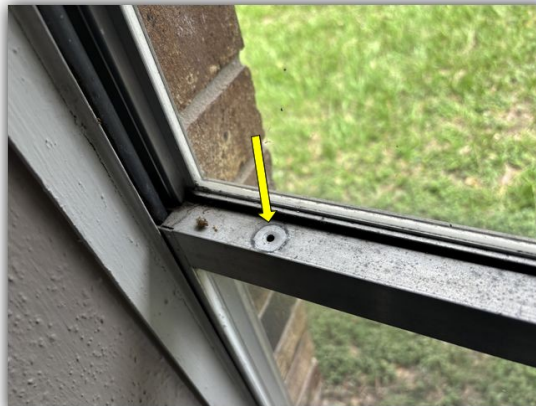
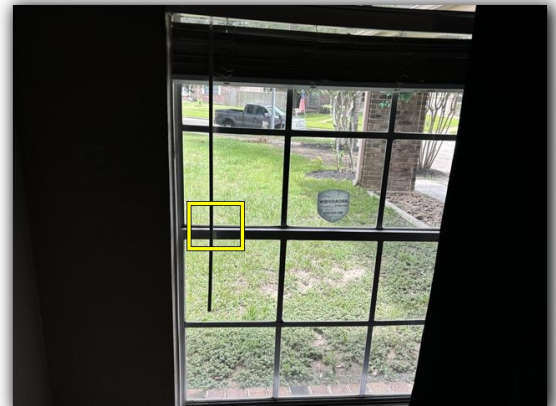
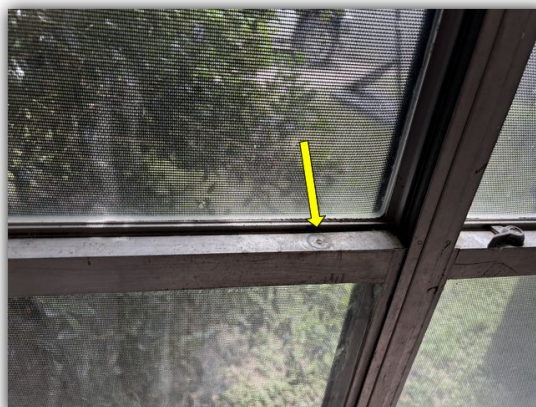
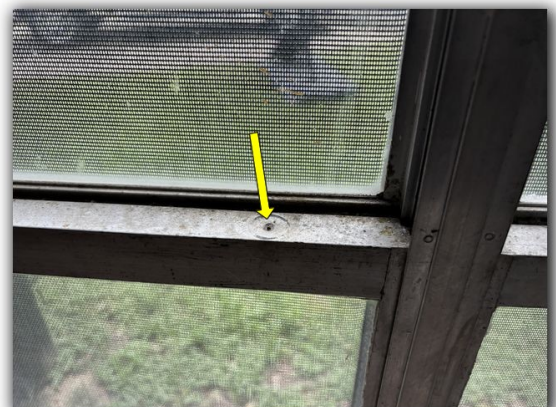
There are windows that are not latching properly at multiple locations in the home.

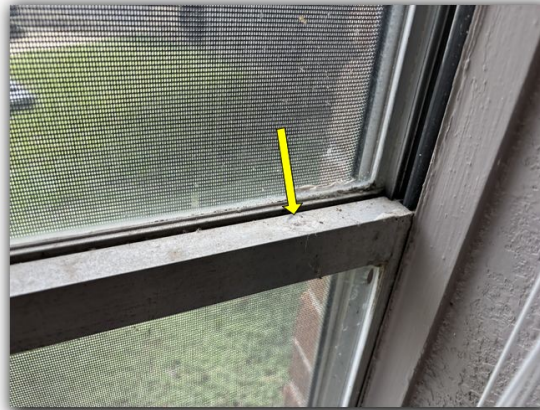
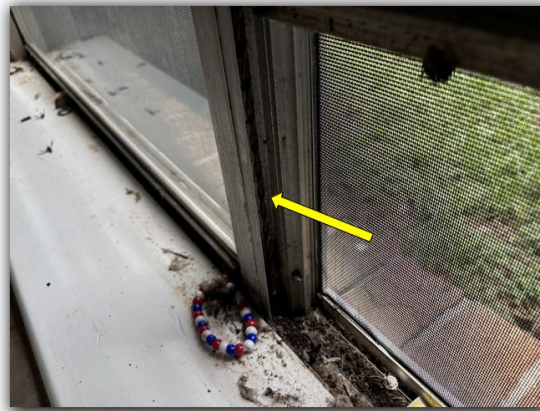
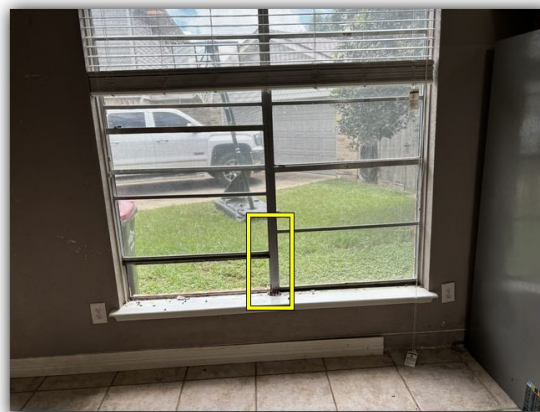
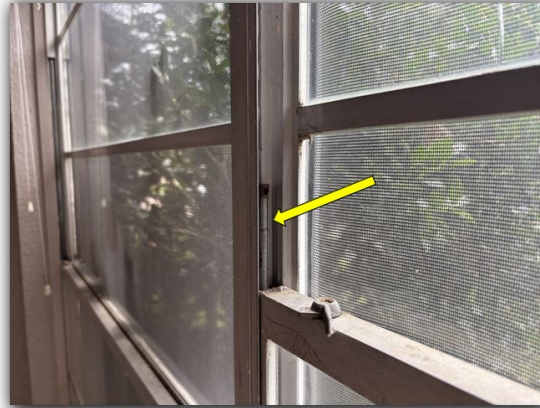
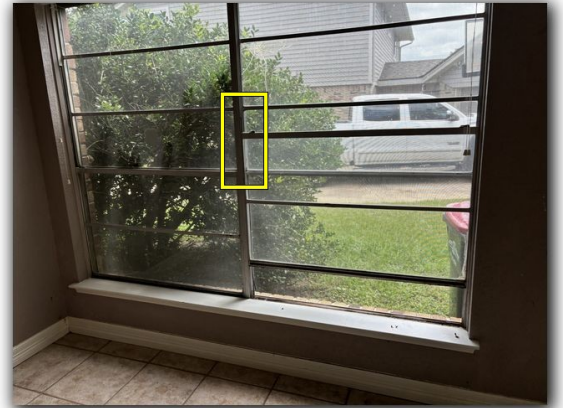
The springs have popped in the window frames inside the home at more than one location.

I recommend having any deficiencies reviewed and corrected by a qualified window specialist.

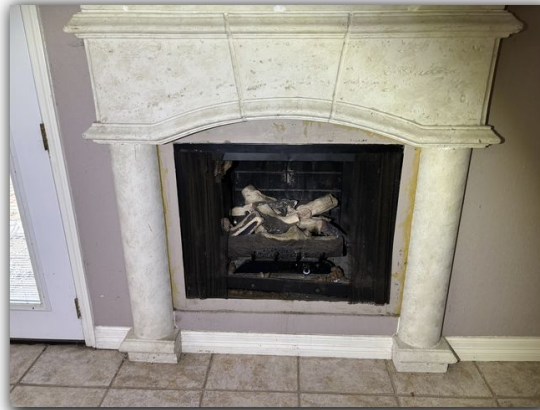
I was unable to get the fireplace to light. There is build up of potentially flammable material in the firebox and chimney. I recommend servicing and cleaning the chimney and fireplace prior to use.

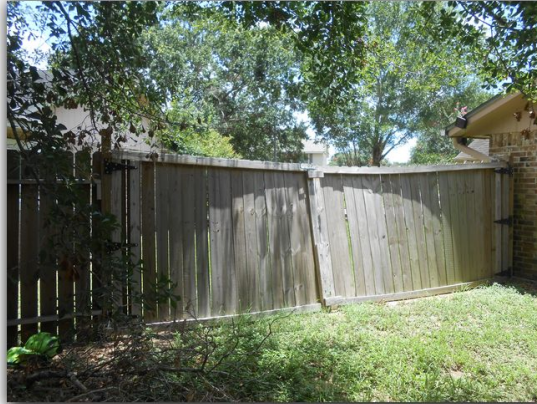
The fence/gate is leaning forward at the front right side of the home.

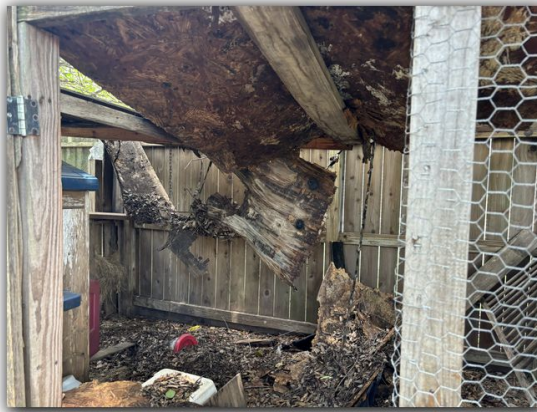
The wooden structure on the back of the back yard has rot/deterioration. I recommend removing this structure.

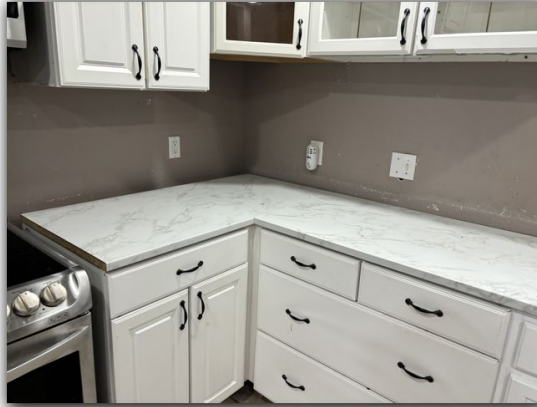
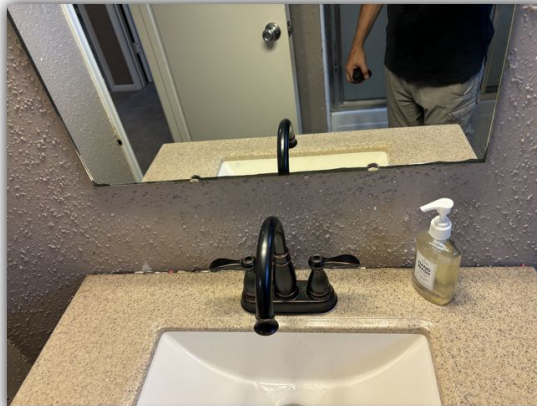
There is no back splash at the kitchen countertop and hall bathroom countertop.

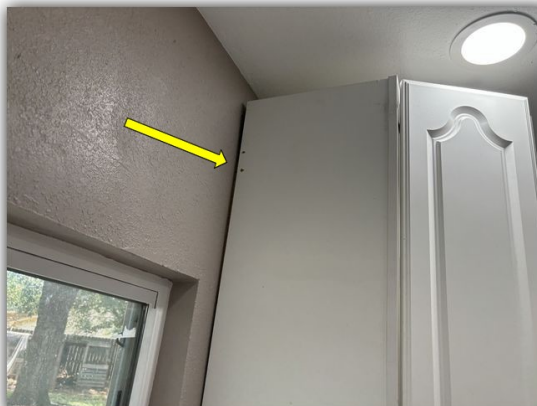
The right top cabinet in the kitchen is loose on the wall. I recommend securing the cabinet to avoid accident/injury.

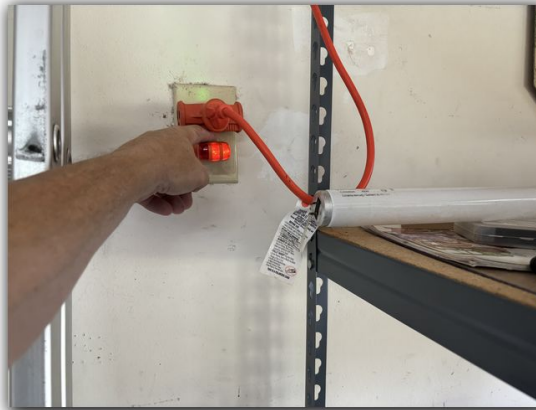
There are no GFCI outlets in the required locations in the unit.

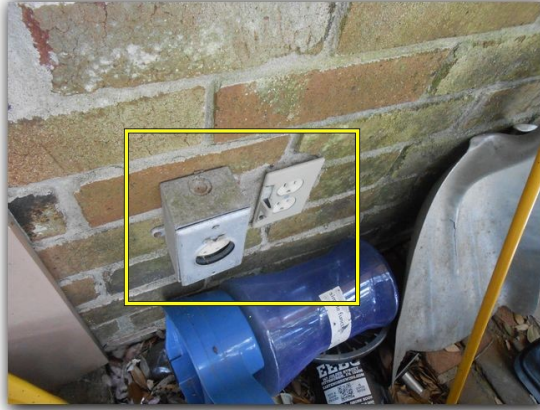
The exterior outlets are not enclosed in a weather proof protective cover. I recommend placing a protective cover over all exterior outlets.

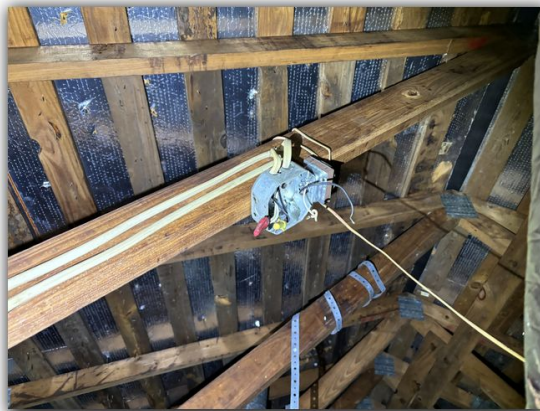
There are spliced wires that are not fully or properly contained inside a junction box in the attic at multiple locations and in the garage at the back wall.

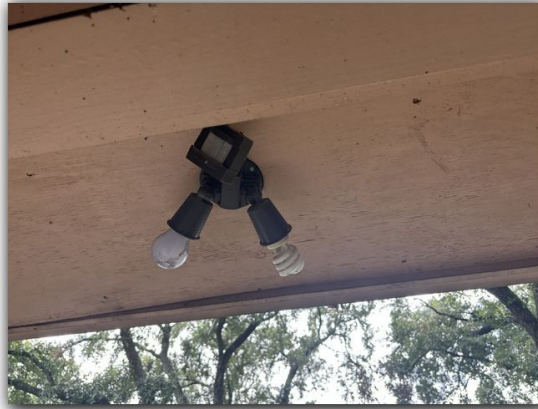
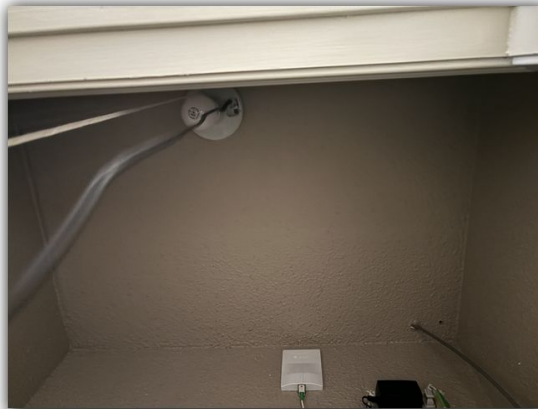
There are light fixtures that did not work when tested at multiple locations. I recommend replacing the light bulbs in these locations to see if that corrects the issue with the lights.

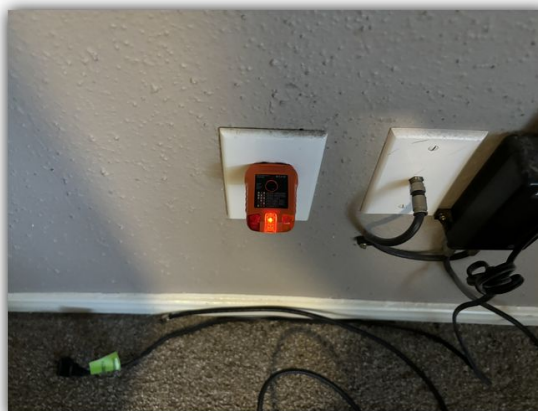
There are open ground outlets at the left wall in the master bedroom.

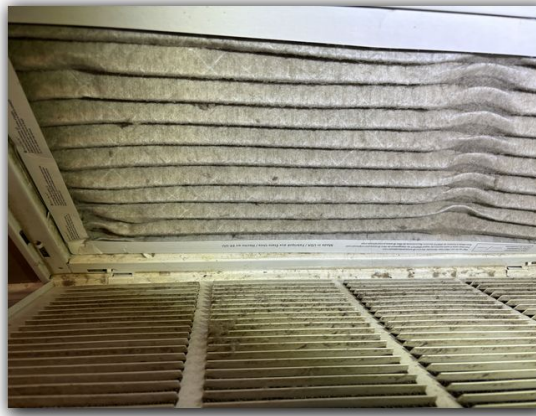
Condition: **Dirty**

NOTE: As a preventive/maintenance measure, I recommend the heating and cooling systems be serviced by a licensed HVAC technician prior to each heating and cooling season.

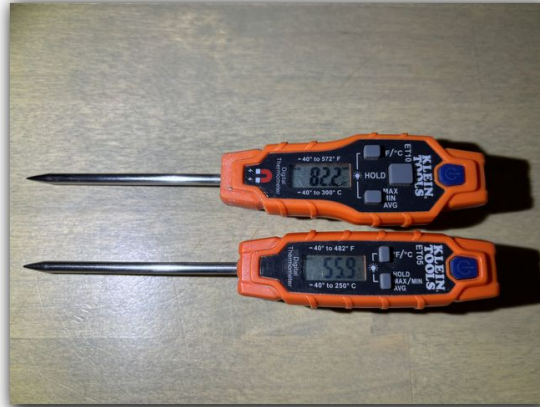
Unit 1 Supply Temp: **55.9** Return Temp: **82.2** Difference: **26.3**

The temperature differential between the supply and return registers should be no more than 20 degrees. The unit is producing a temperature differential that exceeds this maximum requirement. This could be symptomatic of other issues inside the system. I recommend asking the sellers if the unit has had recent service, including adding freon.

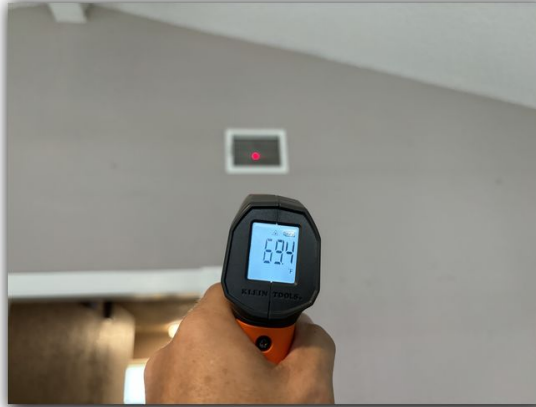
There is a temperature variance across the main living area of approximately 4-5 degrees. This may indicate a balancing issue and I recommend having the system reviewed by a qualified HVAC technician.

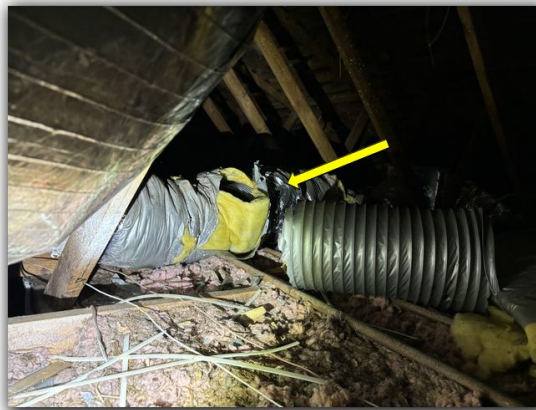
There is damage to the duct work at multiple locations in the attic and is blowing into the attic space. The cooling and heating of the home will not work as efficiently due to the damage to the duct work.

I recommend a complete review of the entire HVAC system by a qualified HVAC technician.

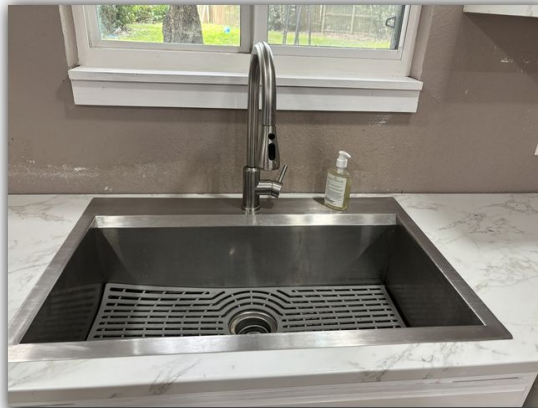
Kitchen Sink:

There was no water at the kitchen sinks. I could not confirm but the valves could be closed. I recommend having the water supplies tested once water has been restored to the sink.

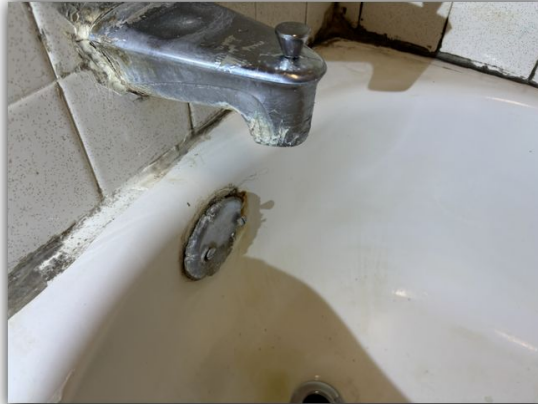
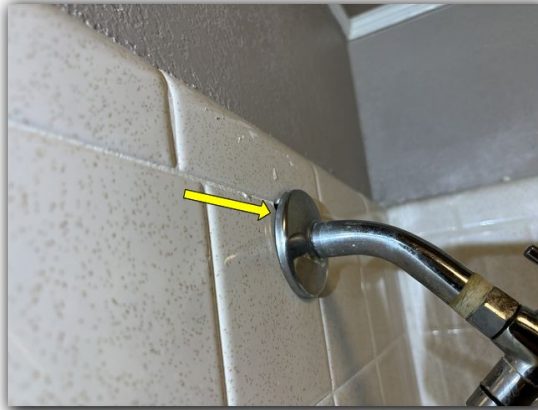
All bathtub wall penetrations and corners should be silicone sealed to help prevent water penetration into the wall cavity. The silicone is missing / deteriorated at the control knob, the tub faucet, and shower head as well as at the shower wall corners and tub edges in the master bathroom.

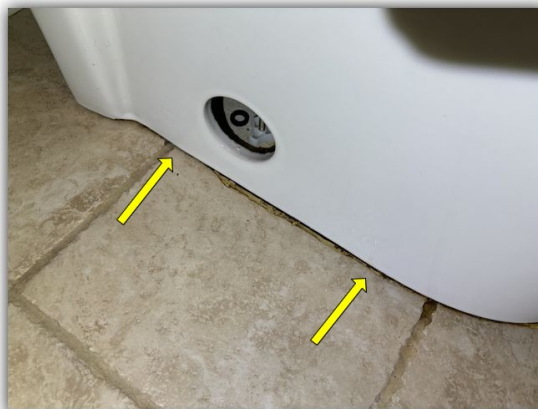
There is missing/deteriorated caulking at the base of the master bathroom toilet.

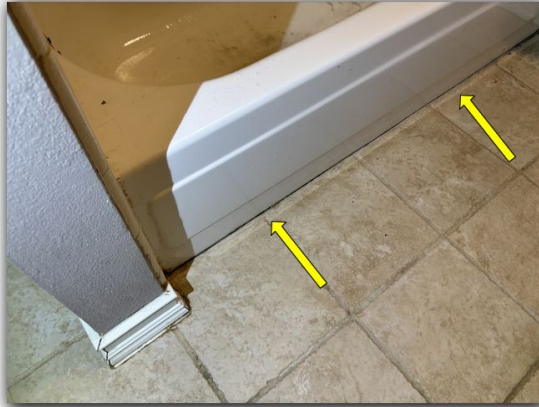
There is missing/deteriorated caulking at the base of the tub/shower in the bathroom toilet.

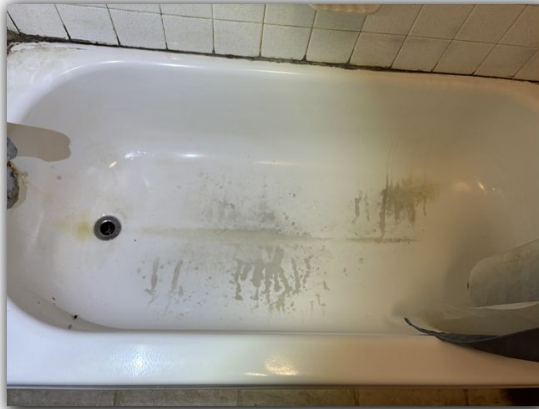
There is damage/staining on the master bathroom tub.

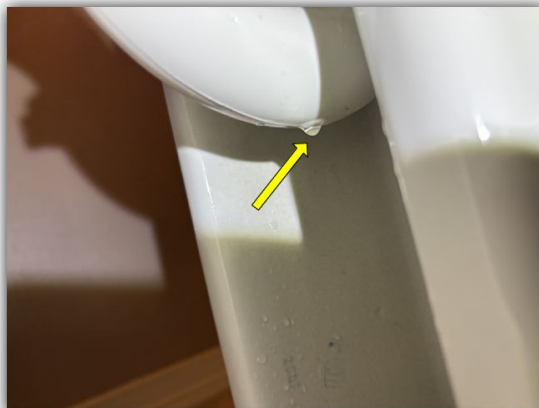
There is a leak at the master bathroom drain connection. Water is pouring on the floor when the water is running.

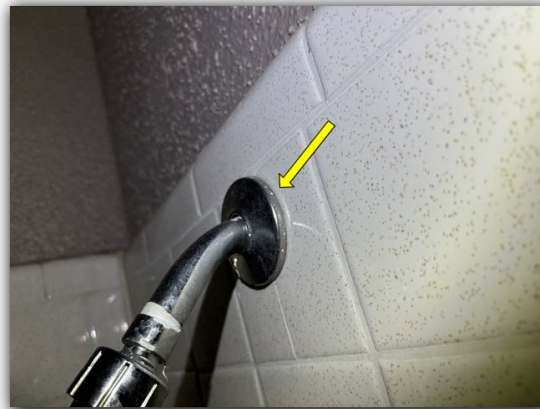
All bathtub wall penetrations and corners should be silicone sealed to help prevent water penetration into the wall cavity. The silicone is missing / deteriorated at the control knob, the tub faucet, and shower head as well as at the shower wall corners and tub edges in the hall bathroom.

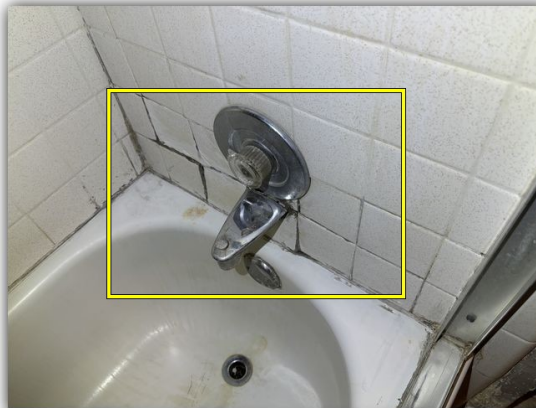
There is damage/cracking to the tub walls at the faucets. Water is leaking behind the shower wall and back wall of the hall closet.
