21418 Park Rock Ln
Katy, TX 77450
Kachi Osuorji

06/27/2024

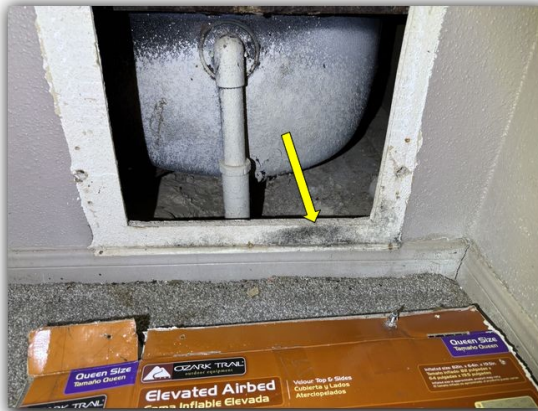
There is organic growth/mildew at the hall closet. NOTE: I recommend further investigation at areas where moisture stains are present as I cannot see into the wall or behind the sheet rock. I cannot determine what may be present inside the wall.

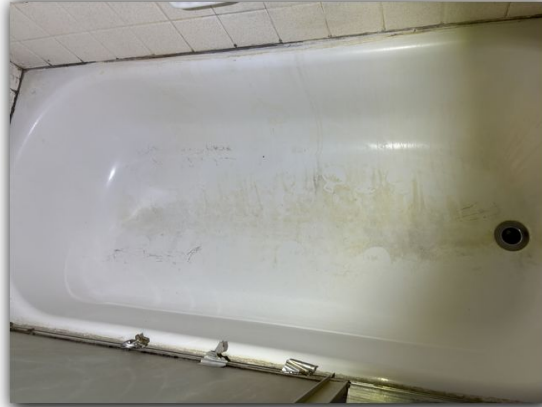
There is damage/staining to the hall bathroom tub.

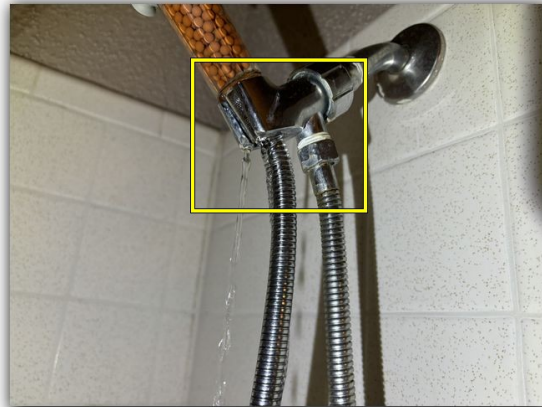
There is a leak at the shower wand supply connection.

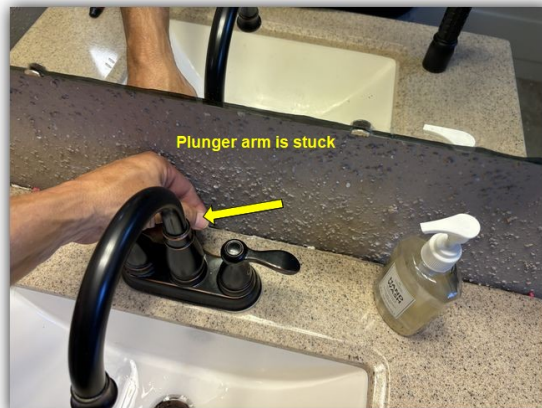
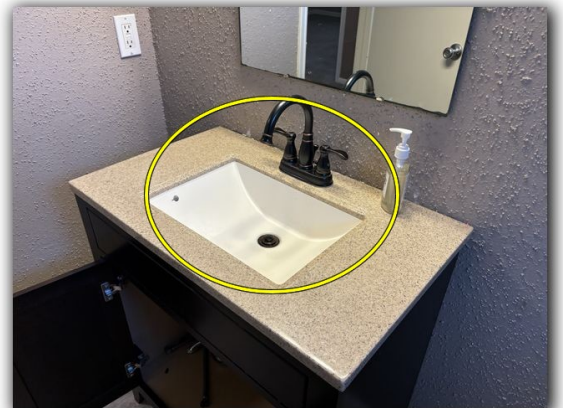
The sink plunger is not working properly at the hall bathroom. This sink will not hold water.

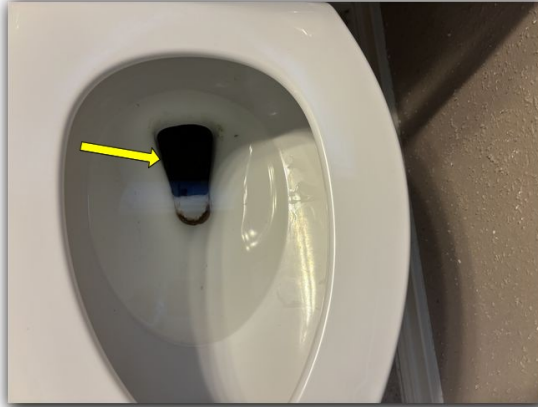
There is rust in the hall bathroom toilet.

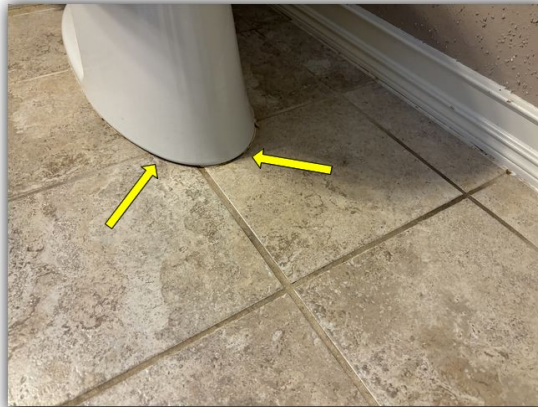
There is missing/deteriorated caulking at the base of the hall bathroom toilet.

I recommend having a licensed plumber review and repair the deficiencies.

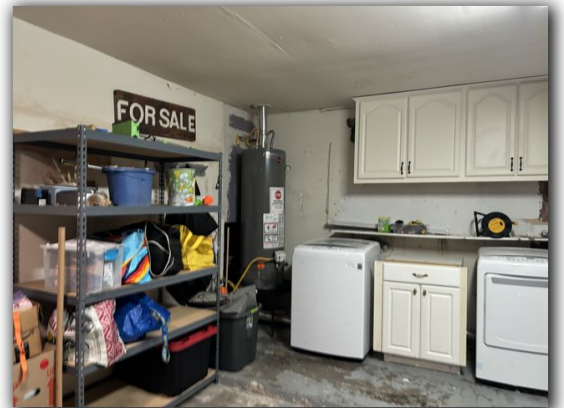
NOTE: The TPR (temperature and pressure relief valve) was not operationally checked at the time of the inspection. If the water heater is not maintained annually, the valve may not seat properly when it is operated, which causes the valve to leak. It is best to replace a TPR valve every 3 years to prevent it from getting clogged with mineral deposits. It is also recommended to open / close the valve at least twice per year as a form of maintenance. Based on the information label the water heater was built in 2019.

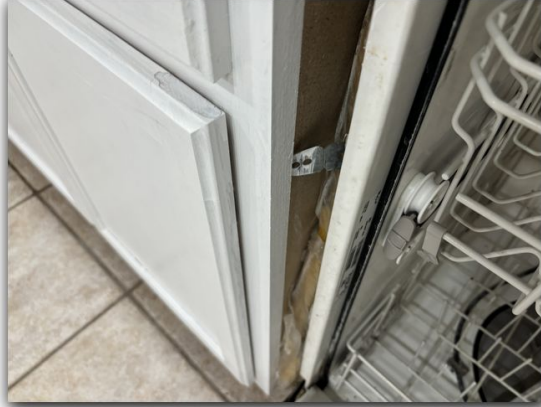
The dishwasher is not properly secured inside the cabinet.

The high loop is missing. This can allow waste water to leak back into the dishwasher.

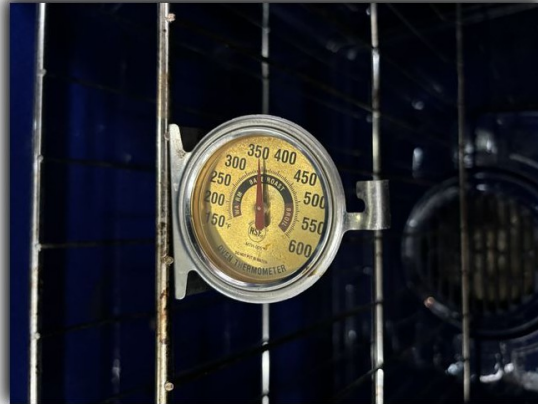
The oven is unlevel and moves when using.

NOTE: I recommend having the unit reviewed by a qualified appliance contractor.

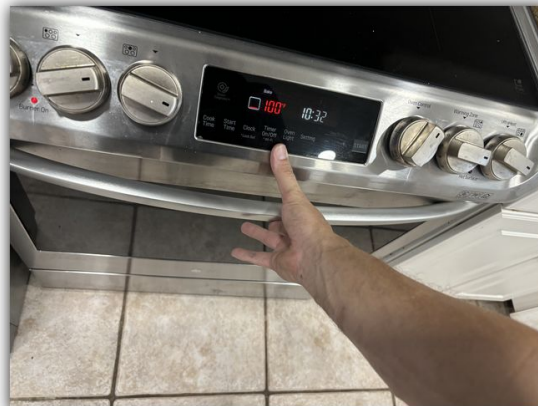
The burners on the cooktop top did not heat up when tested.

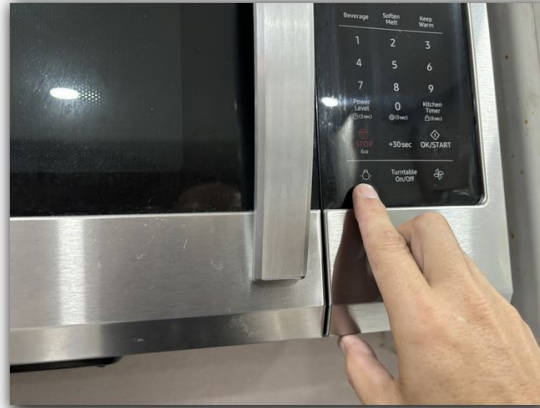
The light on the microwave did not work when tested. I recommend replacing the light bulbs to see if that corrects the issue with light.

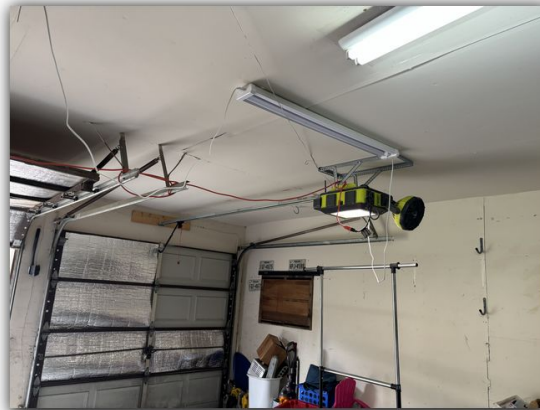
Auto reverse block test acceptable: No

Pressure is applied to the door to simulate hitting a child or object and should auto reverse. I applied pressure and it did not auto reverse. The unit should be adjusted.

I recommend having the door reviewed by a qualified garage door contractor and then have the automatic opener tested.
