Moisture Assessment Report

Nishant Shah and Mita Das

2629 Westgate Street, Unit A

Project Information

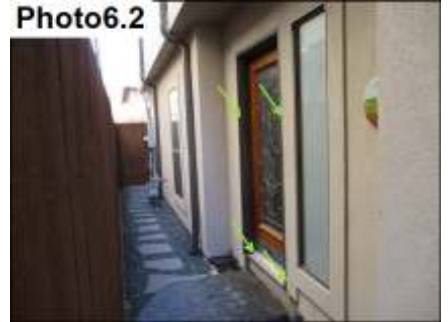
Photo6.2

- The door trim and miter sealants are aged, separated or missing at these locations. The inspector suggests to have a qualified waterproofing contractor seal these areas with a low modulus sealant in an effort to prevent moisture intrusion. These types of sealants are of high quality and compatible with stucco and other termination points. Please refer to photos #6.2, #6.3, #6.4, #6.5 and #6.6 for more detail.
[All areas noted in inspection report were sealed/caulked.](#)

Door Sealants / Seal

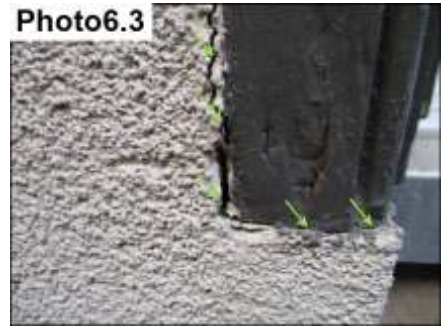
Photo6.3

Door Sealants / Seal

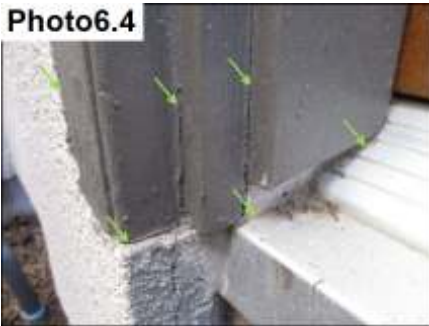
Photo6.4

Door Sealants / Seal

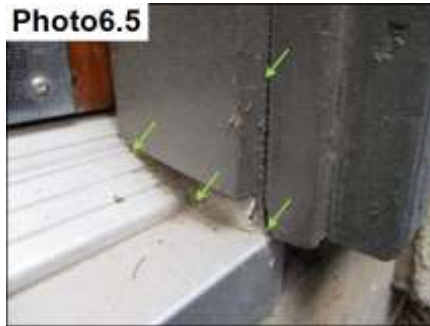
Photo6.5

Door Sealants / Seal

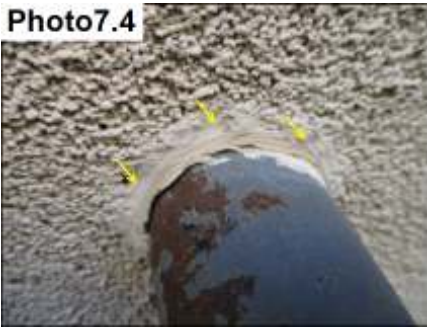
Photo7.4

- The penetration sealants are aged, separated or missing in these locations. The inspector suggests to have a qualified waterproofing contractor seal these areas with a low modulus sealant in an effort to prevent moisture intrusion. These types of sealants are of high quality and compatible with stucco and other termination points. Please refer to photos #7.2, #7.3, #7.4, #7.5 and #7.6 for more detail.

Penetration Sealants / Seal

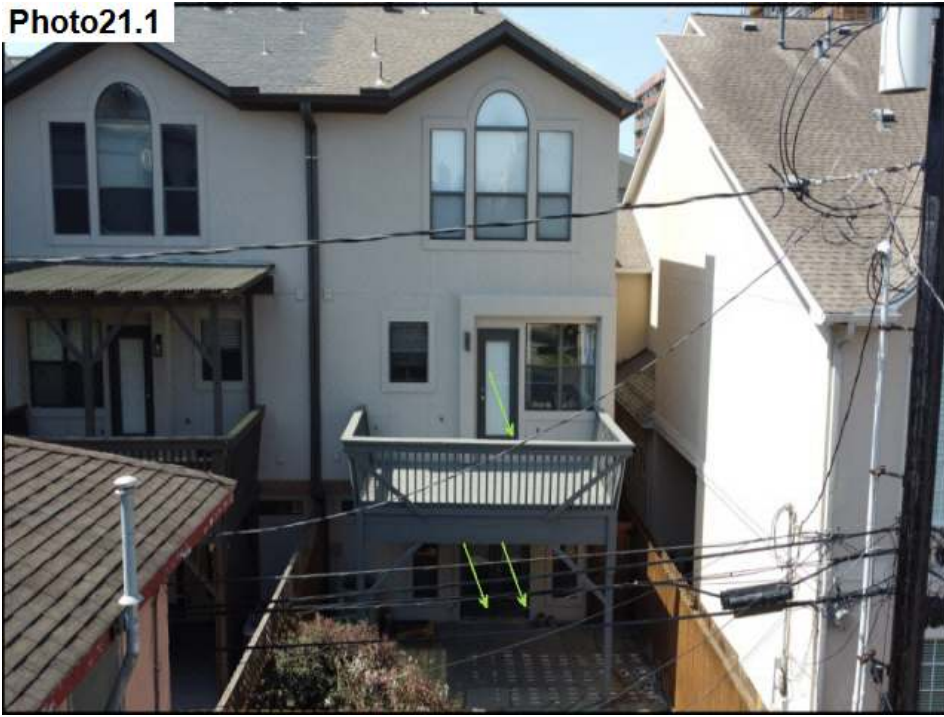
Photo21.1

Grid Location	Item Description	Moisture Readings	Substrate Condition	Observations
Green Arrows	Doors			The door trim and miter sealants are aged or separated at these locations. The inspector suggests to have a qualified waterproofing contractor seal these areas with a low modulus sealant in an effort to prevent moisture intrusion. These types of sealants are of high quality and compatible with stucco and other termination points. Please refer to photos #21.2, #21.3, #21.4, #21.5 and #21.6 for more detail.

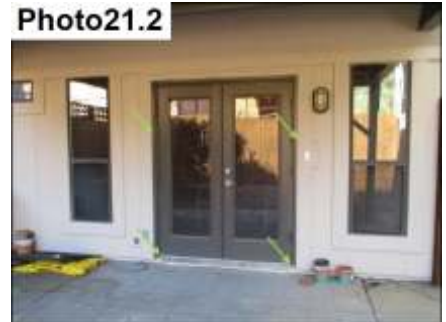
Photo21.2

Door Sealants / Seal

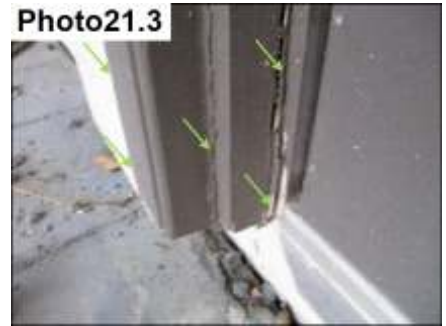
Photo21.3

Door Sealants / Seal

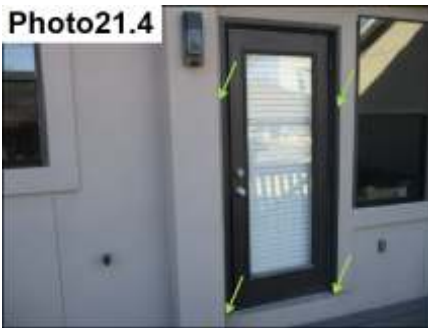
Photo21.4

Door Sealants / Seal

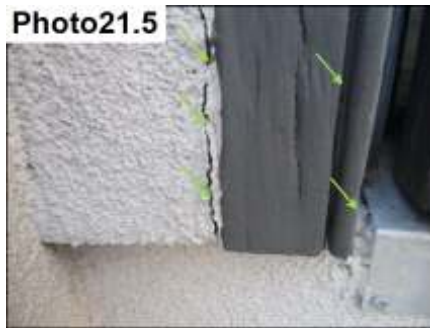
Photo21.5

Door Sealants / Seal

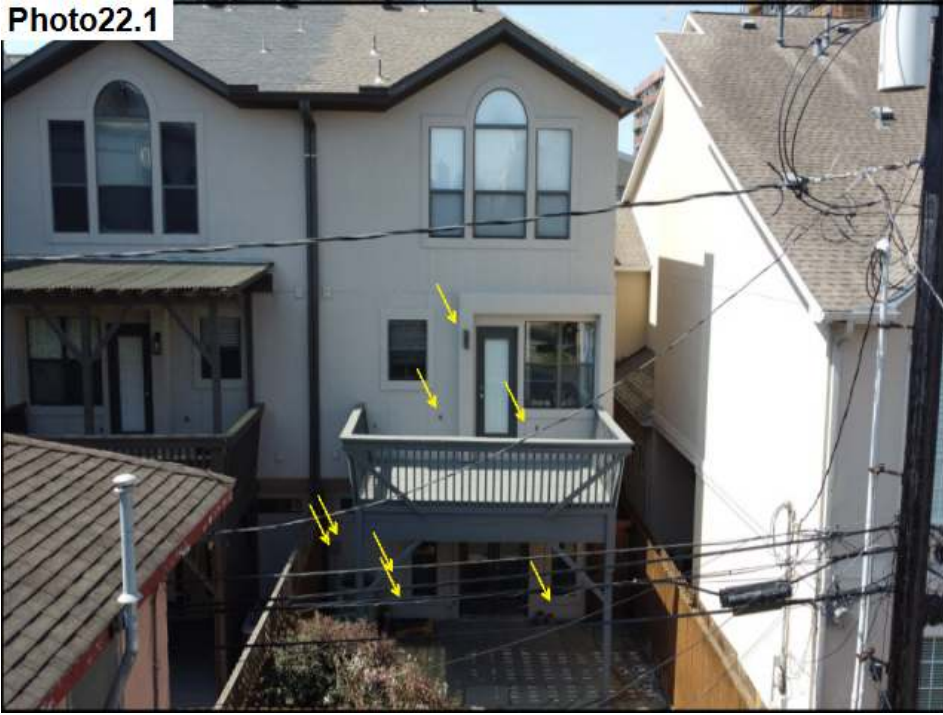
Photo22.1

Grid Location	Item Description	Moisture Readings	Substrate Condition	Observations
Yellow Arrows	Penetrations			The penetration sealants are aged, thin, separated or missing in these locations. The inspector suggests to have a qualified waterproofing contractor seal these areas with a low modulus sealant in an effort to prevent moisture intrusion. These types of sealants are of high quality and compatible with stucco and other termination points. Please refer to photos #22.2, #22.3, #22.4, #22.5 and #22.6 for more detail.

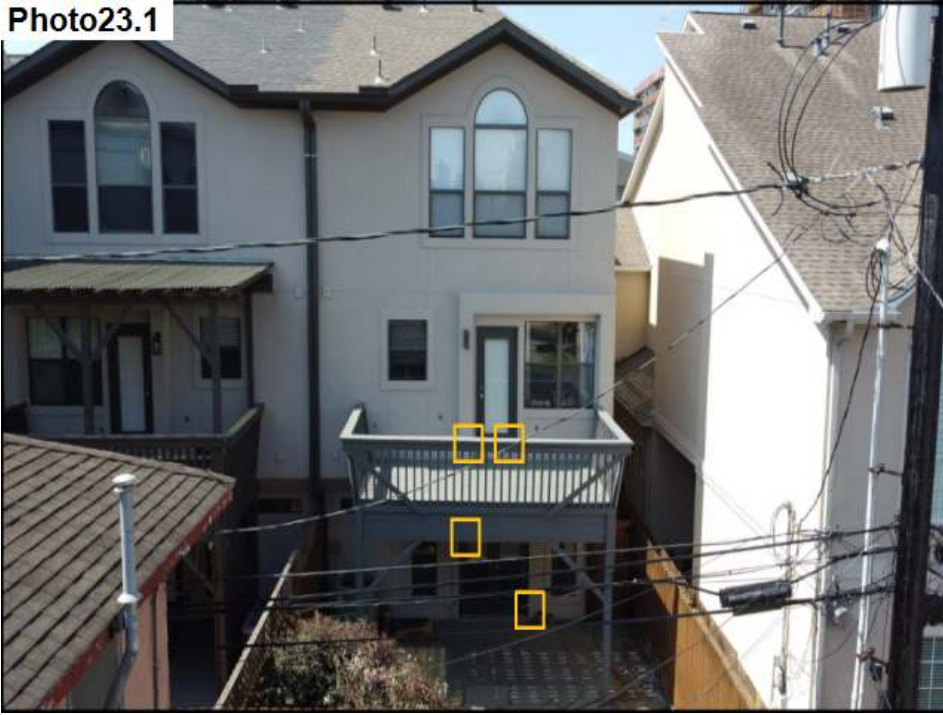
Photo23.1

Grid Location	Item Description	Moisture Readings	Substrate Condition	Observations
Orange Boxes	Wood Rot			The door trim at this area has wood rot. The inspector suggests to have a qualified contractor further assess and repair this area as needed in an effort to prevent moisture intrusion. All wood rot was not necessarily identified in this report. Please refer to photos #23.2, #23.3, #23.4, #23.5, #23.6, #24.1, #24.2, #24.3 and #24.4 for more detail.

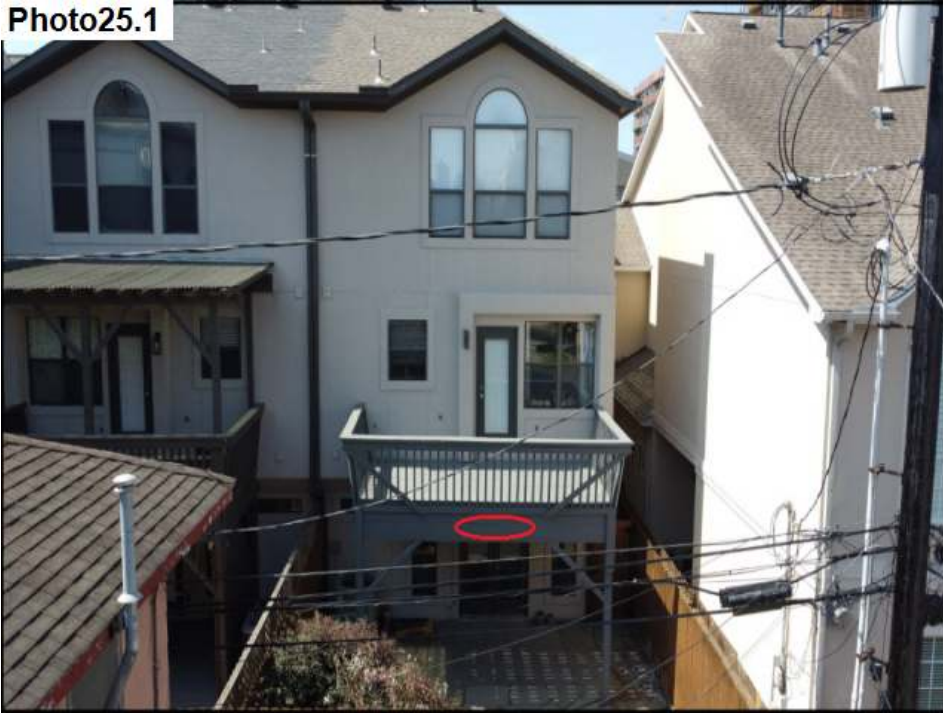
Photo25.1

Grid Location	Item Description	Moisture Readings	Substrate Condition	Observations
Red Circle	Missing Door Head Flashing			The door header below the second floor door pan flashing is missing a proper head flashing with wood rot noted. The inspector suggests to have a qualified waterproofing contractor further assess and install a proper door head flashing to this area as needed in an effort to prevent moisture intrusion. Please refer to photos #25.2 and #25.3 for more detail.

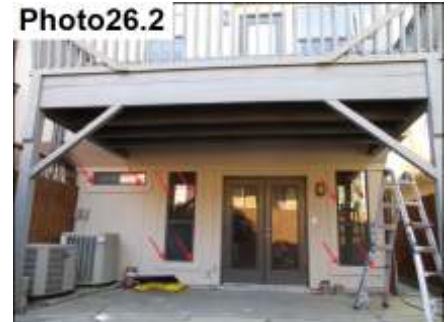
Window Sealants / Seal

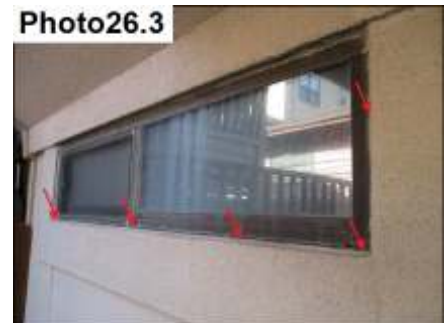
Window Sealants / Seal

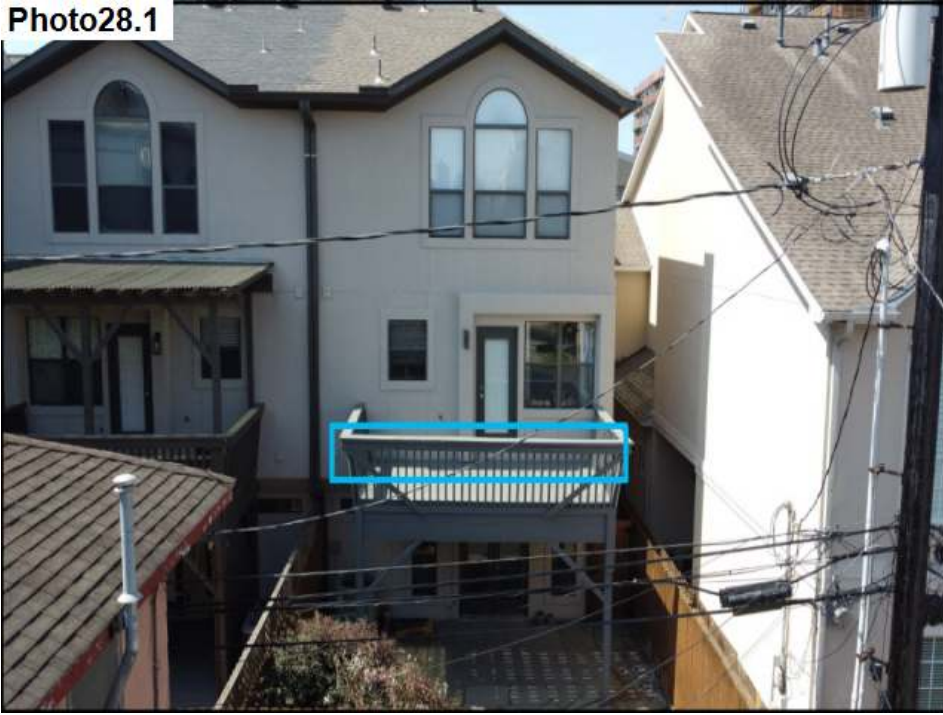
Photo28.1

Grid Location	Item Description	Moisture Readings	Substrate Condition	Observations
Blue Boxes	Balcony & Stucco Termination			Balcony/stucco termination sealants are aged or separated at this location. The inspector suggests to have a qualified waterproofing contractor further assess and seal this area with a low modulus sealant in an effort to prevent moisture intrusion. These types of sealants are of high quality and compatible with stucco and other termination points. Please refer to photos #28.2, #28.3, #28.4, #28.5 and #28.6 for more detail.

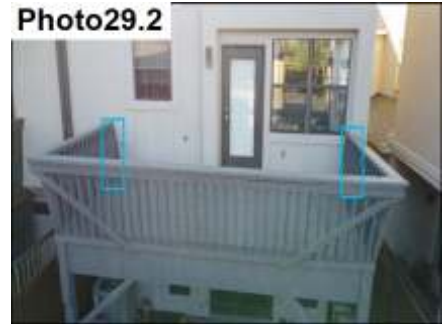
Railing & Stucco Termination / Seal

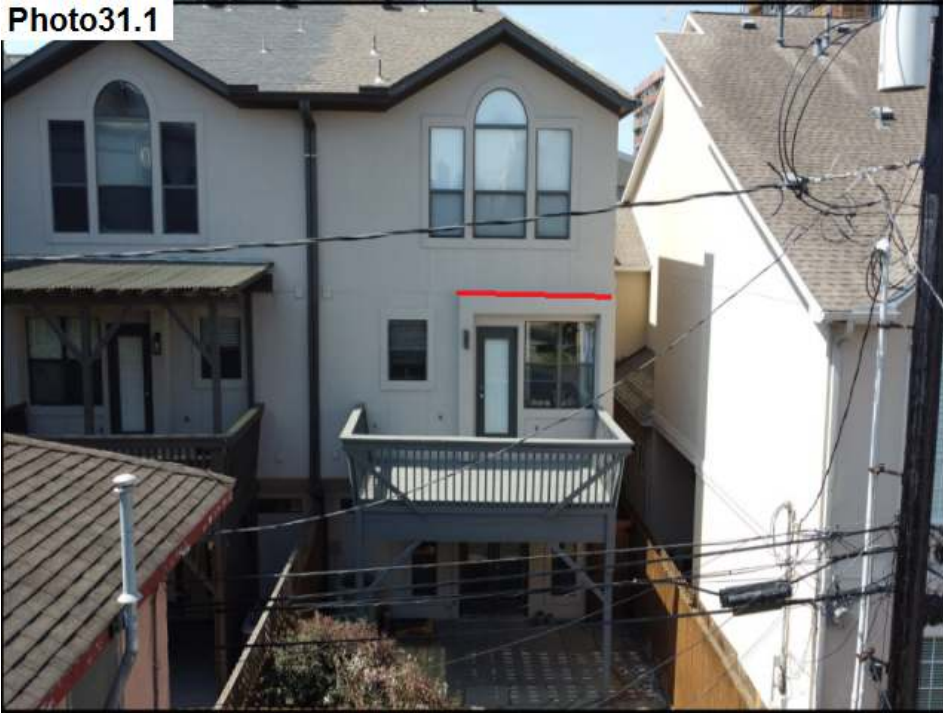
Photo31.1

Grid Location	Item Description	Moisture Readings	Substrate Condition	Observations
Red Line	Flat Accent			A flat accent has been noted in this area. Although the moisture levels were acceptable the inspector suggests to have a waterproofing contractor further assess and to apply elastomeric coating or install a metal cap as needed, in an effort to prevent moisture intrusion. Please refer to photos #31.2, #21.3, #31.4, #31.5 and #31.6 for more detail.

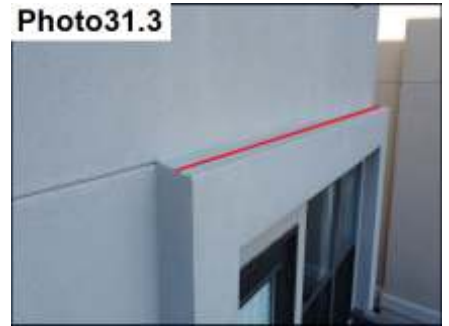
Photo31.3

Flat Accent / Install Metal Cap or Apply Elastomeric Coating

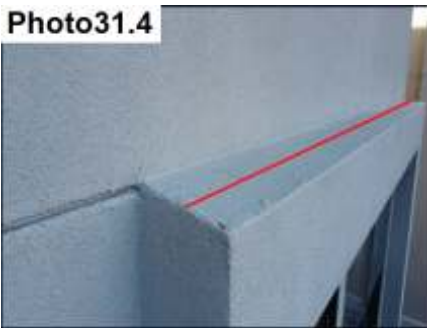
Photo31.4

Flat Accent / Install Metal Cap or Apply Elastomeric Coating

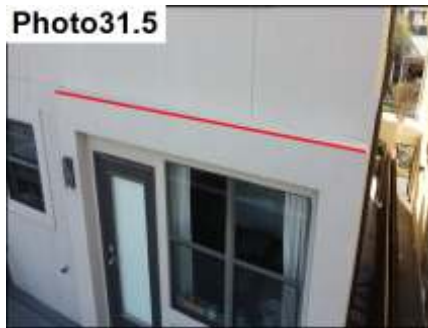
Photo31.5

Flat Accent / Install Metal Cap or Apply Elastomeric Coating

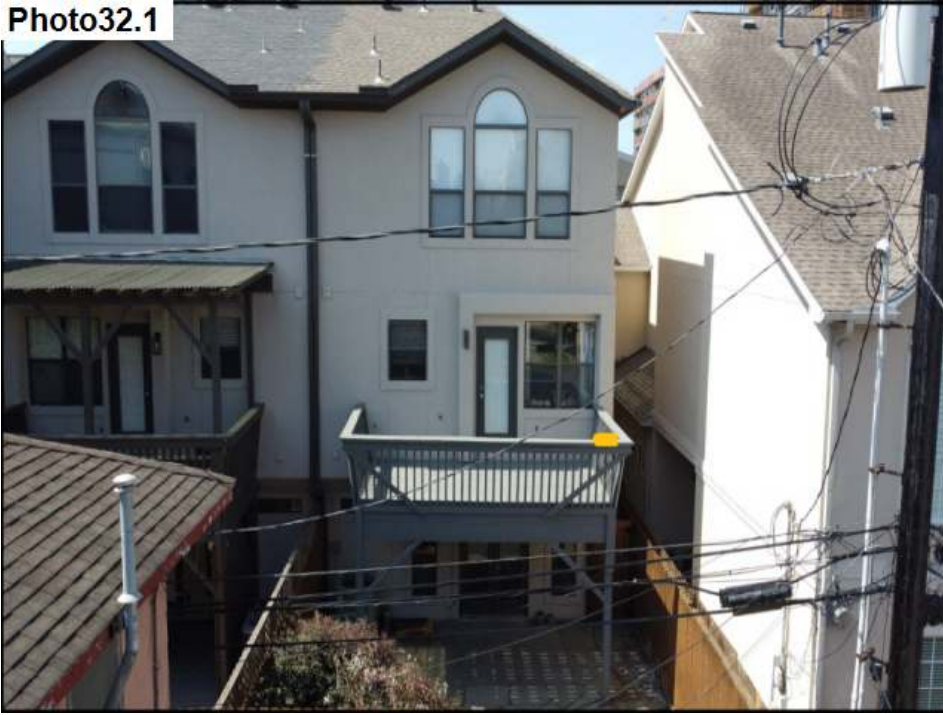
Photo32.1

Grid Location	Item Description	Moisture Readings	Substrate Condition	Observations
Orange Line	Relief			Although the bottom of the wall noted does not have a proper relief, this was a proper detail at the time of construction. Upon invasive testing at this location, the substrate was firm with low moisture readings. The inspector recommends no modification at this point in time but recommends to maintain all sealants above this location to prevent potential moisture intrusion. Please refer to photos #32.2, #32.3 and #32.4 for more detail.

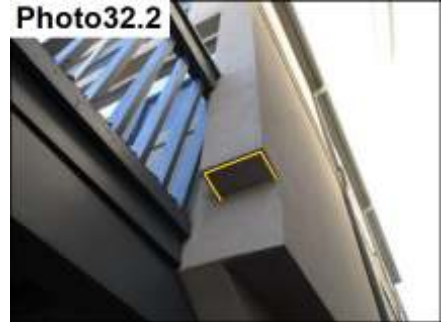
Photo32.2

Relief / No Modification

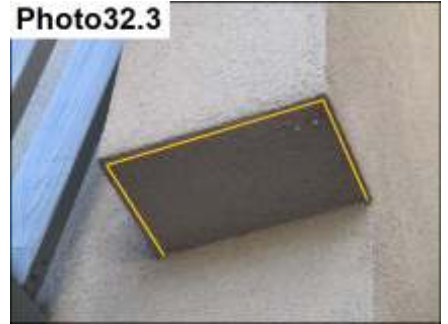
Photo32.3

Relief / No Modification
