Lone Star Stucco, LLC

Moisture Assessment Report

2629 Westgate Street, Unit A

Project Information

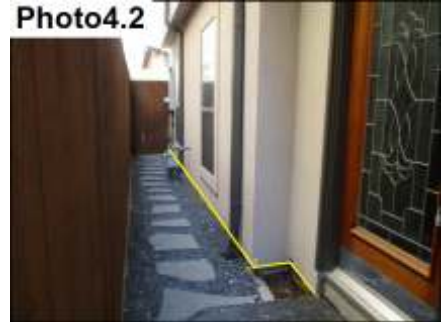
Photo4.2

- Stucco appears to be typically detailed at grade for the time of this construction. The inspector suggests that this is a positive detail and recommends no modification at this time but to always keep soil away from the structure. Please refer to photos #4.2, #4.3, #4.4, #4.5 and #4.6 for more detail.

Proper Grade Termination with Plaster Stop / Positive Detail

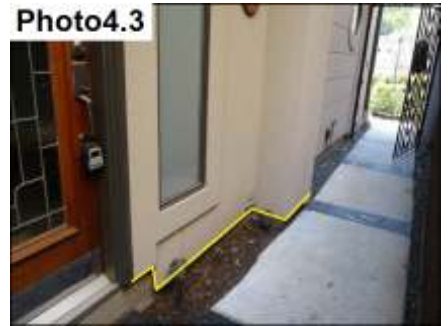
Photo4.3

Proper Grade Termination with Plaster Stop / Positive Detail

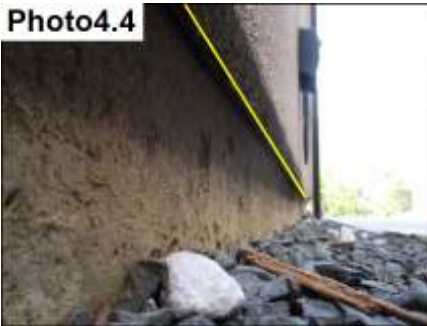
Photo4.4

Proper Grade Termination with Plaster Stop / Positive Detail

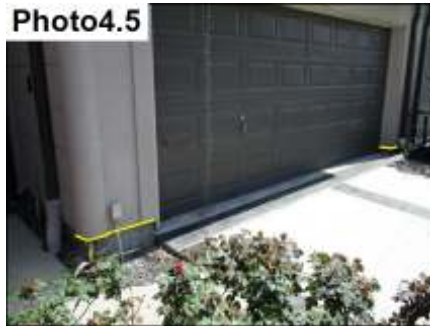
Photo4.5

Proper Grade Termination with Plaster Stop / Positive Detail

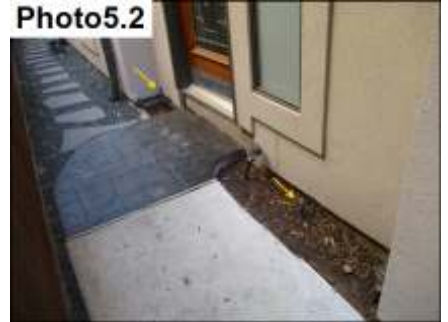
Photo5.2

- Sprinklers have been noted on this home. The inspector suggests to always redirect sprinkler heads away from the system and windows as needed in an effort to prevent moisture intrusion. Please refer to photos #5.2, #5.3, #5.4, #5.5 and #5.6 for more detail.

Sprinklers / Redirect as Needed

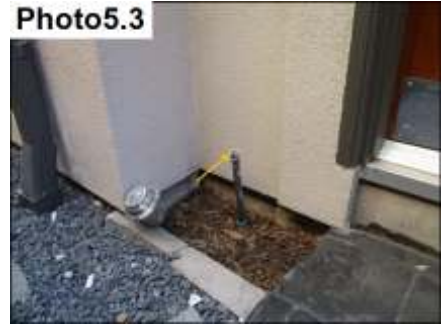
Photo5.3

Sprinklers / Redirect as Needed

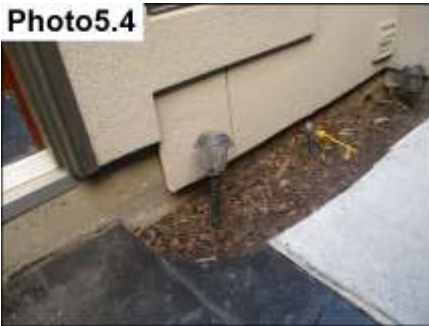
Photo5.4

Sprinklers / Redirect as Needed

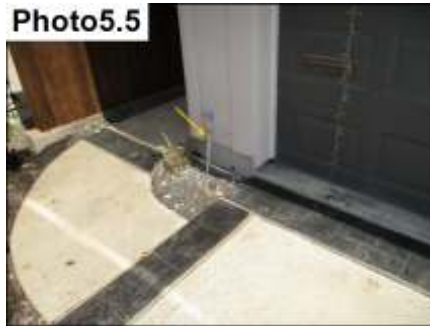
Photo5.5

Sprinklers / Redirect as Needed

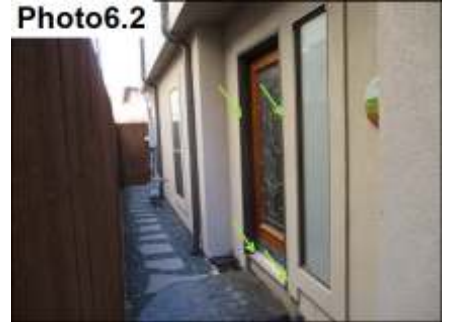
Photo6.2

- The door trim and miter sealants are aged, separated or missing at these locations. The inspector suggests to have a qualified waterproofing contractor seal these areas with a low modulus sealant in an effort to prevent moisture intrusion. These types of sealants are of high quality and compatible with stucco and other termination points. Please refer to photos #6.2, #6.3, #6.4, #6.5 and #6.6 for more detail.
[All areas noted in inspection report were sealed/caulked.](#)

Door Sealants / Seal

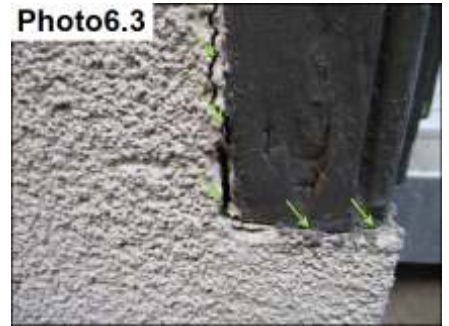
Photo6.3

Door Sealants / Seal

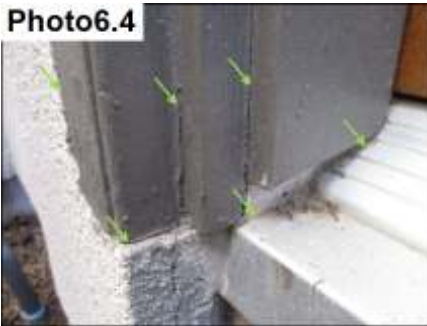
Photo6.4

Door Sealants / Seal

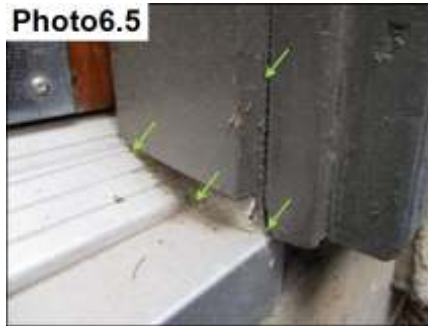
Photo6.5

Door Sealants / Seal

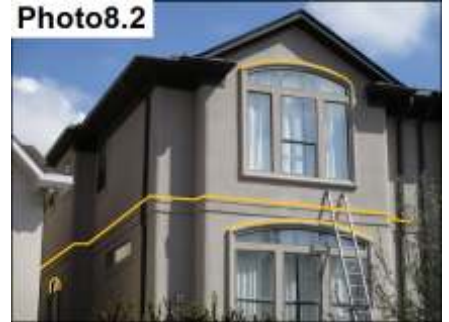
Photo8.2

- Accent terminations/stucco termination sealants are aged or separated at these locations. The inspector suggests to have a qualified waterproofing contractor further assess and seal these areas with a low modulus sealant in an effort to prevent moisture intrusion. These types of sealants are of high quality and compatible with stucco and other termination points. Please refer to photos #8.2, #8.3, #8.4, #8.5 and #8.6 for more detail.

Accent & Stucco Termination / Seal

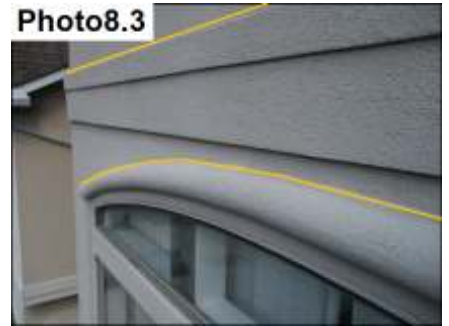
Photo8.3

Accent & Stucco Termination / Seal

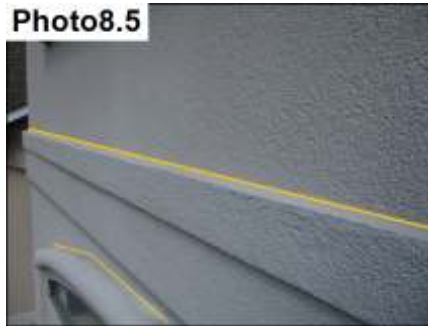
Photo8.5

Accent & Stucco Termination / Seal

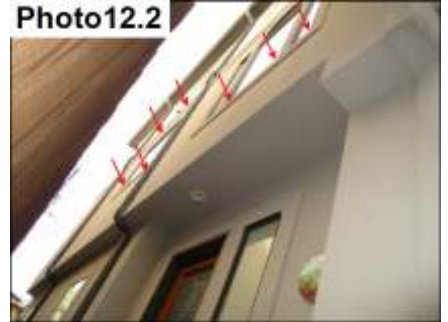
Photo12.2

Window Sealants / Seal

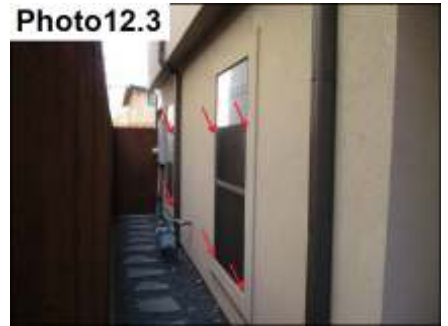
Photo12.3

Window Sealants / Seal

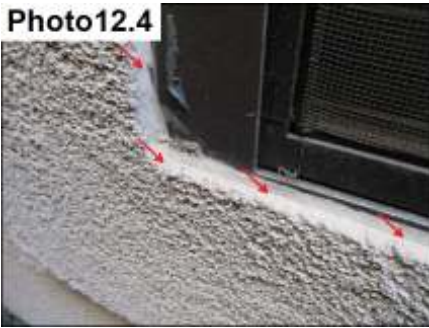
Photo12.4

Window Sealants / Seal

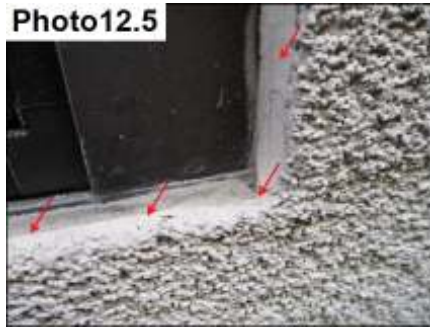
Photo12.5

Window Sealants / Seal

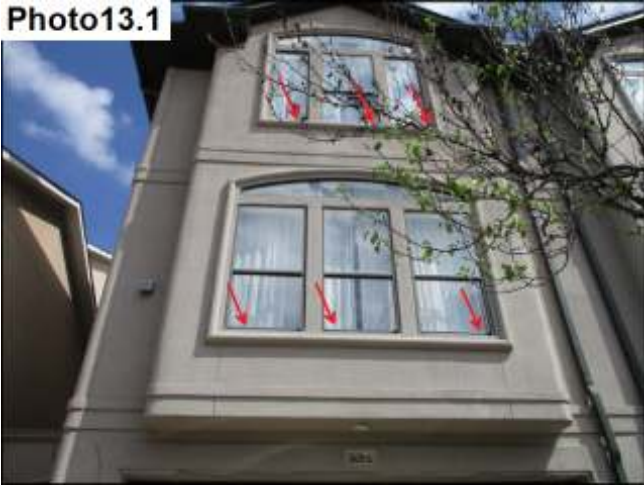
Photo13.1

Window Sealants / Seal

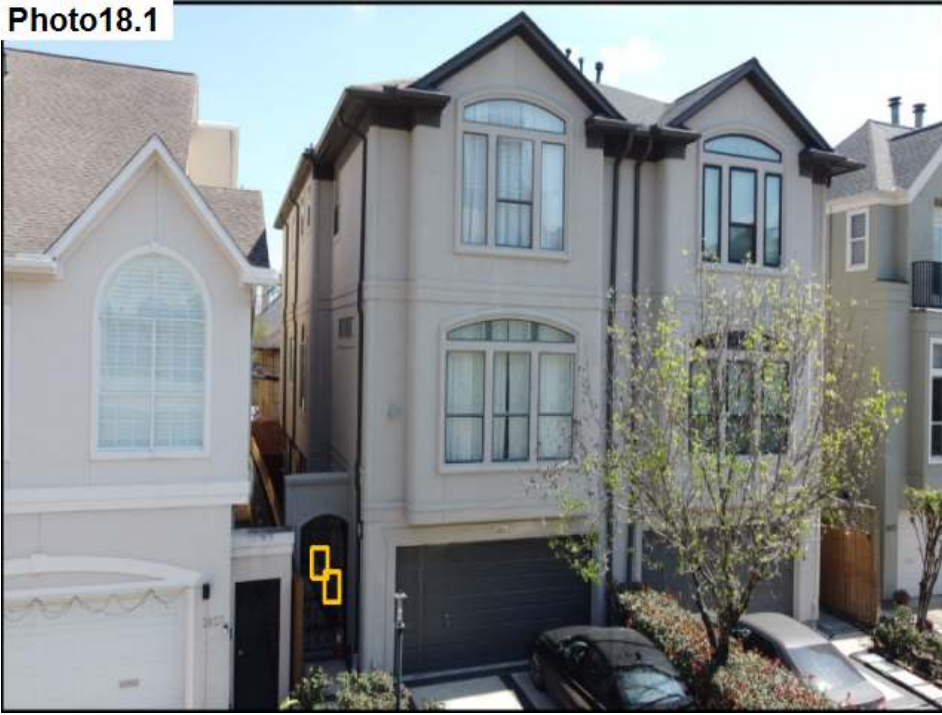
Photo18.1

Grid Location	Item Description	Moisture Readings	Substrate Condition	Observations
Orange Boxes	Wood Rot			The door trim at this area has wood rot. The inspector suggests to have a qualified contractor further assess and repair this area as needed in an effort to prevent moisture intrusion. All wood rot was not necessarily identified in this report. Please refer to photos #18.2, #18.3, #18.4, #18.5 and #18.6 for more detail.

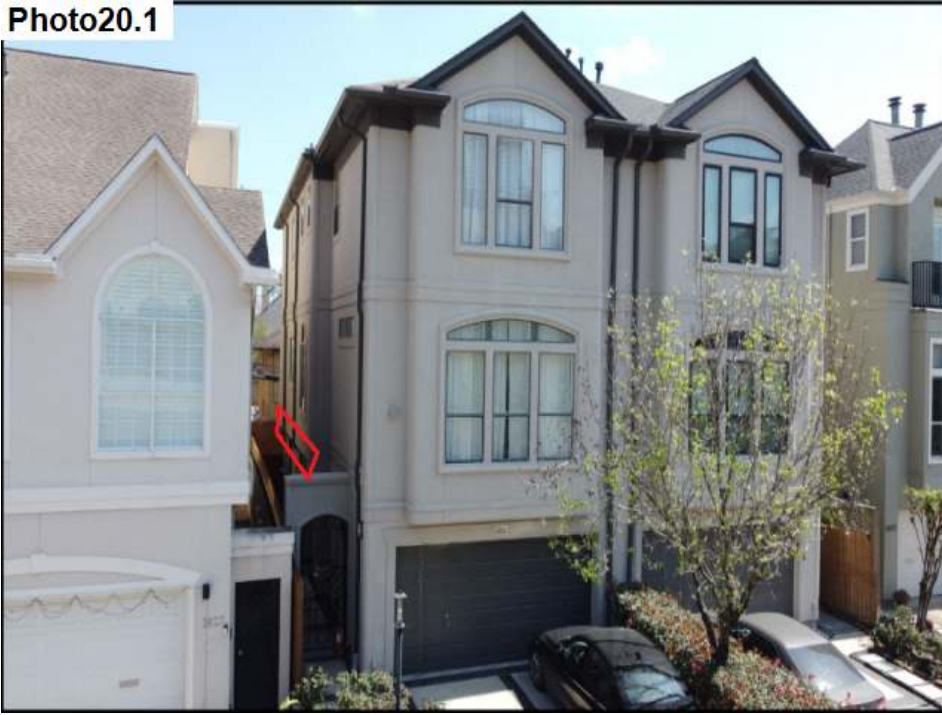
Photo20.1

Grid Location	Item Description	Moisture Readings	Substrate Condition	Observations
Red Box	Potential Damage			Soft substrate is noted at the bottom of the wall below the bank of windows. The inspector recommends having a qualified waterproofing contractor core sample to further assess the extent, then repair if needed and install a proper relief in an effort to prevent moisture intrusion. Please refer to photos #20.2, #20.3, #20.4, #20.5 and #20.6 for more detail.

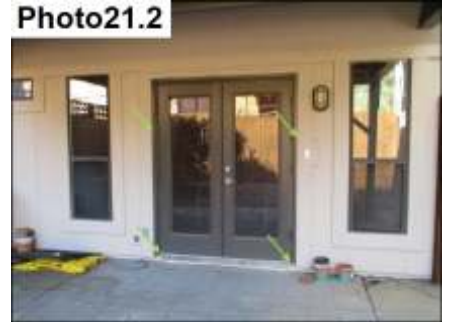
Photo21.2

Door Sealants / Seal

Grid Location	Item Description	Moisture Readings	Substrate Condition	Observations
Green Arrows	Doors			The door trim and miter sealants are aged or separated at these locations. The inspector suggests to have a qualified waterproofing contractor seal these areas with a low modulus sealant in an effort to prevent moisture intrusion. These types of sealants are of high quality and compatible with stucco and other termination points. Please refer to photos #21.2, #21.3, #21.4, #21.5 and #21.6 for more detail.

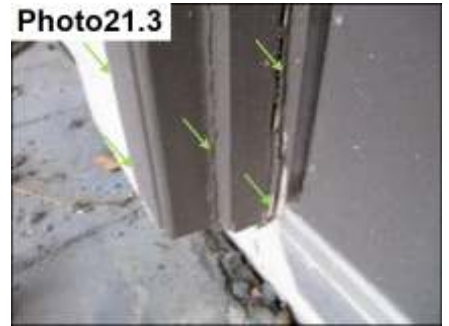
Photo21.3

Door Sealants / Seal

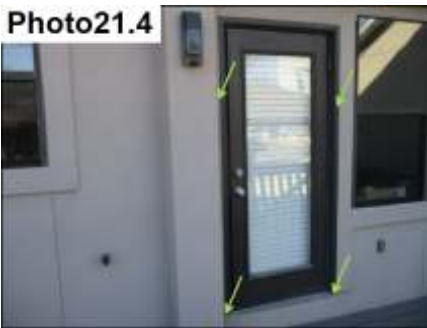
Photo21.4

Door Sealants / Seal

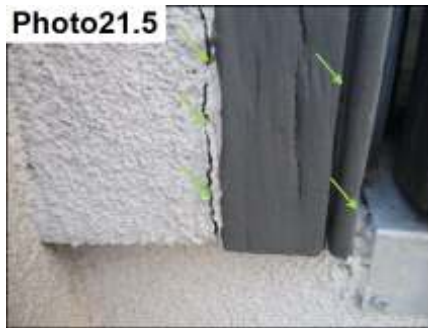
Photo21.5

Door Sealants / Seal

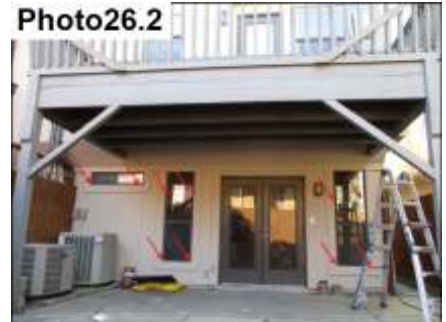
Window Sealants / Seal

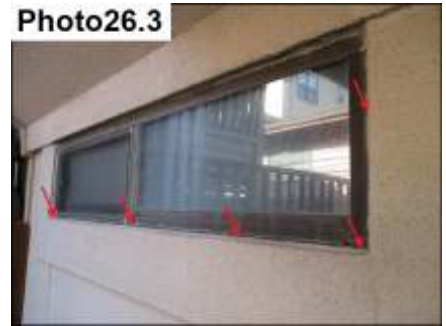
Window Sealants / Seal

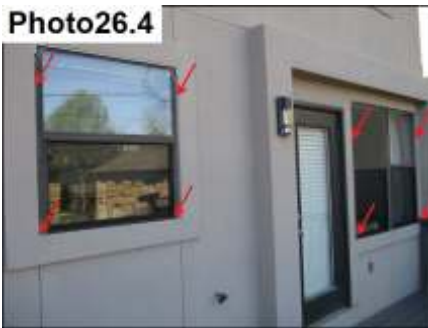
Window Sealants / Seal

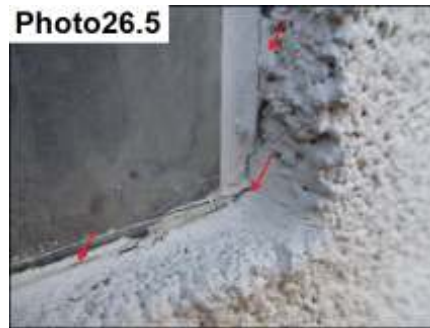
Window Sealants / Seal

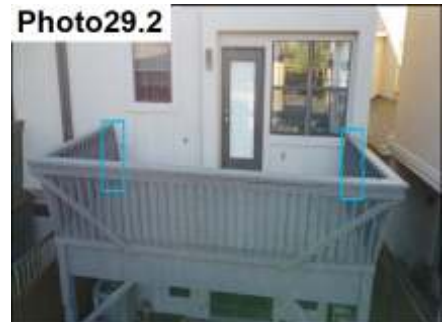
Railing & Stucco Termination / Seal

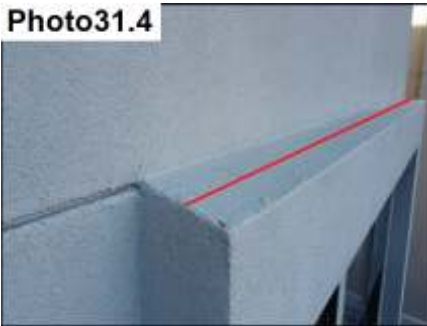
Photo31.4

Flat Accent / Install Metal Cap or Apply Elastomeric Coating

Grid Location	Item Description	Moisture Readings	Substrate Condition	Observations
Red Line	Flat Accent			A flat accent has been noted in this area. Although the moisture levels were acceptable the inspector suggests to have a waterproofing contractor further assess and to apply elastomeric coating or install a metal cap as needed, in an effort to prevent moisture intrusion. Please refer to photos #31.2, #21.3, #31.4, #31.5 and #31.6 for more detail.

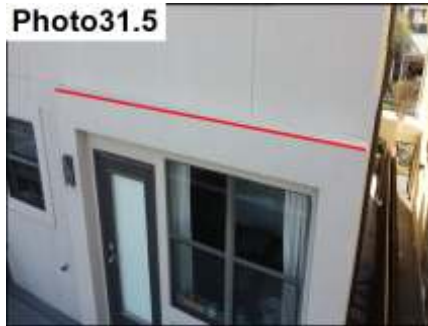
Photo31.5

Flat Accent / Install Metal Cap or Apply Elastomeric Coating

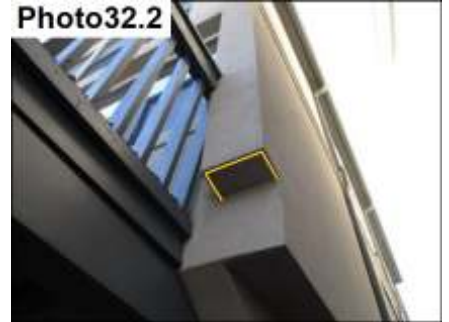
Photo32.2

Relief / No Modification

Grid Location	Item Description	Moisture Readings	Substrate Condition	Observations
Orange Line	Relief			Although the bottom of the wall noted does not have a proper relief, this was a proper detail at the time of construction. Upon invasive testing at this location, the substrate was firm with low moisture readings. The inspector recommends no modification at this point in time but recommends to maintain all sealants above this location to prevent potential moisture intrusion. Please refer to photos #32.2, #32.3 and #32.4 for more detail.

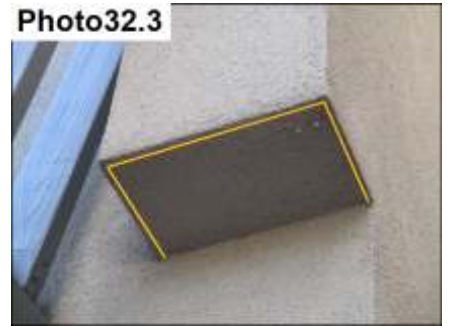
Photo32.3

Relief / No Modification
