HEDDERMAN SERVICES

STRUCTURAL INSPECTION

10726 Tupper Lake Dr
Houston TX 77042

JULY 2, 2021

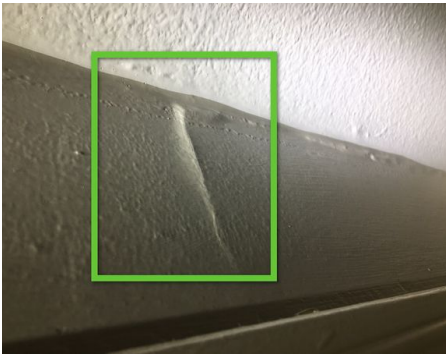
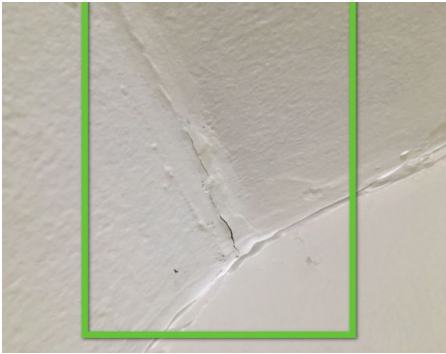
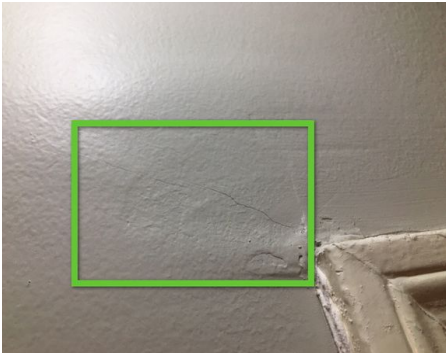
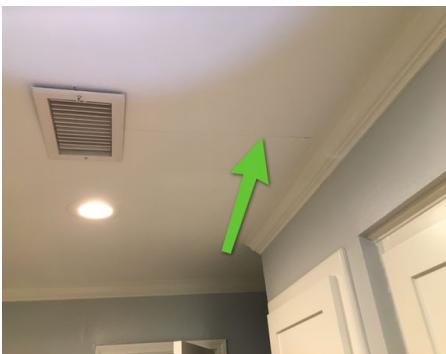
West bedroom, stairs, second-floor hallway, second-floor bathroom, north bedroom, and the east bedroom.

Differential Movement: Sheetrock Cracks/Patches/Compression ridges

Sheetrock cracks, patches, and/or compression ridges were observed in the house during the inspection, including at the specified locations.

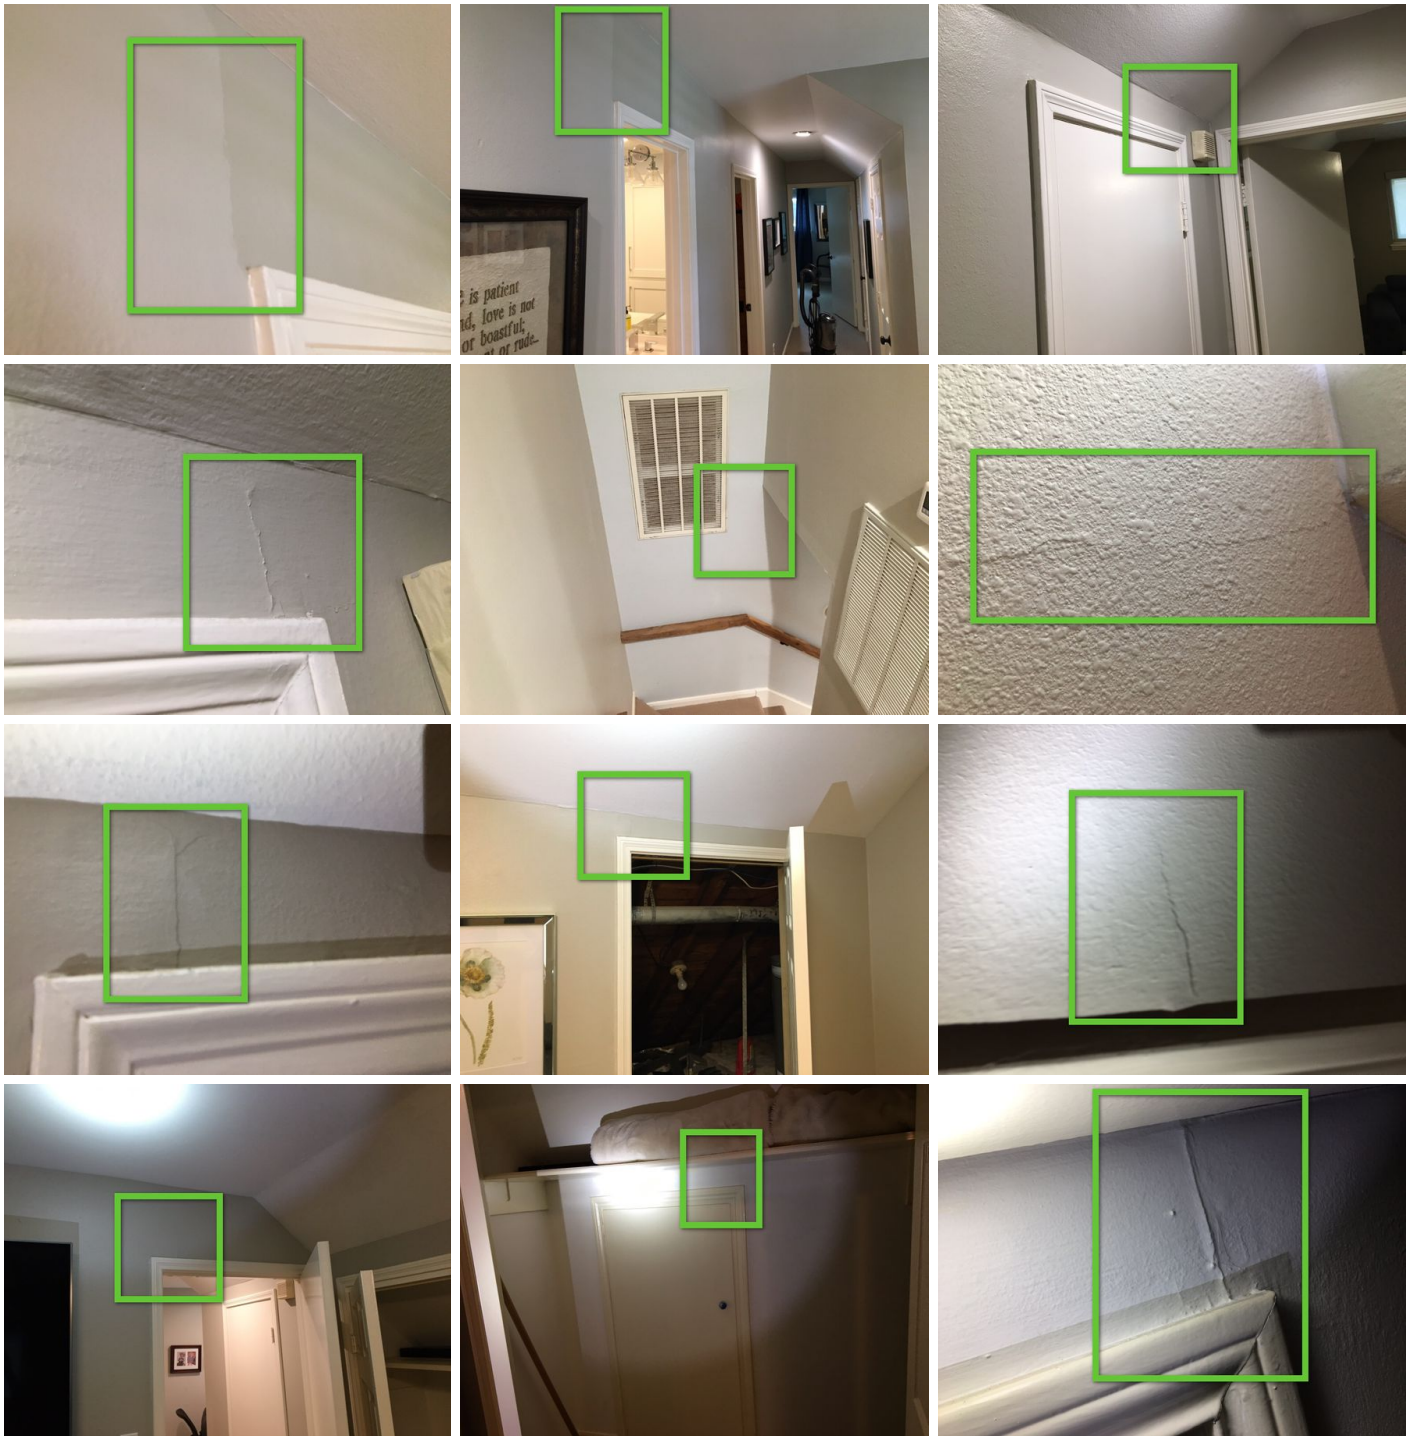
West bedroom

Differential Movement: Sheetrock - Nail pops

Nail pops were observed in the surface of the sheetrock at the time of the inspection including at the above locations.

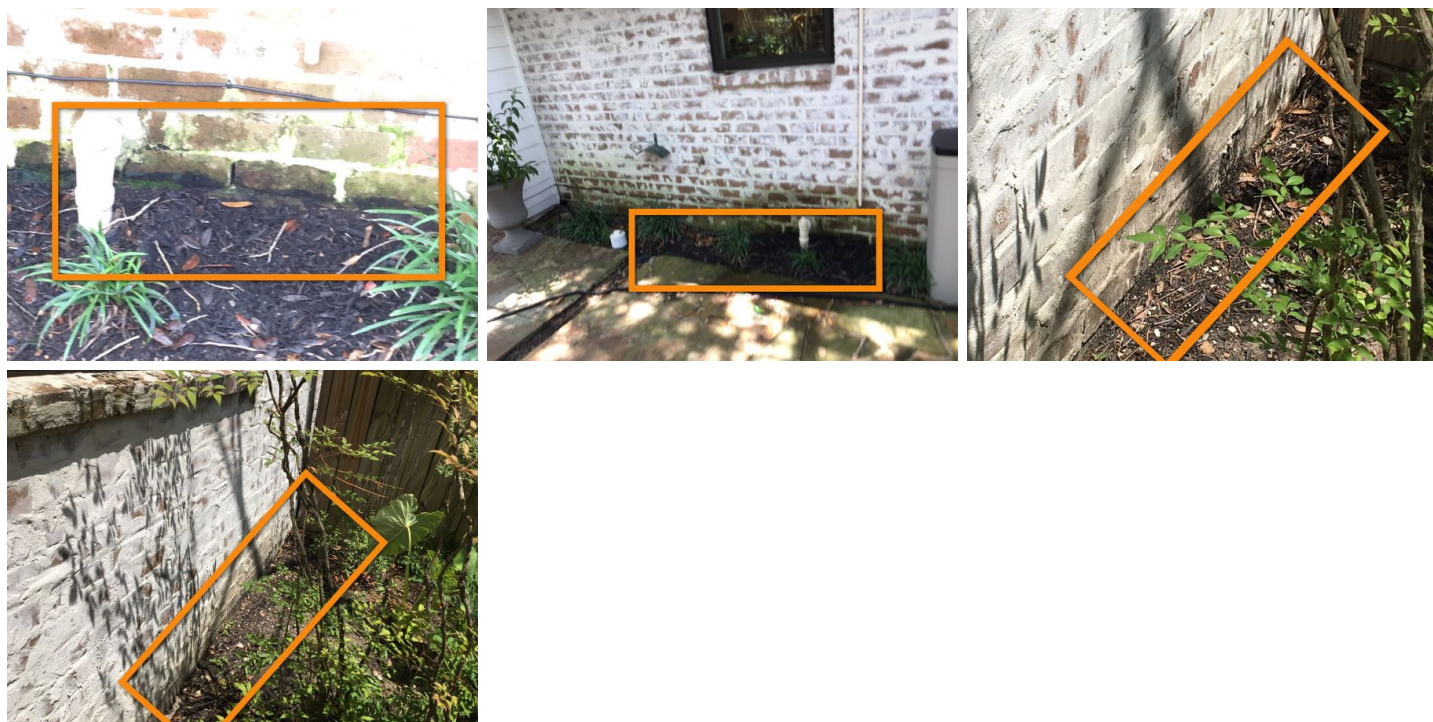
4.7.2 Perimeter Grading/Drainage

UNDERGROUND DRAIN, UNKNOWN EXIT POINT

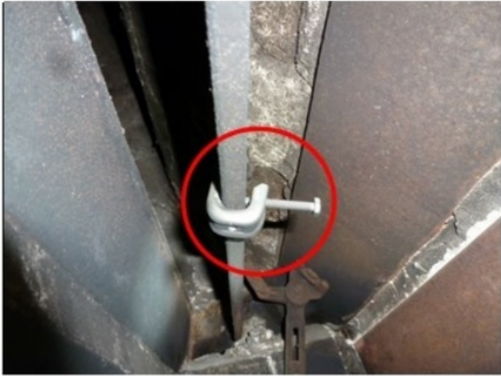
HEI file photo showing c-clamp in masonry fireplace

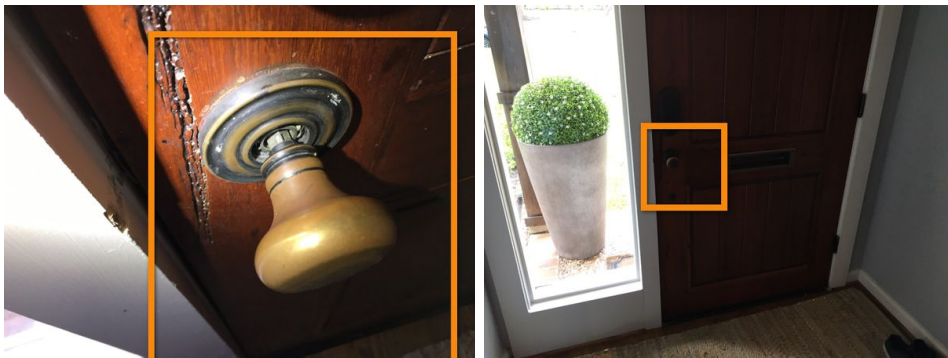
11.1.4 Doors

HARDWARE REPAIR

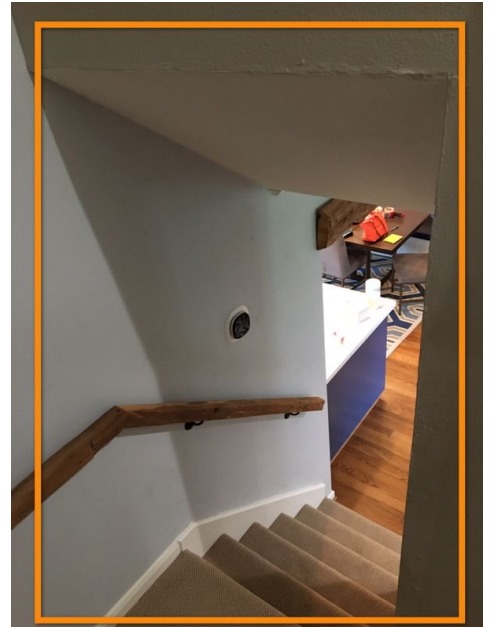
11.7.3 Stairs/Handrails/Guardrails

STAIRWAY RISER HEIGHT IMPROPER

The riser heights did not fall within the variation limits as specified by the International Residential Code. The maximum riser height shall be 7-3/4 inches, and the greatest riser height within any flight of stairs shall not exceed the smallest by more than 3/8 inch. Have a service company provide a cost estimate for all needed repairs.

Obtain Cost Estimate

Recommendation
Contact a qualified professional.
