RESIDENTIAL INSPECTION REPORT

4326 Hazelton St
Houston, TX 77035

PROPERTY INSPECTION REPORT FORM

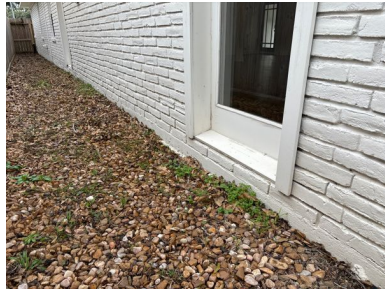
Performance Opinion: Further Evaluation is Recommended:

Further evaluation by a licensed structural engineer and/or a foundation contractor is recommended.

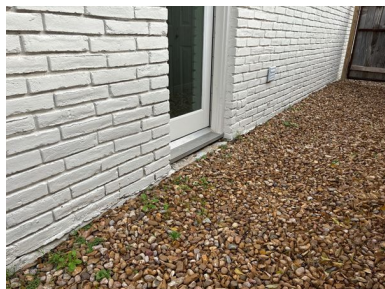
Left side

Parts of the slab not visible:

Parts of the slab facing were not visible due to high soil, heavy foliage, and/or debris against the house.

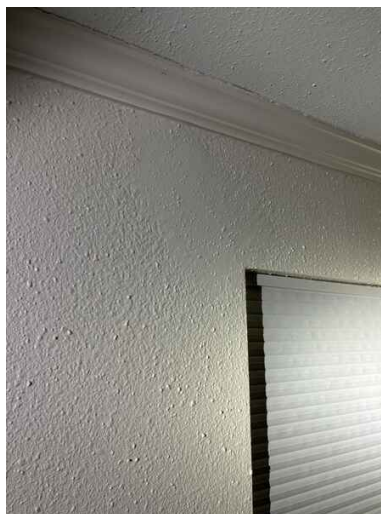
Front bedroom

1: Evidence of Foundation Settlement Present

Noticeable floor slope, Drywall cracks, Brick Cracks, Slab Cracks -

Due to evidence of foundation settlement, further evaluation by a licensed structural engineer and/or qualified foundation contractor is recommended.

Recommendation: Contact a qualified structural engineer.

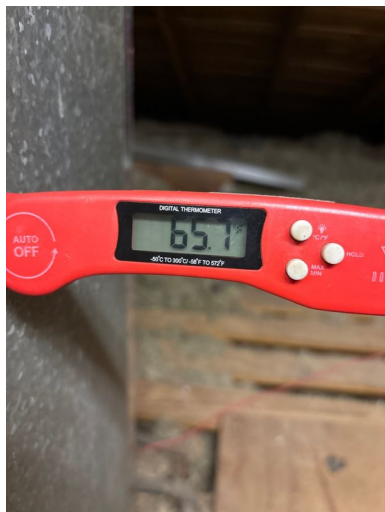
Return temperature

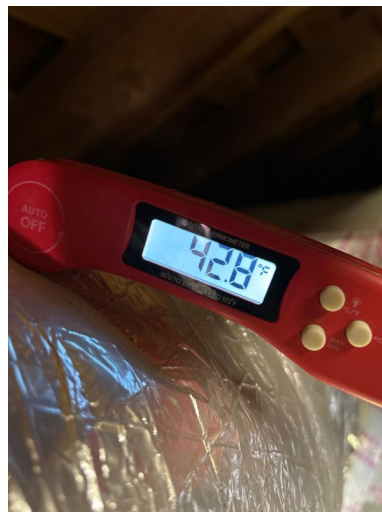
Supply temperature
