Lone Star Stucco, LLC

Moisture Assessment Report

2638 Westgate Street

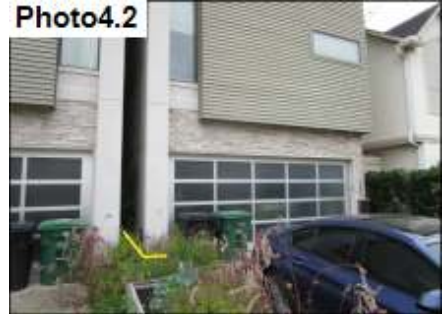
Photo4.2

- Stucco/manufactured stone veneer appears to be typically detailed at grade for the time of this construction. The inspector suggests that this is a positive detail and recommends no modification at this time but to always keep soil away from the structure. Please refer to photos #4.2, #4.3, #4.4, #4.5 and #4.6 for more detail.

Proper Grade Termination with Weep Screed / Positive Detail

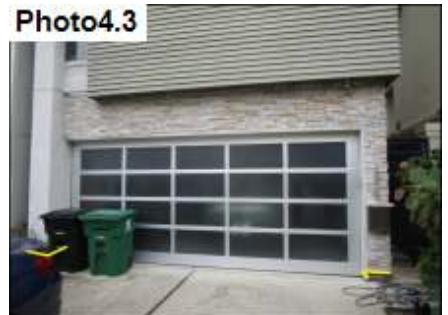
Photo4.3

Proper Grade Termination with Weep Screed / Positive Detail

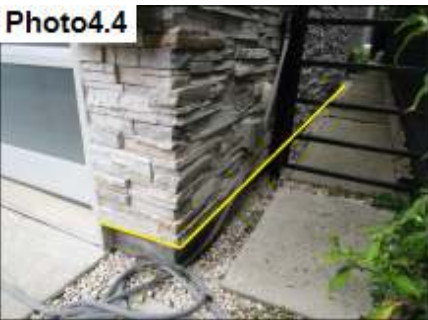
Photo4.4

Proper Grade Termination with Weep Screed / Positive Detail

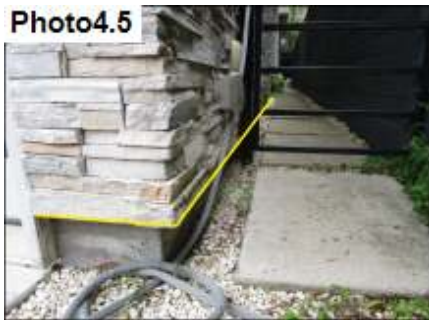
Photo4.5

Proper Grade Termination with Weep Screed / Positive Detail

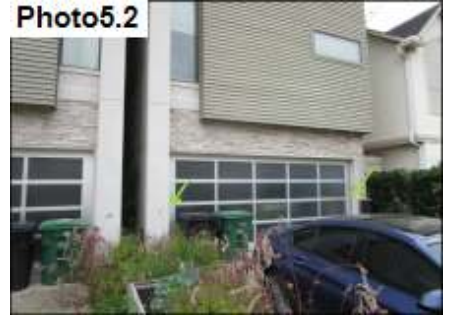
Photo5.2

- The garage door trim sealants are aged at this location. The inspector suggests to have a qualified waterproofing contractor seal this area with a low modulus sealant in an effort to prevent moisture intrusion. These types of sealants are of high quality and compatible with stucco and other termination points. Please refer to photos #5.2, #5.3, #5.4, #5.5 and #5.6 for more detail. [The garage door trim has been sealed.](#)

Garage Door Trim Sealant / Seal

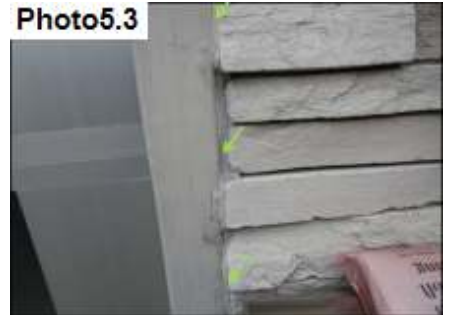
Photo5.3

Garage Door Trim Sealant / Seal

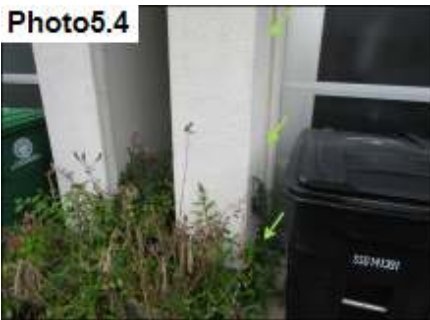
Photo5.4

Garage Door Trim Sealant / Seal

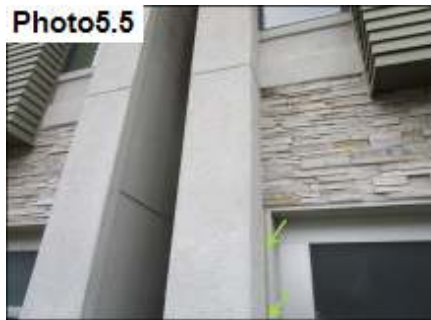
Photo5.5

Garage Door Trim Sealant / Seal

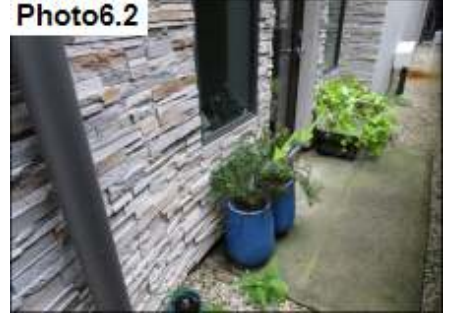
Photo6.2

- The door trim and miter sealants are aged at this location. The inspector suggests to have a qualified waterproofing contractor seal this area with a low modulus sealant in an effort to prevent moisture intrusion. These types of sealants are of high quality and compatible with stucco and other termination points. Please refer to photos #6.2, #6.3, #6.4, #6.5 and #6.6 for more detail. [Door trim and miters have been sealed.](#)

Door Trim and Miter Sealant / Seal

Grid Location	Item Description	Moisture Readings	Substrate Condition	Observations
Green Arrows	Doors			The door trim and miter sealants are aged at this location. The inspector suggests to have a qualified waterproofing contractor seal this area with a low modulus sealant in an effort to prevent moisture intrusion. These types of sealants are of high quality and compatible with stucco and other termination points. Please refer to photos #6.2, #6.3, #6.4, #6.5 and #6.6 for more detail.

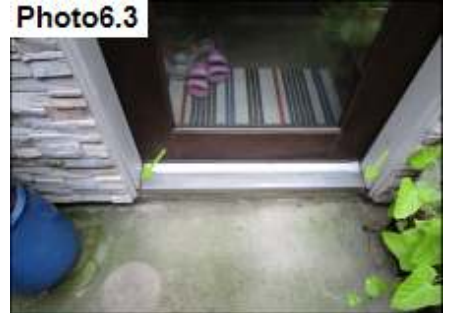
Photo6.3

Door Trim and Miter Sealant / Seal

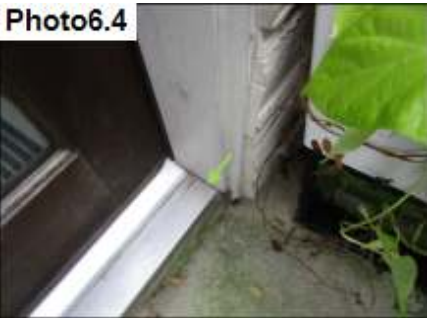
Photo6.4

Door Trim and Miter Sealant / Seal

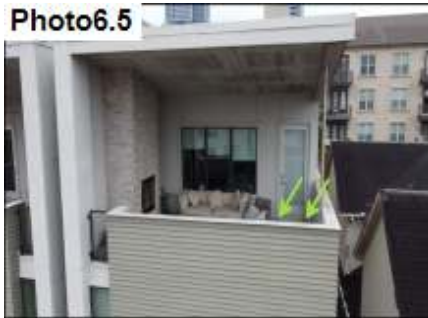
Photo6.5

Door Trim and Miter Sealant / Seal

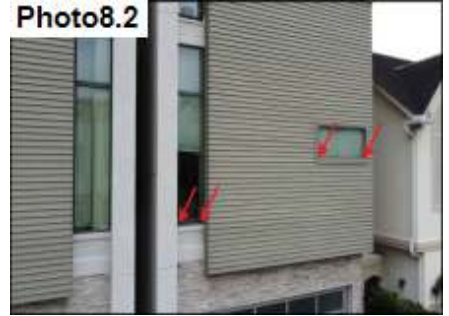
Photo8.2

- The window sealants are aged. The inspector suggests to have a qualified waterproofing contractor further assess and seal this area with a low modulus sealant in an effort to prevent moisture intrusion. These types of sealants are of high quality and compatible with stucco and other termination points. Please refer to photos #8.2, #8.3, #8.4, #8.5, #8.6, #9.1, #9.2 and #9.3 for more detail. [All windows have been sealed.](#)

Window Sealants / Seal

Grid Location	Item Description	Moisture Readings	Substrate Condition	Observations
Red Arrows	Windows			The window sealants are aged. The inspector suggests to have a qualified waterproofing contractor further assess and seal this area with a low modulus sealant in an effort to prevent moisture intrusion. These types of sealants are of high quality and compatible with stucco and other termination points. Please refer to photos #8.2, #8.3, #8.4, #8.5, #8.6, #9.1, #9.2 and #9.3 for more detail.

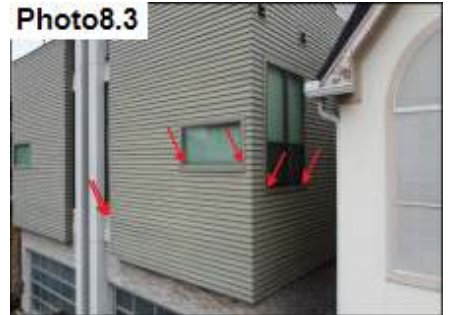
Photo8.3

Window Sealants / Seal

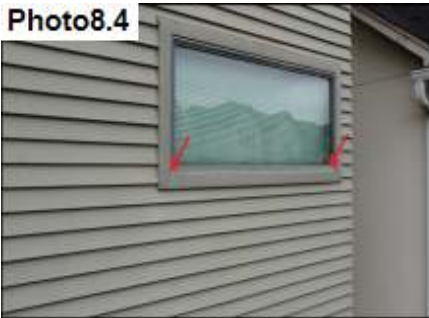
Photo8.4

Window Sealants / Seal

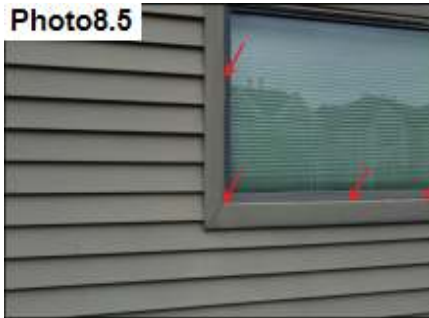
Photo8.5

Window Sealants / Seal

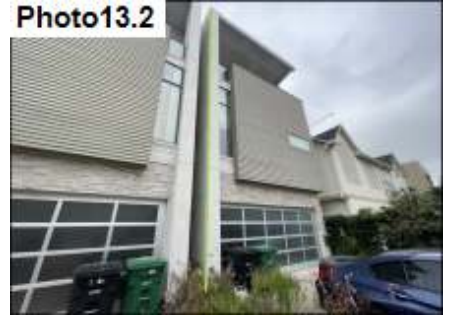
Photo13.2

- Siding/stucco termination sealants are aged or separated at this location. The inspector suggests to have a qualified waterproofing contractor further assess and seal this area with a low modulus sealant in an effort to prevent moisture intrusion. These types of sealants are of high quality and compatible with stucco and other termination points. Please refer to photos #13.2, #13.3, #13.4, #13.5, #13.6, #14.1 and #14.2 for more detail. [Siding/stucco terminations have been sealed.](#)

Siding & Stucco Termination / Seal

Grid Location	Item Description	Moisture Readings	Substrate Condition	Observations
Green Line	Stucco Termination			Siding/stucco termination sealants are aged or separated at this location. The inspector suggests to have a qualified waterproofing contractor further assess and seal this area with a low modulus sealant in an effort to prevent moisture intrusion. These types of sealants are of high quality and compatible with stucco and other termination points. Please refer to photos #13.2, #13.3, #13.4, #13.5, #13.6, #14.1 and #14.2 for more detail.

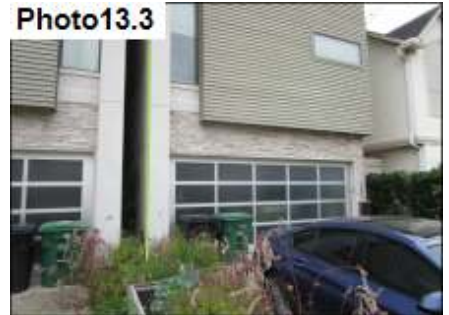
Photo13.3

Siding & Stucco Termination / Seal

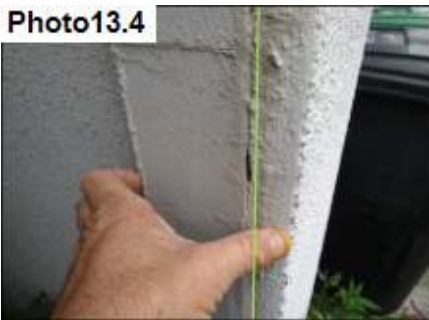
Photo13.4

Siding & Stucco Termination / Seal

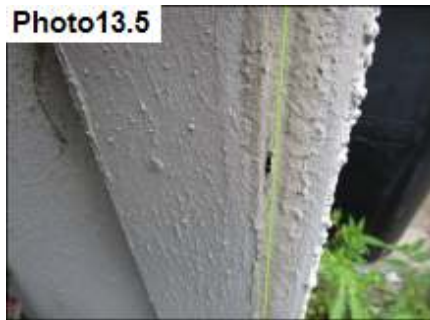
Photo13.5

Siding & Stucco Termination / Seal

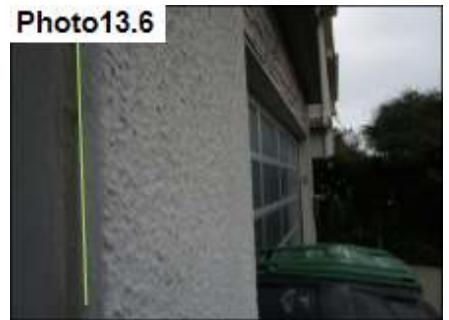
Photo13.6

Siding & Stucco Termination / Seal

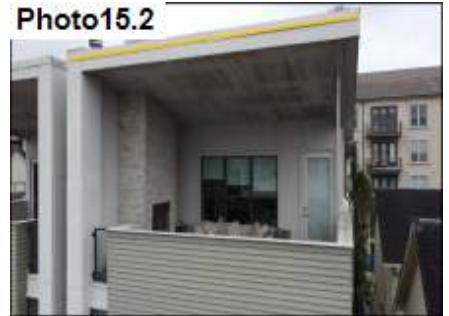
Photo15.2

Metal Cap Termination / Seal

Grid Location	Item Description	Moisture Readings	Substrate Condition	Observations
Orange Line	Metal Cap			The metal cap sealants are separated at this location. The inspector suggests to have a qualified waterproofing contractor further assess and seal this area with a low modulus sealant in an effort to prevent moisture intrusion. These types of sealants are of high quality and compatible with stucco and other termination points. Please refer to photos #15.2, #15.3, #15.4, #15.5 and #15.6 for more detail.

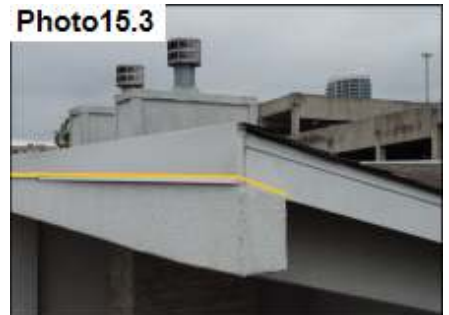
Photo15.3

Metal Cap Termination / Seal

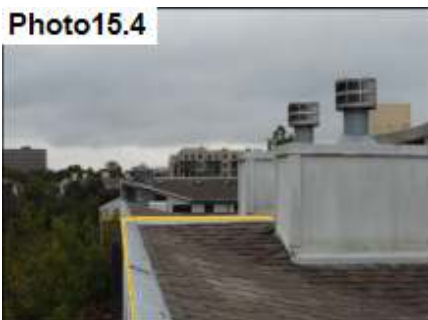
Photo15.4

Metal Cap Termination / Seal

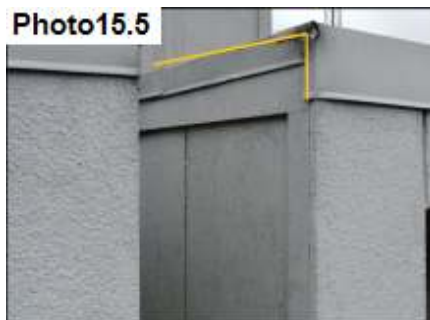
Photo15.5

Metal Cap Termination / Seal

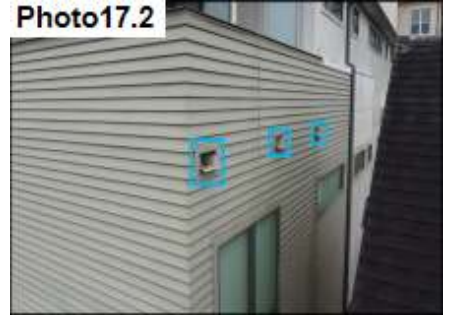
Photo17.2

Scuppers / Seal

Grid Location	Item Description	Moisture Readings	Substrate Condition	Observations
Blue Box	Scuppers			The scupper sealants are aged in this location. The inspector suggests to have a qualified waterproofing contractor seal this area in an effort to prevent moisture intrusion. Please refer to photos #17.2, #17.3, #17.4 and #17.5 for more detail.

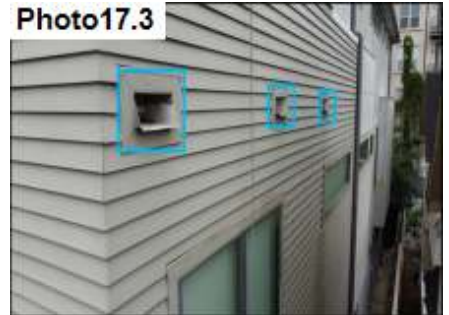
Photo17.3

Scuppers / Seal

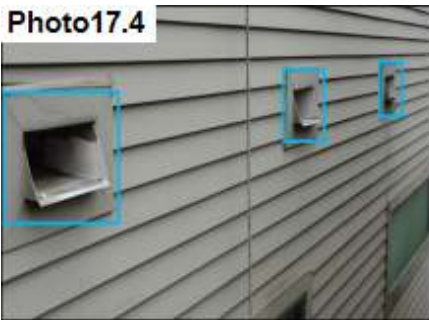
Photo17.4

Scuppers / Seal

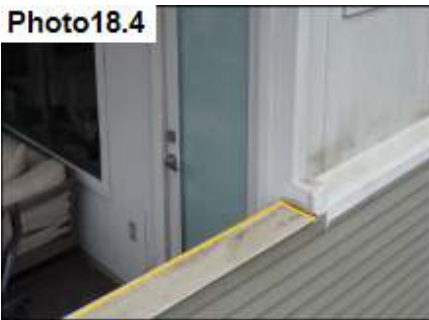
Photo18.4

Metal Cap / Seal

Grid Location	Item Description	Moisture Readings	Substrate Condition	Observations
Orange Line	Metal Cap			The metal cap sealants are aged at this location. The inspector suggests to have a qualified waterproofing contractor further assess and seal this area in an effort to prevent moisture intrusion. Please refer to photos #18.2, #18.3, #18.4 and #18.5 for more detail.

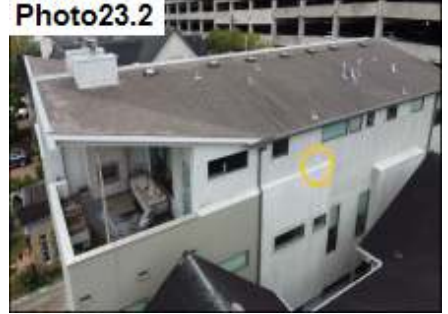
Photo23.2

Cementitious Fiber Panel / Re-Fasten

Grid Location	Item Description	Moisture Readings	Substrate Condition	Observations
Orange Circle	Siding			The cementitious fiber panels are separated at this location. The inspector suggests having a qualified waterproofing contractor further assess this area and re-fasten all panels to prevent moisture intrusion. Please refer to photos #23.2, #23.3, #23.4, #23.5 and #23.6 for more detail.

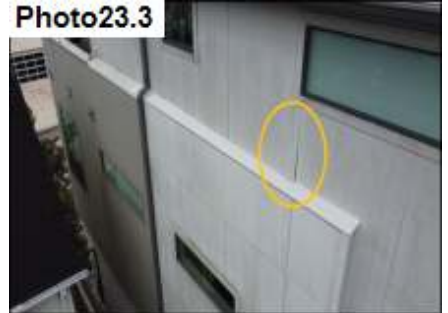
Photo23.3

Cementitious Fiber Panel / Re-Fasten

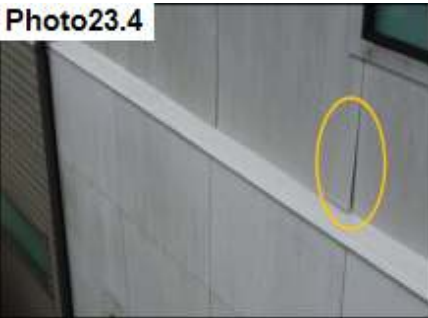
Photo23.4

Cementitious Fiber Panel / Re-Fasten

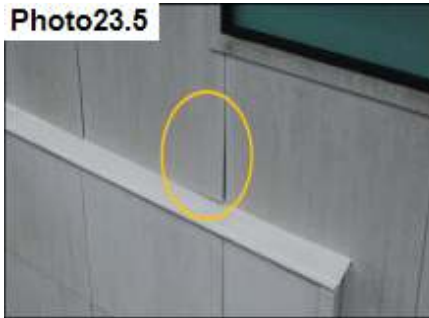
Photo23.5

Cementitious Fiber Panel / Re-Fasten

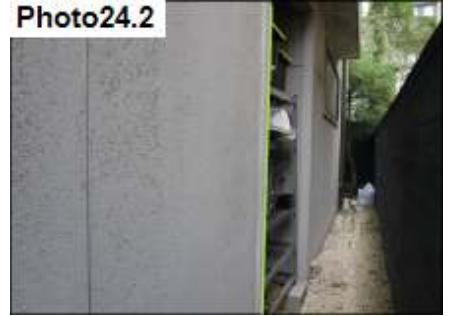
Photo24.2

Trim Termination / Seal

Grid Location	Item Description	Moisture Readings	Substrate Condition	Observations
Green Line	Trim Termination			Trim termination sealants are separated at this location. The inspector suggests to have a qualified waterproofing contractor further assess and seal this area in an effort to prevent moisture intrusion. Please refer to photos #24.2, #24.3, #24.4 and #24.5 for more detail.

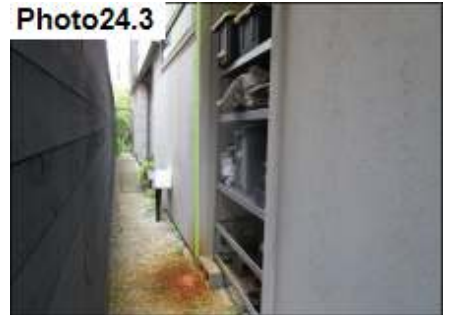
Photo24.3

Trim Termination / Seal

Trim terminations have been sealed.

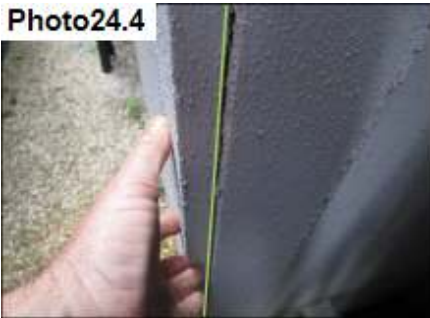
Photo24.4

Trim Termination / Seal

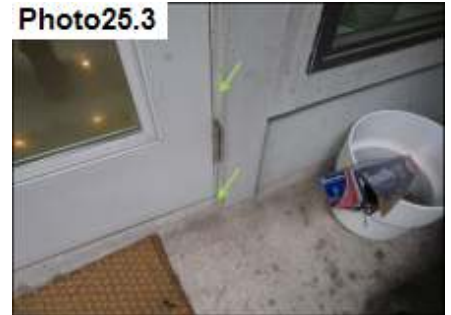
Photo25.3

Door Trim and Miter Sealant / Seal

Grid Location	Item Description	Moisture Readings	Substrate Condition	Observations
Green Arrow	Doors			The door trim and miter sealants are aged at this location. The inspector suggests to have a qualified waterproofing contractor seal this area in an effort to prevent moisture intrusion. Please refer to photos #25.2, #25.3 and #25.4 for more detail.

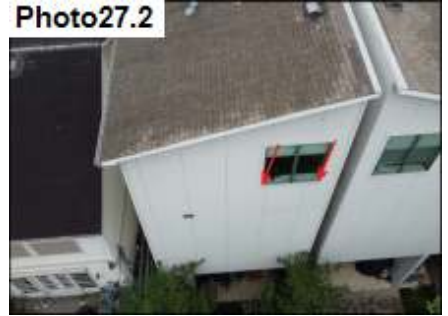
Photo27.2

Window Sealants / Seal

Grid Location	Item Description	Moisture Readings	Substrate Condition	Observations
Red Arrows	Windows			The window sealants are aged. The inspector suggests to have a qualified waterproofing contractor further assess and seal this area with a low modulus sealant in an effort to prevent moisture intrusion. These types of sealants are of high quality and compatible with stucco and other termination points. Please refer to photos #27.2, #27.3, #27.4 and #27.5 for more detail.

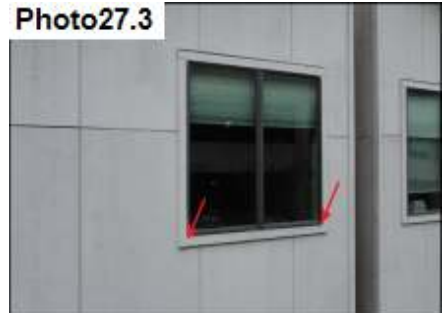
Photo27.3

Window Sealants / Seal

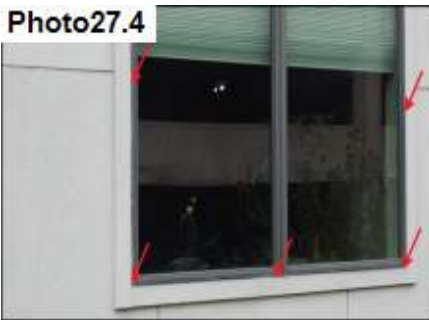
Photo27.4

Window Sealants / Seal

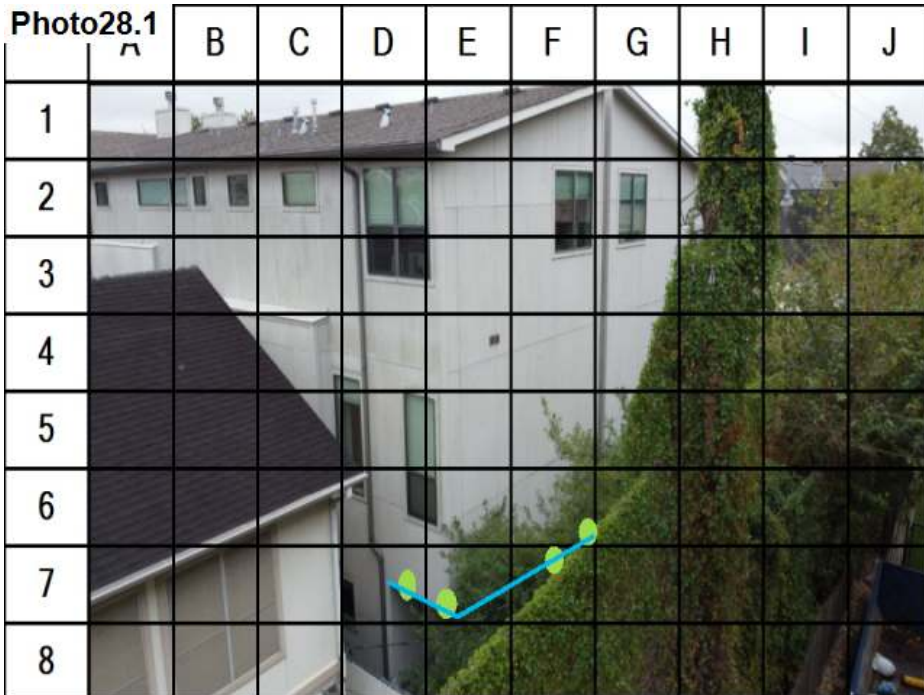
No Relief / No Modification

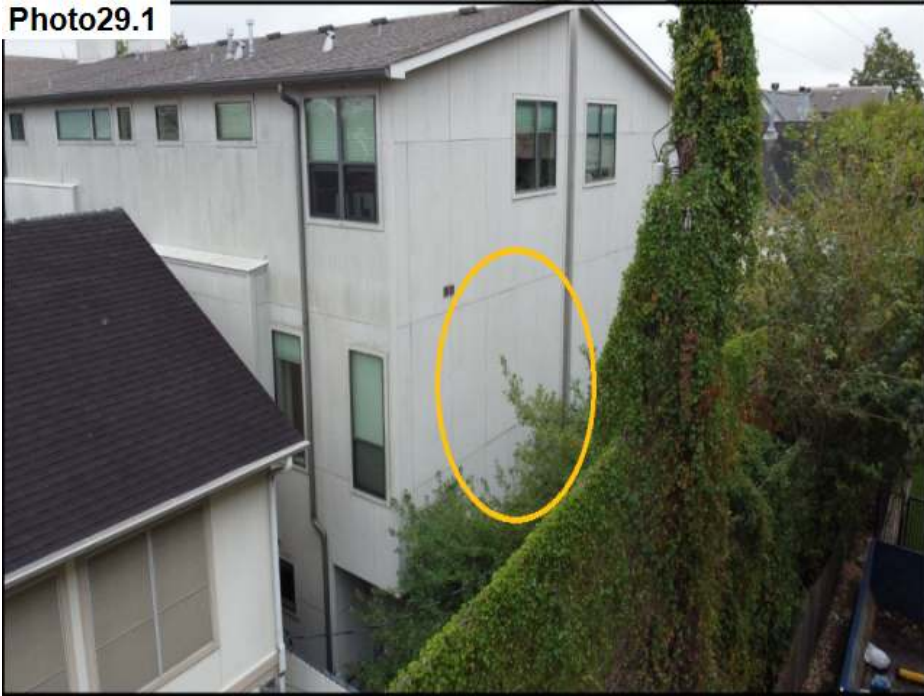
Photo29.1

Grid Location	Item Description	Moisture Readings	Substrate Condition	Observations
Orange Circle	Siding			The cementitious fiber panels are separated at this location. The inspector suggests having a qualified waterproofing contractor further assess this area and re-fasten all panels to prevent moisture intrusion. Please refer to photos #29.2, #29.3, #29.4 and #29.5 for more detail.

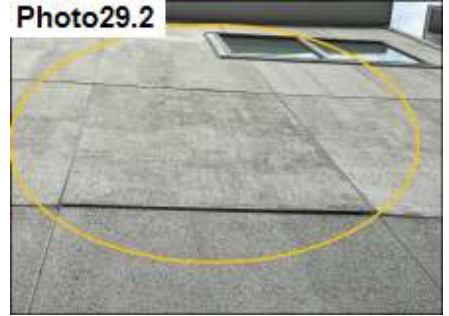
Photo29.2

- The cementitious fiber panels are separated at this location. The inspector suggests having a qualified waterproofing contractor further assess this area and re-fasten all panels to prevent moisture intrusion. Please refer to photos #29.2, #29.3, #29.4 and #29.5 for more detail.
[Cement panels have been re-fastened.](#)

Cementitious Fiber Panel / Re-Fasten

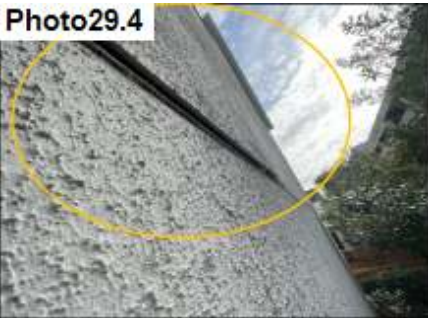
Photo29.4

Cementitious Fiber Panel / Re-Fasten
