Property Inspection Report #5/16/2022 2832 Lockett Street
8616 Daffodil St. Houston, TX 77063

PROPERTY INSPECTION REPORT FORM

<u>Juan Echeverry</u>	<u>5/16/2022</u>
<i>Name of Client</i>	<i>Date of Inspection</i>
<u>2832 Lockett Street , Houston, TX 77021</u>	
<i>Address of Inspected Property</i>	
<u>Josh Burk</u>	<u>22850</u>
<i>Name of Inspector</i>	<i>TREC License #</i>
<u> </u>	<u> </u>
<i>Name of Sponsor (if applicable)</i>	<i>TREC License #</i>

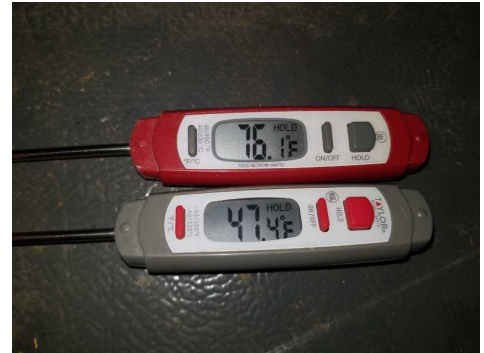
Too cold, needs service

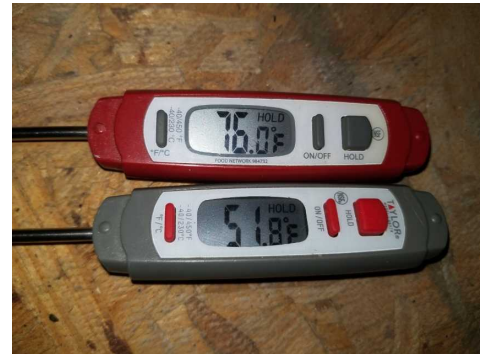
Too cold needs service

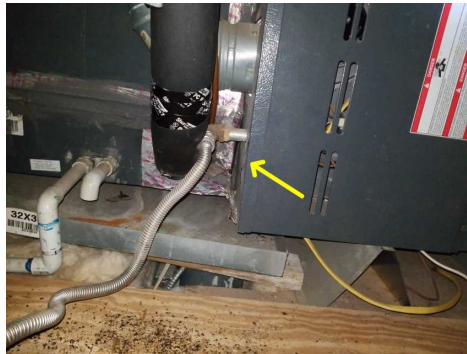
Excessive air loss around transition/coil/heater/plenum; East unit.

Excessive air loss between furnace and coils; East unit

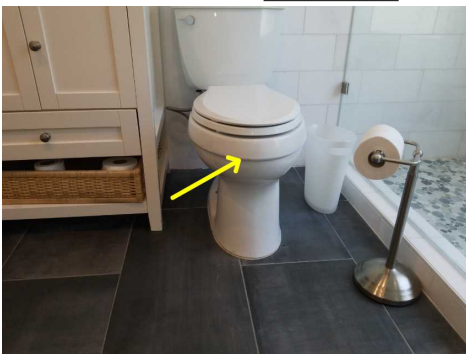
Porcelain chipped at guest bath

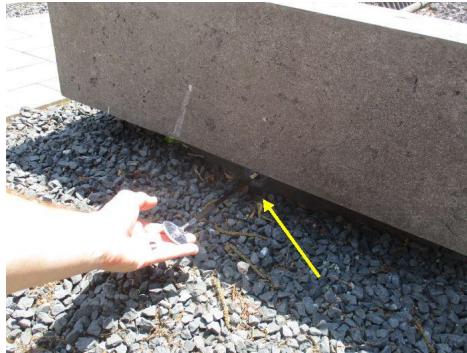
The outdoor firepit was not operational, not performing its intended function. Inspector turned both valves on (at gas meter, and below unit). Valves and or unit in need of repair/replacement.

Operated both valves
