## PROPERTY INSPECTION REPORT

Prepared For: Crystal Hawkins  
(Name of Client)

Concerning: 315 South Silvershire Circle , Spring, TX 77381  
(Address or Other Identification of Inspected Property)

By: Tim Carpenter Lic.#: 23947 07/02/2021  
(Name and License Number of Inspector) (Date)

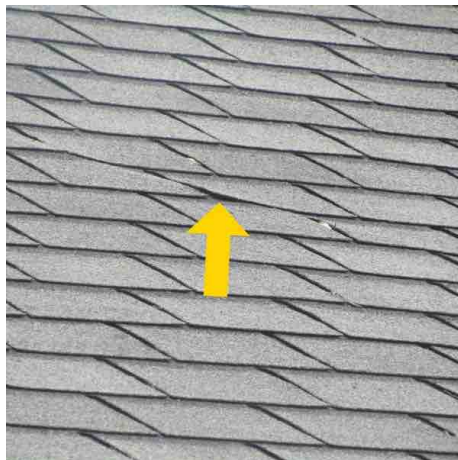
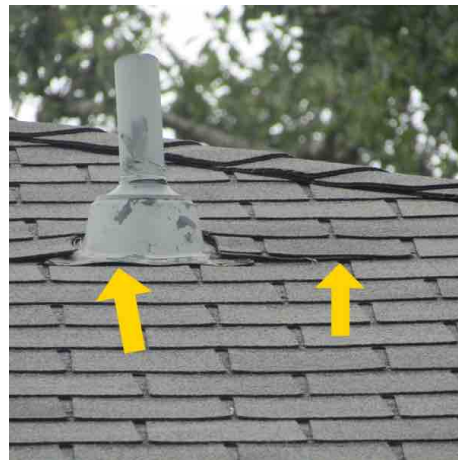
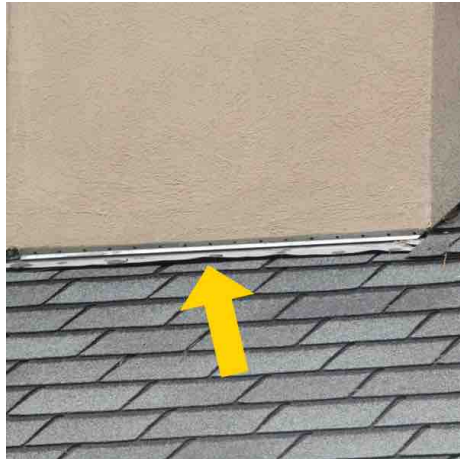
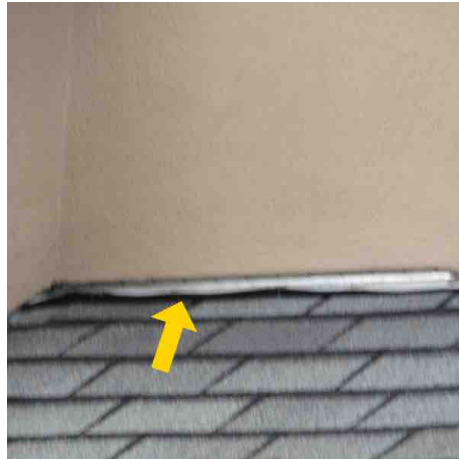
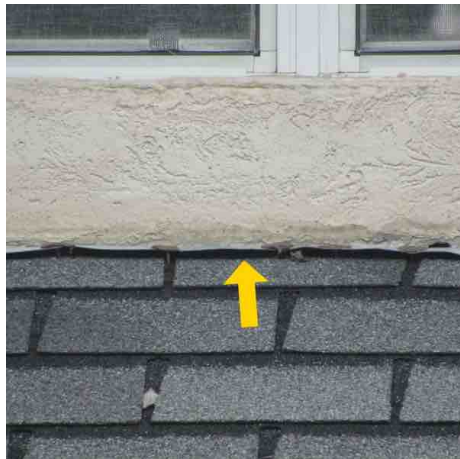
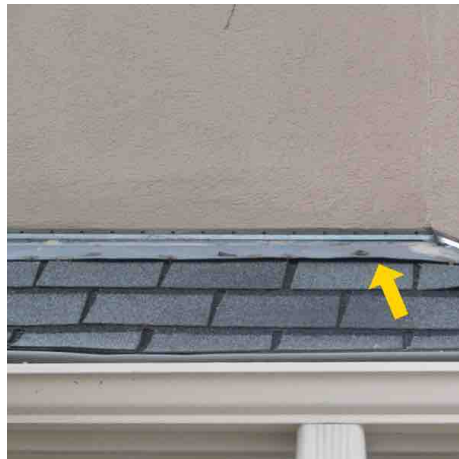
- **Raised shingles and flashing noted in several areas. Shingles need to lay flat to seal properly. Hot weather will not correct this issue. Raised or unsealed flashing can allow water to penetrate. Shingles installed in this condition may void manufacturers warranty.**

**Recommend having a qualified roofing contractor evaluate and rectify all affected areas as necessary to restore intended operation and function of roof covering.**

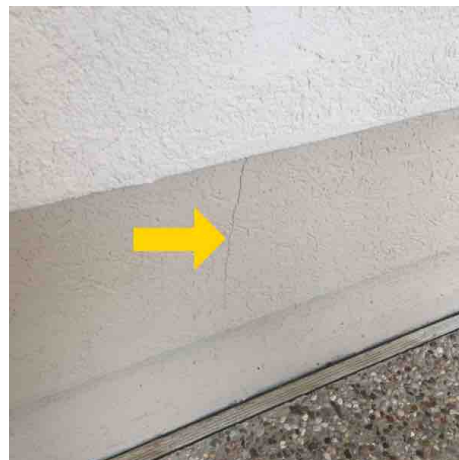
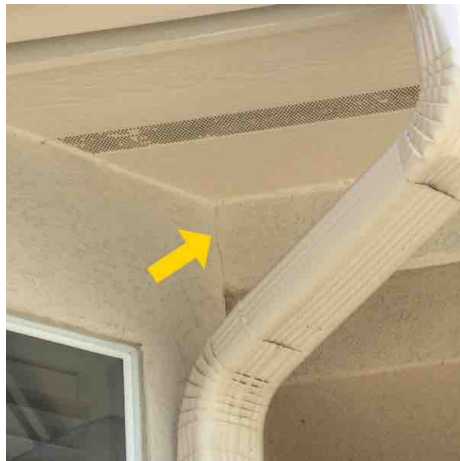
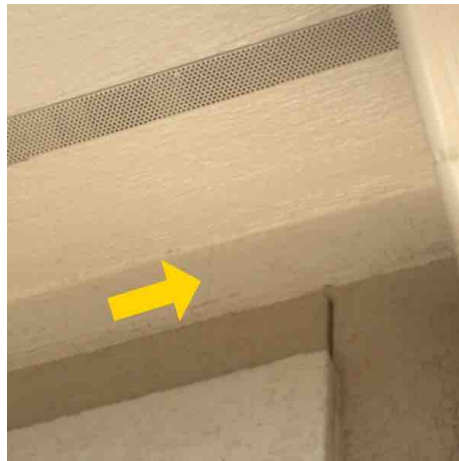
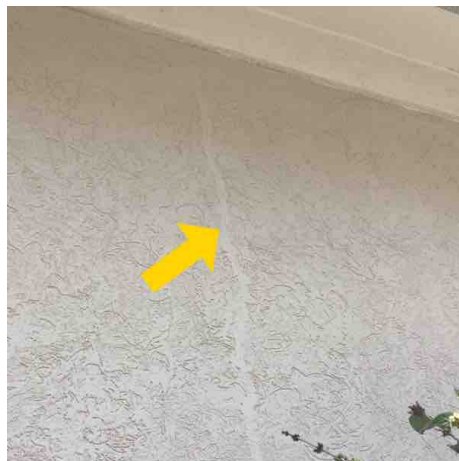
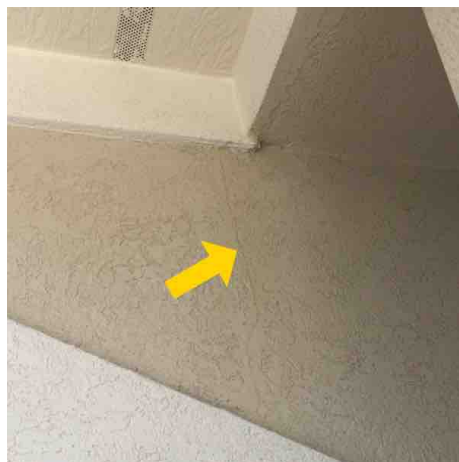
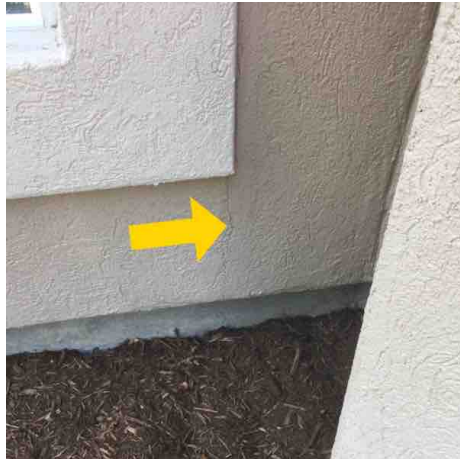
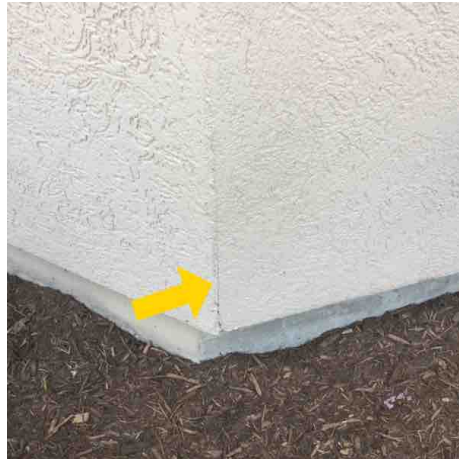
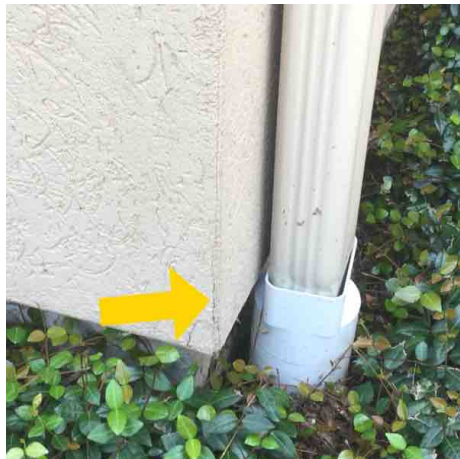
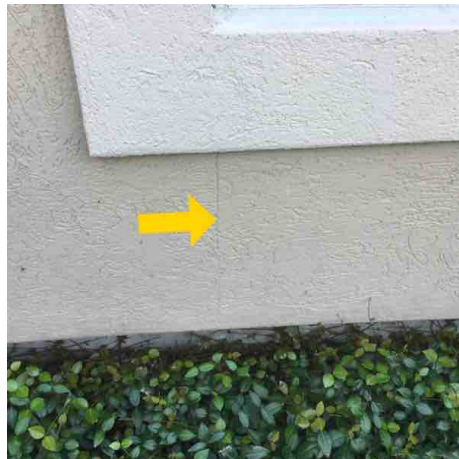
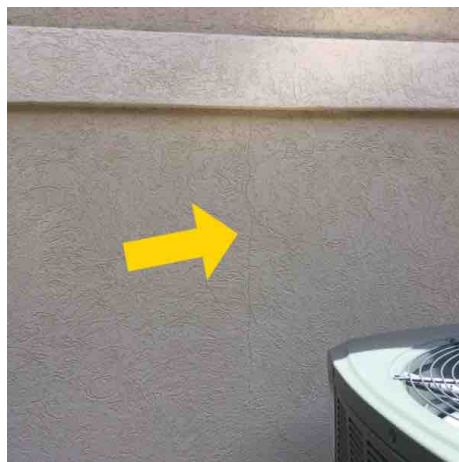
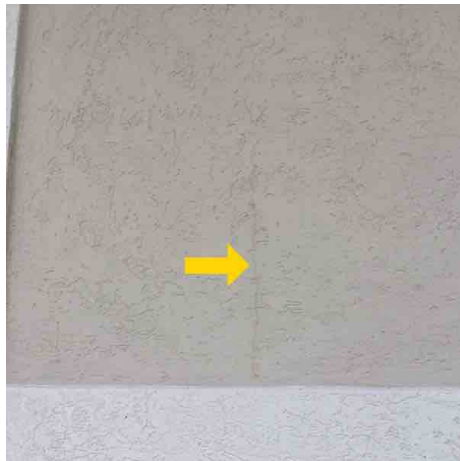
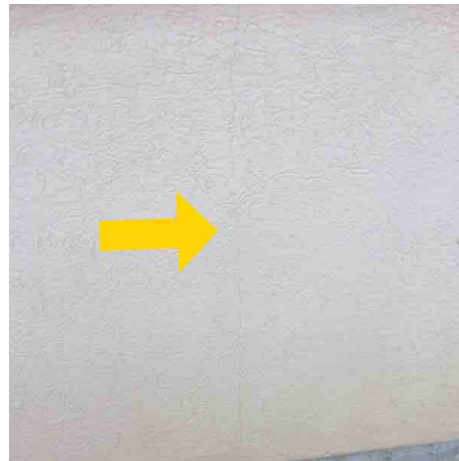
- **Several cracks noted in stucco type finish on exterior walls, these conditions could be conducive to unwanted moisture and insect intrusions. Recommend licensed stucco contractor evaluate and repair.**

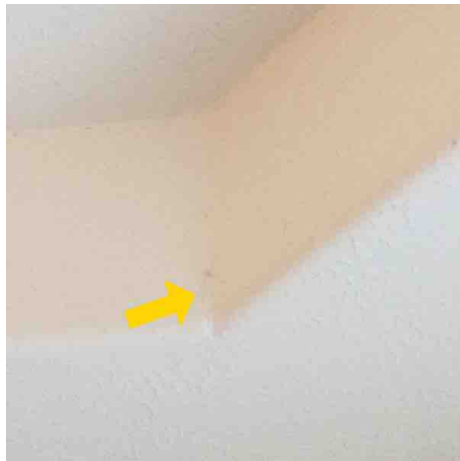
• Typical minor settlement cracks noted, this is typical of structures this age and should be considered cosmetic in nature.

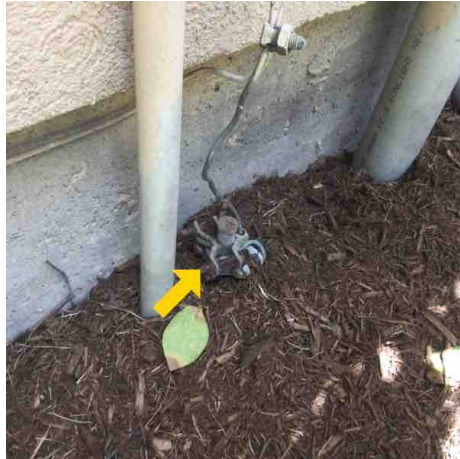
- **Improper use of a pipe clamp was observed securing ground wire to ground rod (see photo). Recommend replacement of pipe clamp with a proper "Acorn" type clamp.**

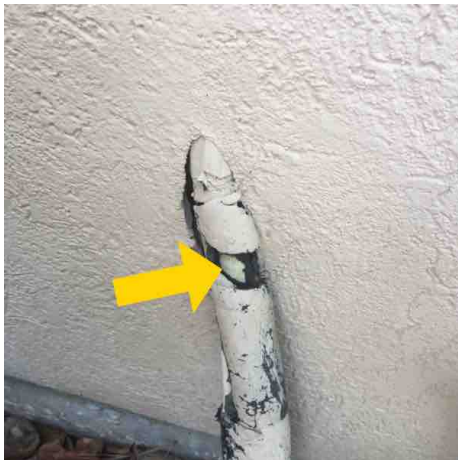
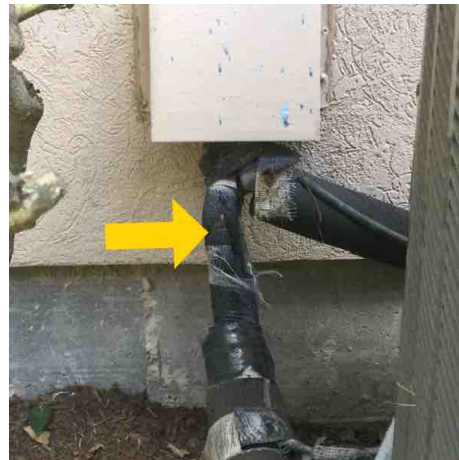
• Refrigerant lines have damaged insulation which should be repaired. Unit #1 and unit #2.

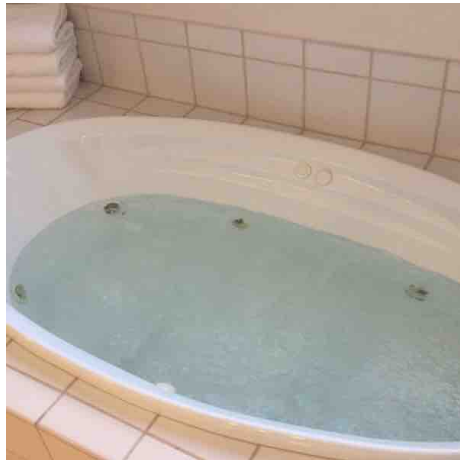
Dedicated GFCI functioned properly.

Limitation: Access panel is sealed/caulked and could not be opened without damage to surrounding surfaces, unable to observe mechanical or plumbing fixtures/connections.

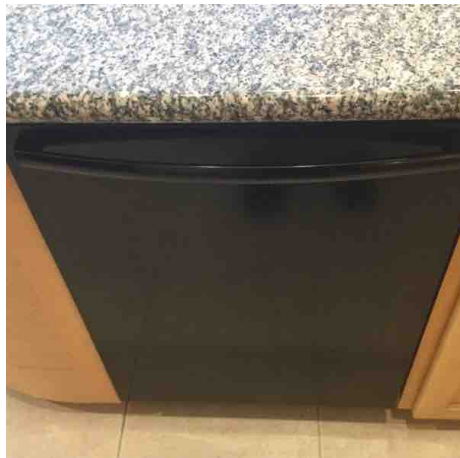
- "Dishwasher was operated in normal mode, run through a complete, normal cycle. Function and operation appear to be normal. Lower access panel not removed. At the time of the inspection the dishwasher did not leak. Care should be taken the first time the dishwasher is run after a period of inactivity because seals tend to dry out and can leak at first. If this happens dry the area inside the unit where the leak is occurring and then re-start the dishwasher. Also be sure to follow the manufactures recommendation for type of soap and amount as this can be the cause of leaking. If it continues to leak repair is required."

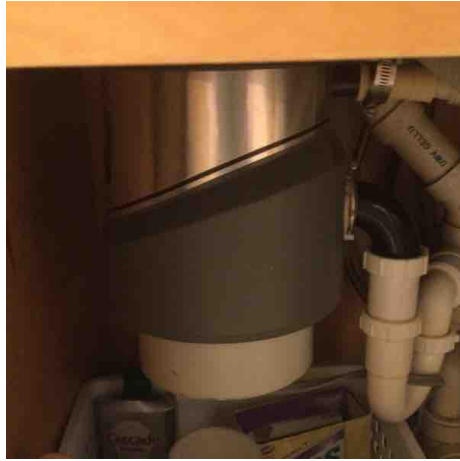
- Functioned properly.

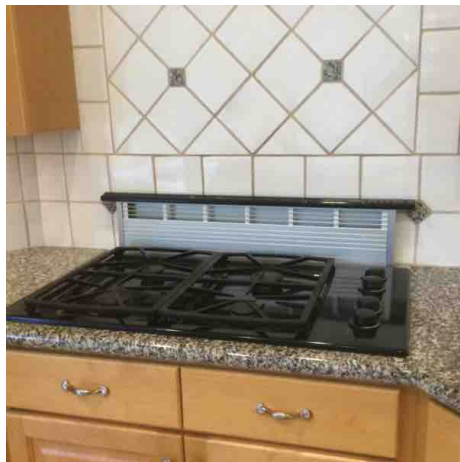
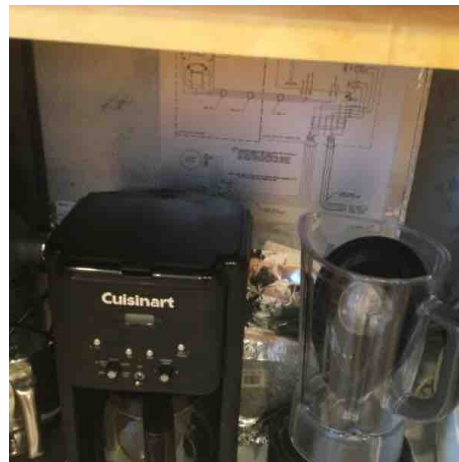
- Functioned properly.

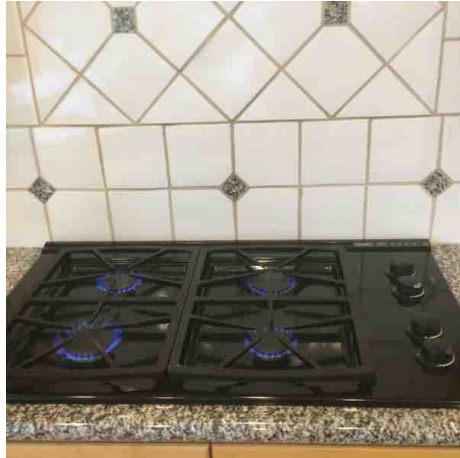
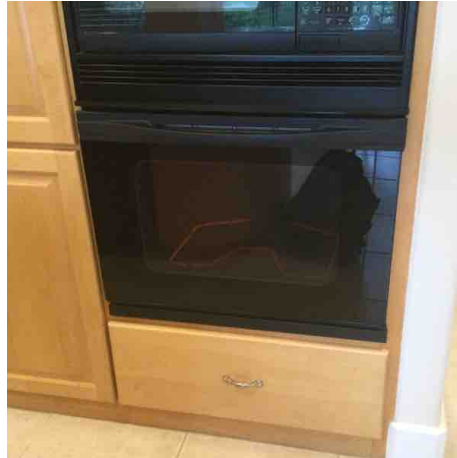
- All burners on gas cooktop functioning properly.

Oven Temperature was 345 degrees when set at 350 within the 25 degree tolerance.

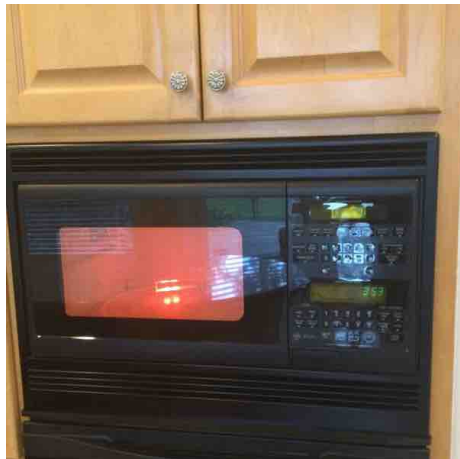
- Microwave built-in unit functioning as intended at time of inspection.

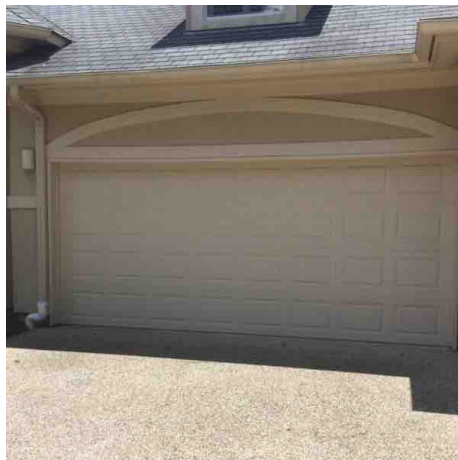
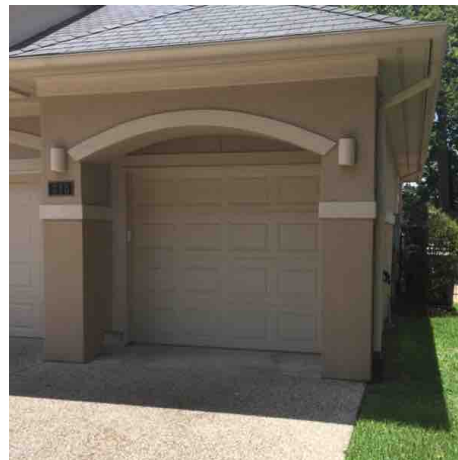
- The garage door opener was tested and the door opens and closes normally. The reversing function tested satisfactorily. Both Doors.

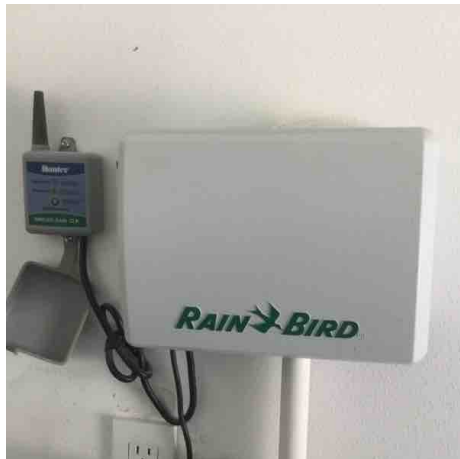
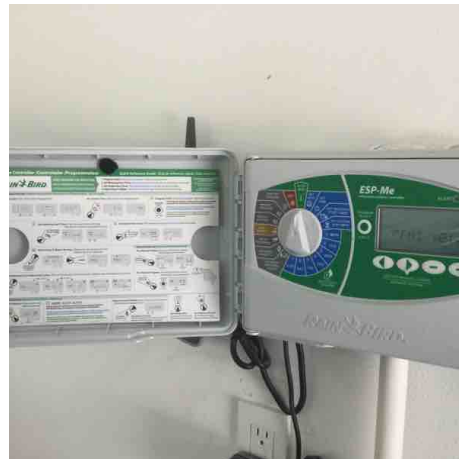
- Rain Bird control is located in the garage.

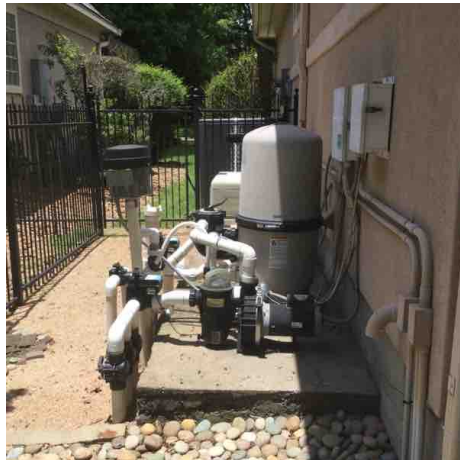
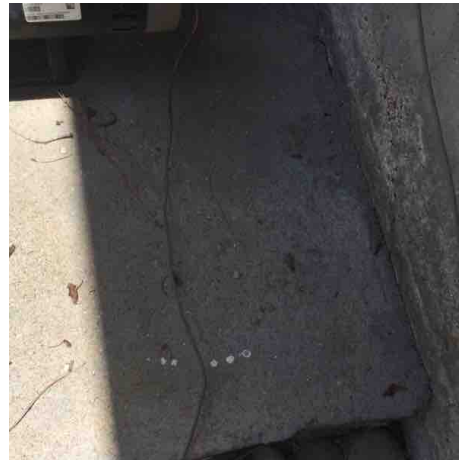
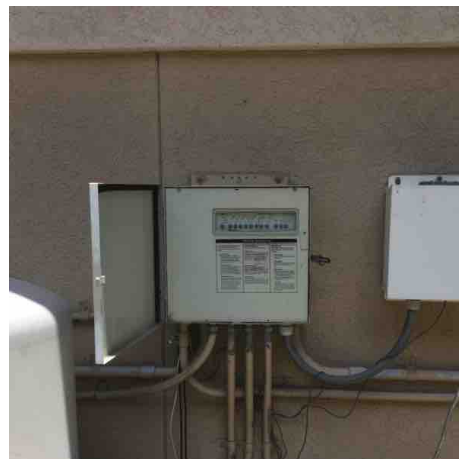
Pool equipment appears to be bonded properly.

Pool equipment was tested in service mode at the panel.

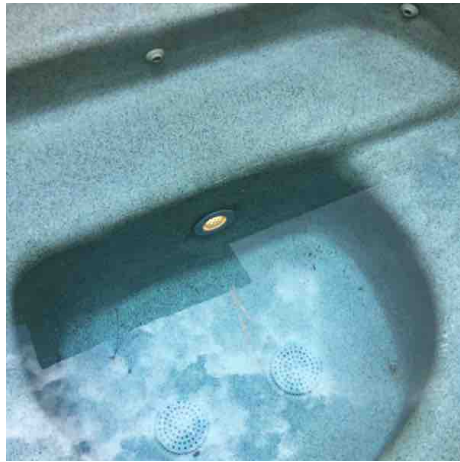
- Pool/Spa light functioned properly.

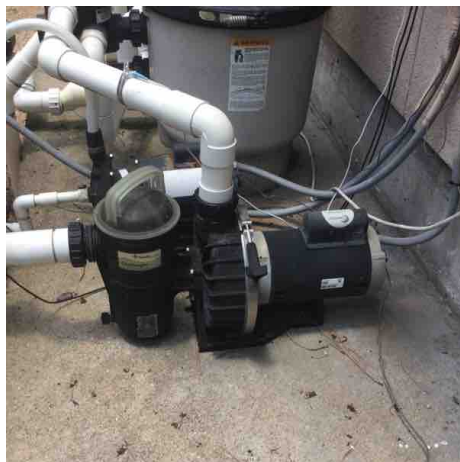
- Filter pump functioned properly.

Cartridge filter with in-line chlorinator is operating at 22 psi.

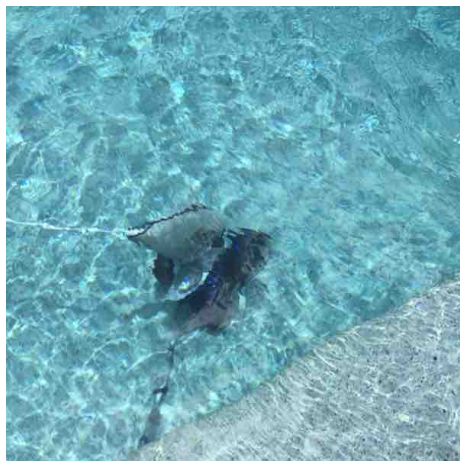
• Pool vacuum cleaner functioned properly.
