Lone Star Stucco, LLC

Moisture Assessment Report

4102 Roseland Street

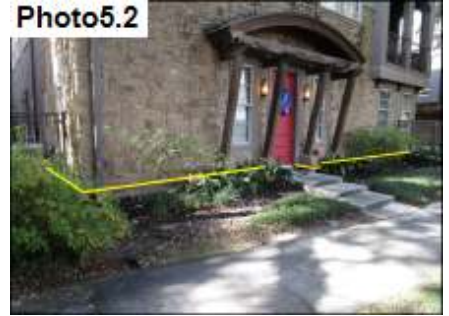
Photo5.2

- Manufactured stone veneer (MSV) appears to be typically detailed at grade for the time of this construction. The inspector suggests that this is a positive detail and recommends no modification at this time but to always keep soil away from the structure. Please refer to photos #5.2, #5.3, #5.4, #5.5 and #5.6 for more detail.

Proper Grade Termination with Weep Screed / Positive Detail

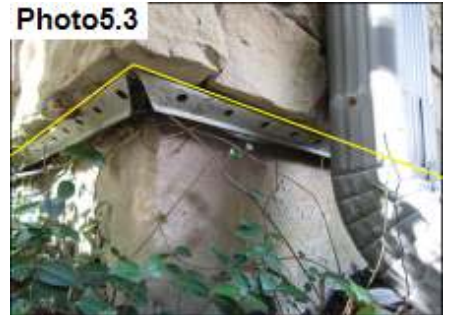
Photo5.3

Proper Grade Termination with Weep Screed / Positive Detail

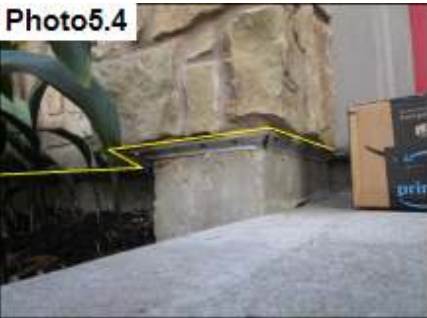
Photo5.4

Proper Grade Termination with Weep Screed / Positive Detail

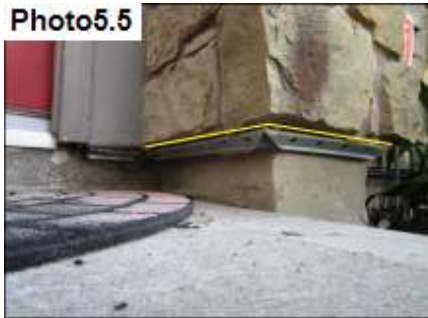
Photo5.5

Proper Grade Termination with Weep Screed / Positive Detail

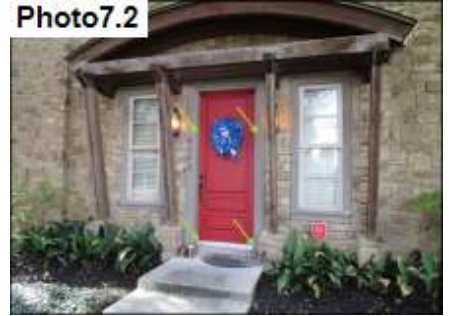
Photo7.2

- The door trim and miter sealants are aged or separated at these locations. The inspector suggests to have a qualified waterproofing contractor seal these areas with a low modulus sealant in an effort to prevent moisture intrusion. These types of sealants are of high quality and compatible with stucco and other termination points. Please refer to photos #7.2, #7.3, #7.4, #7.5 and #7.6 for more detail.

Door Sealants / Seal

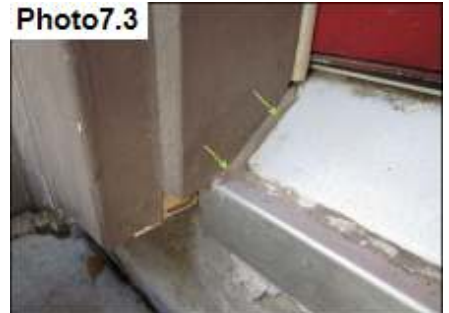
Photo7.3

Door Sealants / Seal

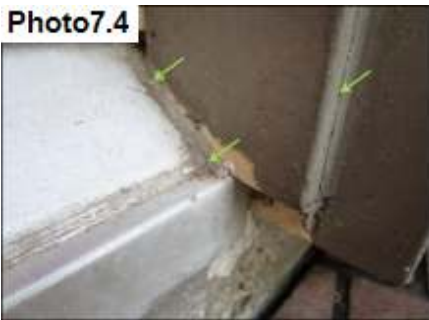
Photo7.4

Door Sealants / Seal

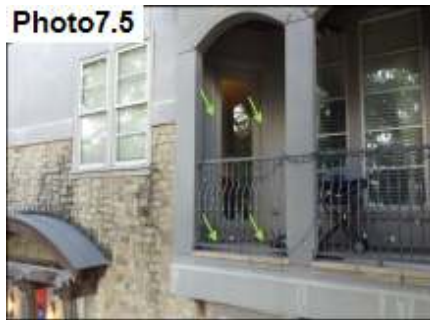
Photo7.5

Door Sealants / Seal

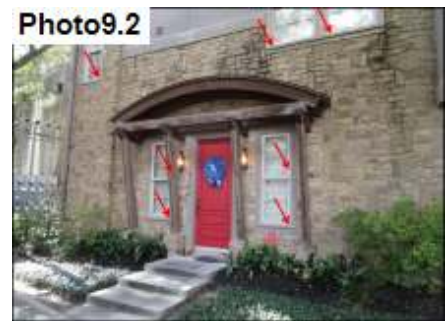
Window Sealants / Seal

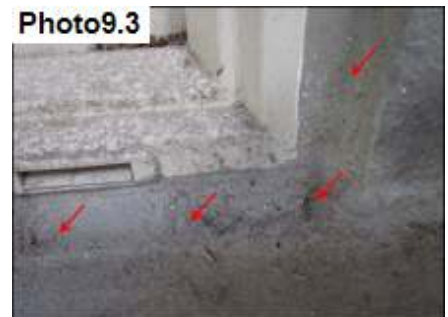
Window Sealants / Seal

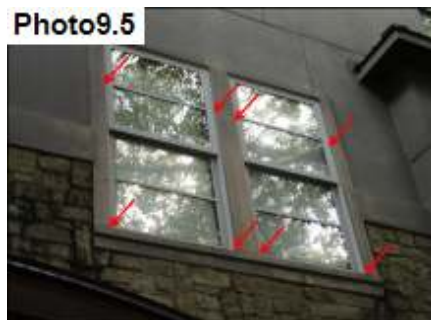
Window Sealants / Seal

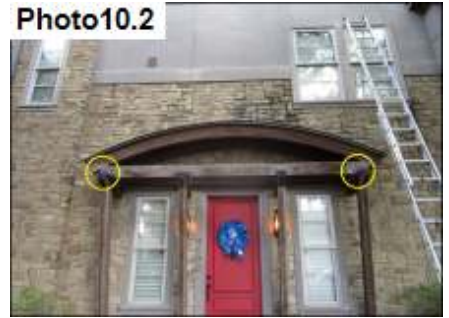
Kickout Flashing / Seal

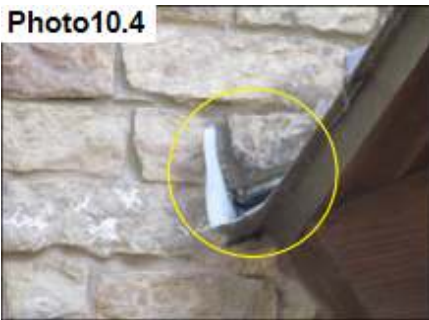
Kickout Flashing / Seal

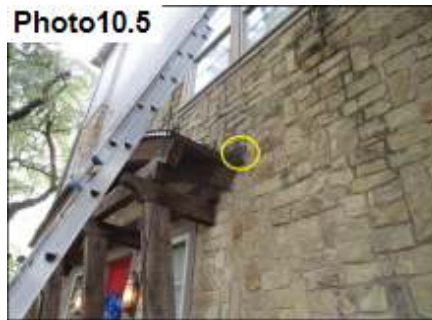
Kickout Flashing / Seal

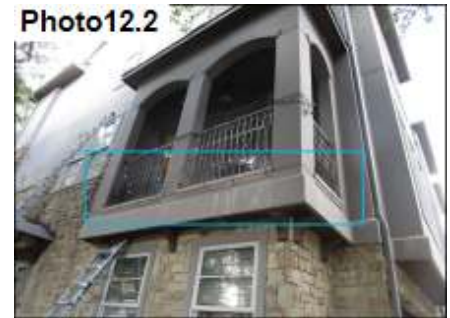
Balcony Flashing / Seal

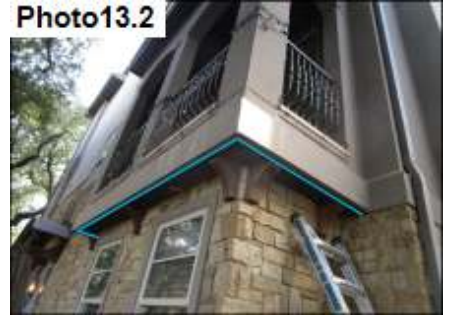
Photo13.2

- Although the bottom of the balcony wall noted does not have a proper relief, this was a proper detail at the time of construction. Upon invasive testing at this location, the substrate was firm with low moisture readings. The inspector recommends no modification at this point in time but recommends to maintain all sealants above this location to prevent potential moisture intrusion. Please refer to photos #13.2, #13.3, #13.4 and #13.5 for more detail.

No Relief / No Modification

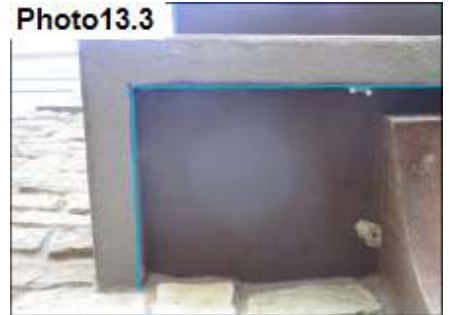
Photo13.3

No Relief / No Modification

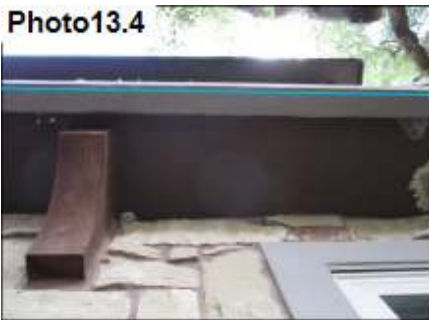
Photo13.4

No Relief / No Modification

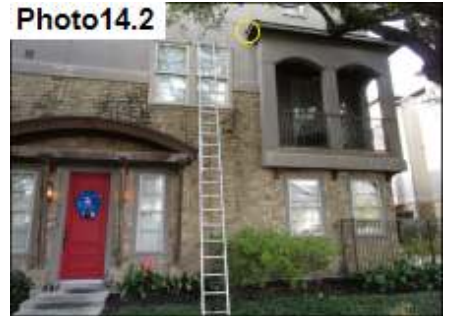
Kickout Flashing / Seal

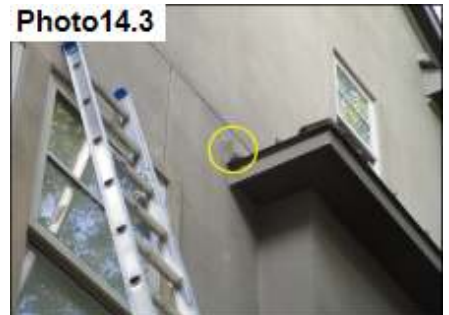
Kickout Flashing / Seal

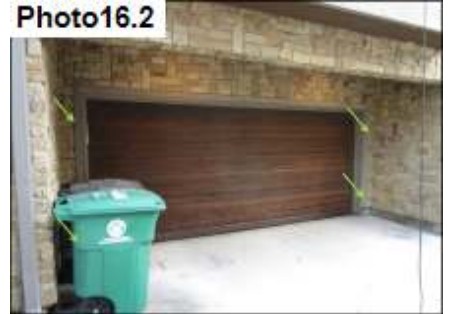
Photo16.2

Door Sealants / Seal

Grid Location	Item Description	Moisture Readings	Substrate Condition	Observations
Green Arrows	Doors			The door trim and miter sealants are aged or separated at this location. The inspector suggests to have a qualified waterproofing contractor seal this area with a low modulus sealant in an effort to prevent moisture intrusion. These types of sealants are of high quality and compatible with stucco and other termination points. Please refer to photos #16.2, #16.3 and #16.4 for more detail.

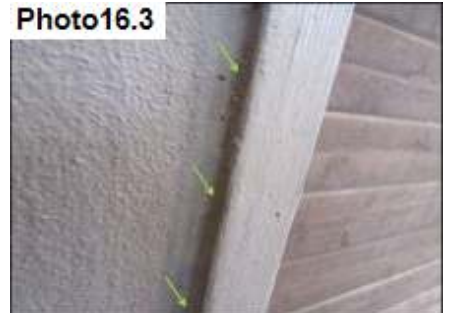
Photo16.3

Door Sealants / Seal

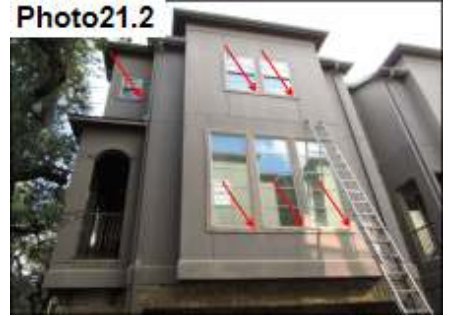
Photo21.2

Window Sealants / Seal

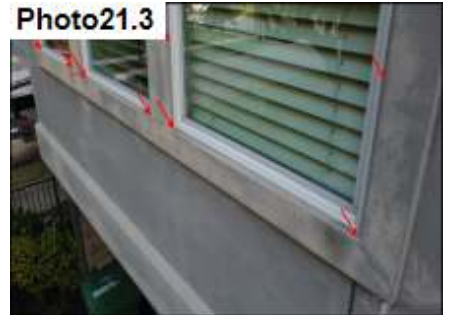
Photo21.3

Window Sealants / Seal

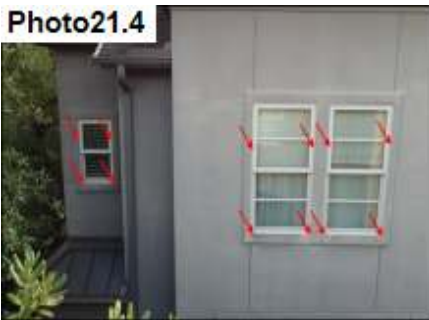
Photo21.4

Window Sealants / Seal

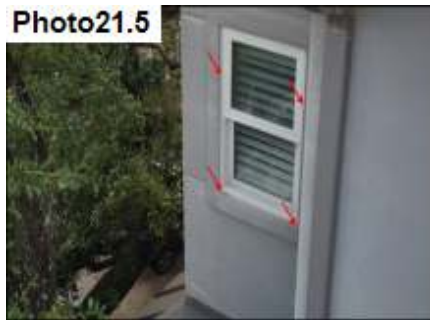
Photo21.5

Window Sealants / Seal

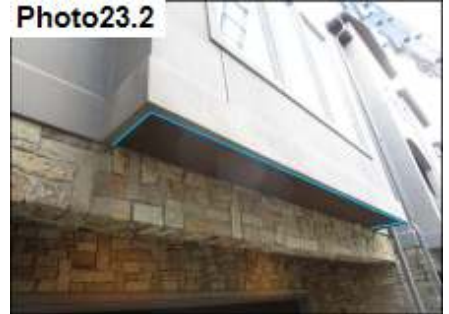
Photo23.2

Relief / Assess and Clean Out

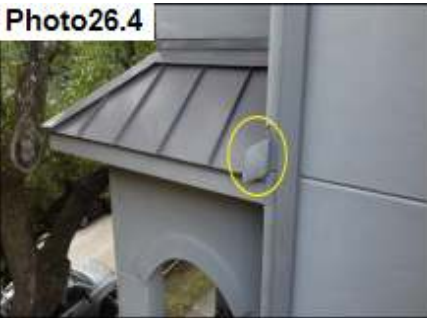
Photo26.4

Kickout Flashing / Seal

Grid Location	Item Description	Moisture Readings	Substrate Condition	Observations
Yellow Circles	Kickout			The kickout flashing sealants are aged or separated at these locations. The inspector suggests to have a qualified waterproofing contractor further assess and seal these areas with a low modulus sealant in an effort to prevent moisture intrusion. These types of sealants are of high quality and compatible with stucco and other termination points. Please refer to photos #26.2, #26.3 #26.4, #26.5 and #26.6 for more detail.

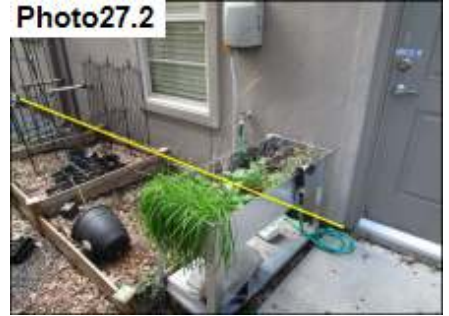
Photo27.2

Proper Grade Termination with Weep Screed / Positive Detail

Grid Location	Item Description	Moisture Readings	Substrate Condition	Observations
Yellow Line	Grade Termination			Stucco appears to be typically detailed at grade for the time of this construction. The inspector suggests that this is a positive detail and recommends no modification at this time but to always keep soil away from the structure. Please refer to photos #27.2, #27.3, #27.4, #27.5 and #27.6 for more detail.

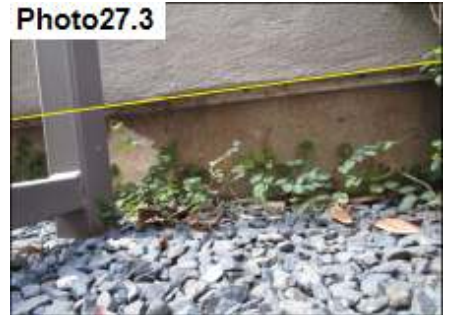
Photo27.3

Proper Grade Termination with Weep Screed / Positive Detail

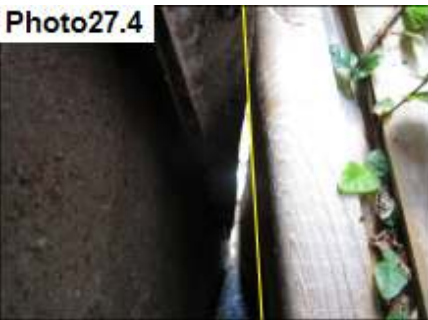
Photo27.4

Proper Grade Termination with Weep Screed / Positive Detail

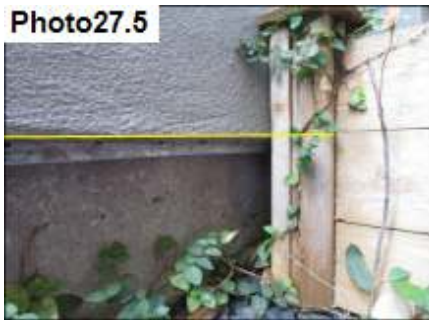
Photo27.5

Proper Grade Termination with Weep Screed / Positive Detail

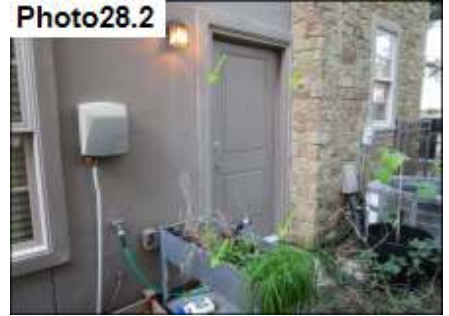
Photo28.2

- The door trim and miter sealants are aged or separated at this location. The inspector suggests to have a qualified waterproofing contractor seal this area with a low modulus sealant in an effort to prevent moisture intrusion. These types of sealants are of high quality and compatible with stucco and other termination points. Please refer to photos #28.2, #28.3 and #28.4 for more detail.

Door Sealants / Seal

Grid Location	Item Description	Moisture Readings	Substrate Condition	Observations
Green Arrow	Doors			The door trim and miter sealants are aged or separated at this location. The inspector suggests to have a qualified waterproofing contractor seal this area with a low modulus sealant in an effort to prevent moisture intrusion. These types of sealants are of high quality and compatible with stucco and other termination points. Please refer to photos #28.2, #28.3 and #28.4 for more detail.

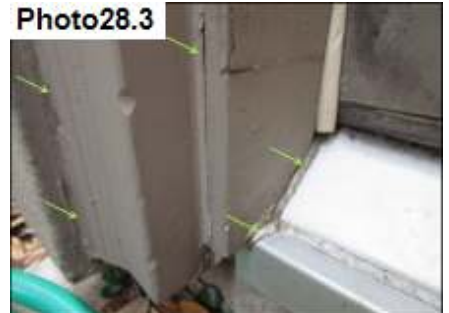
Photo28.3

Door Sealants / Seal

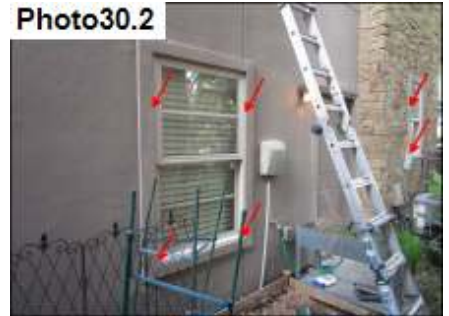
Window Sealants / Seal

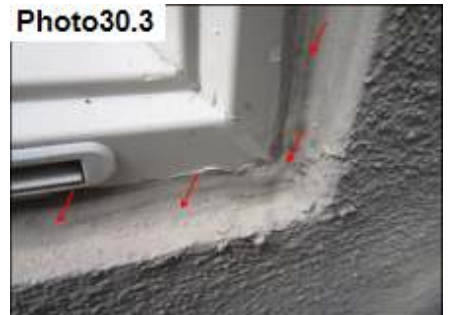
Window Sealants / Seal

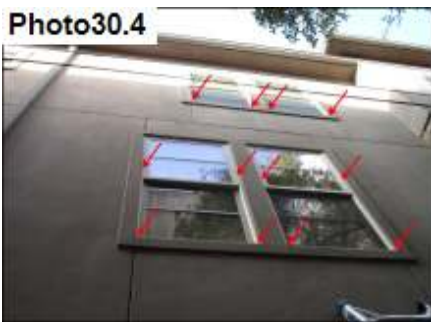
Window Sealants / Seal

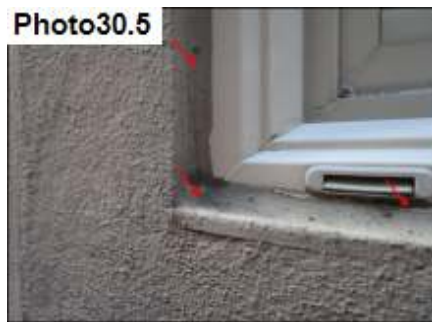
Window Sealants / Seal

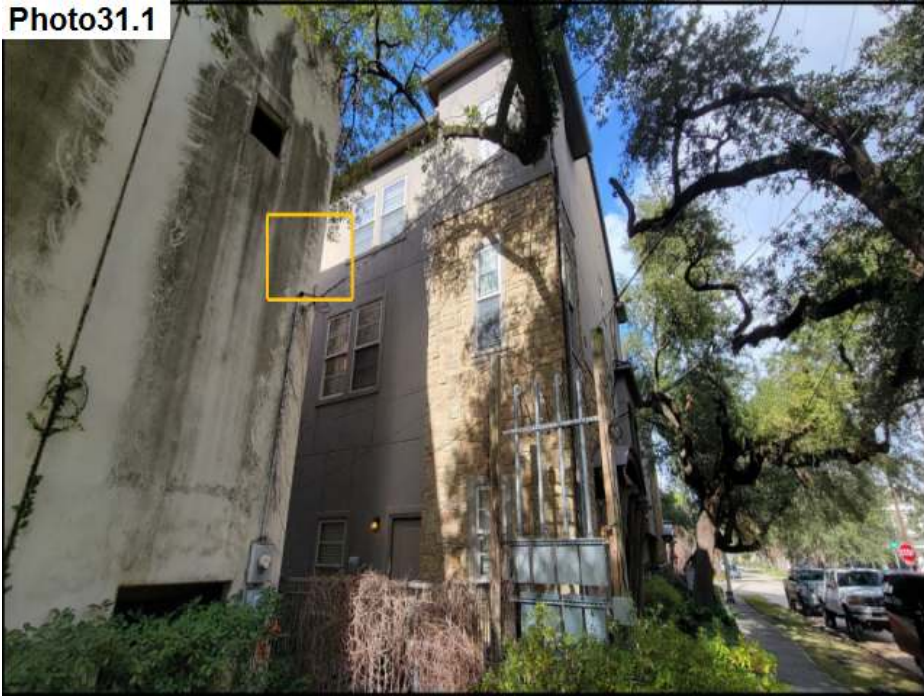
Photo31.1

Grid Location	Item Description	Moisture Readings	Substrate Condition	Observations
Orange Box	Cracks			Cracks are noted at this location. The inspector suggests to have a qualified waterproofing contractor further assess and properly seal, paint or repair these cracks to prevent moisture intrusion. All cracking was not necessarily identified in this report. Please refer to photos #31.2, #31.3, #31.4 and #31.5 for more detail.

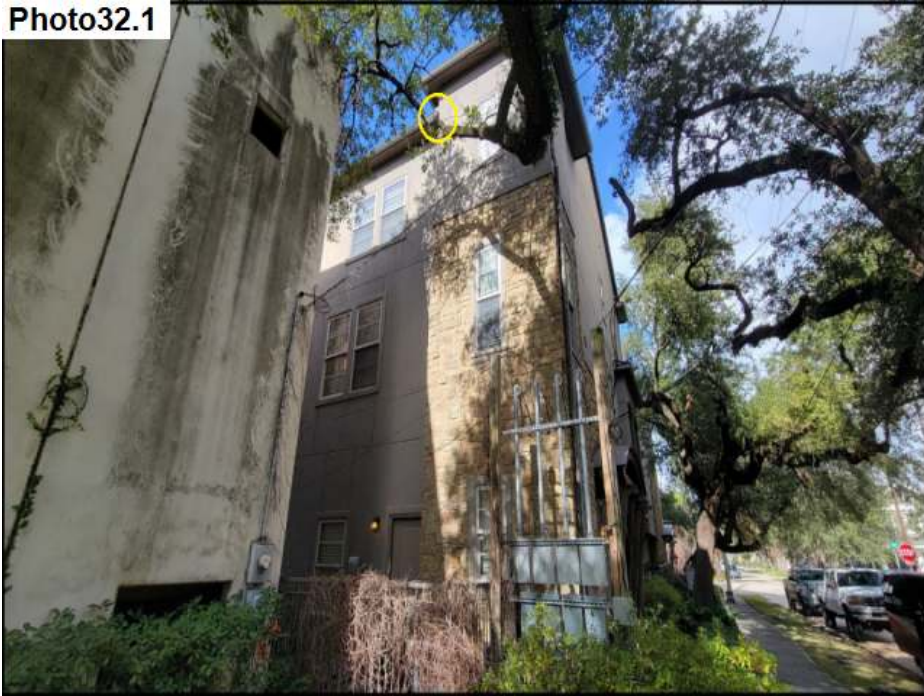
Photo32.1

Grid Location	Item Description	Moisture Readings	Substrate Condition	Observations
Yellow Circle	Kickout			The kickout flashing sealants are aged or separated at this location. The inspector suggests to have a qualified waterproofing contractor further assess and seal this area with a low modulus sealant in an effort to prevent moisture intrusion. These types of sealants are of high quality and compatible with stucco and other termination points. Please refer to photos #32.2, #32.3, #32.4 and #32.5 for more detail.

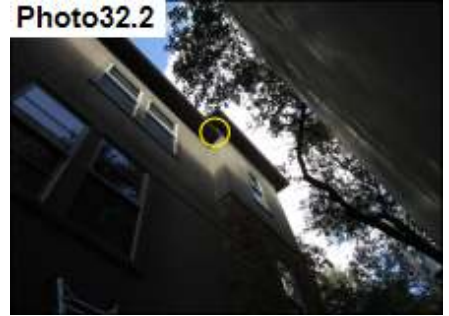
Photo32.2

- The kickout flashing sealants are aged or separated at this location. The inspector suggests to have a qualified waterproofing contractor further assess and seal this area with a low modulus sealant in an effort to prevent moisture intrusion. These types of sealants are of high quality and compatible with stucco and other termination points. Please refer to photos #32.2, #32.3, #32.4 and #32.5 for more detail.

Kickout Flashing / Seal
