Prepared for Emerson Property Management

5/30/2024

8202 Furray Road A

Items that Need Attention Summary

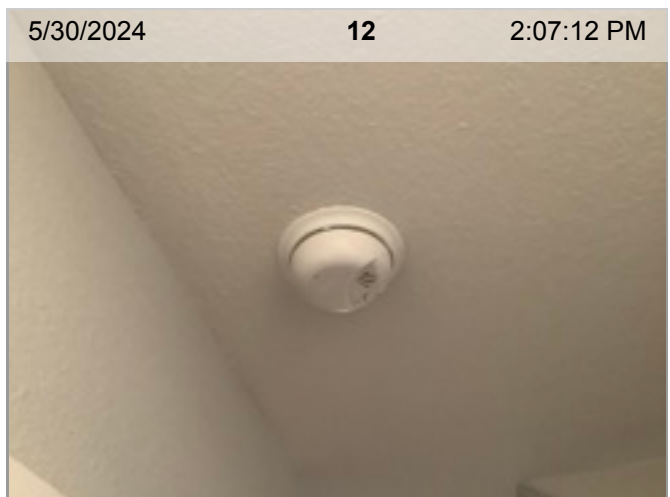
Wired Smoke Alarm (mfd 9/2022) | Smoke test: Passed | Alarm in place

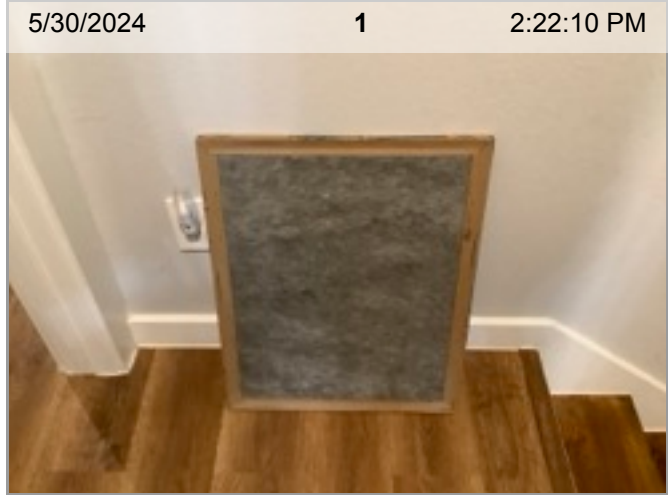
20 x 25 x 1 Air Filter Removed | Front

20 x 25 x 1 Air Filter Removed | Back

20 x 25 x 1 Air Filter Removed | Close-up of size/initials/date

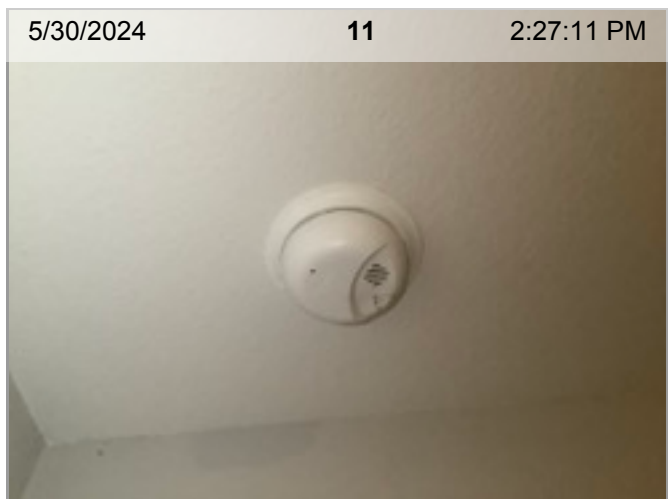
Wired Smoke Alarm (mfd 9/2022) | Smoke test: Passed | Alarm in place
