Prepared for Emerson Property Management

6/22/2024

8202 Furray Road #B

Houston TX 77028

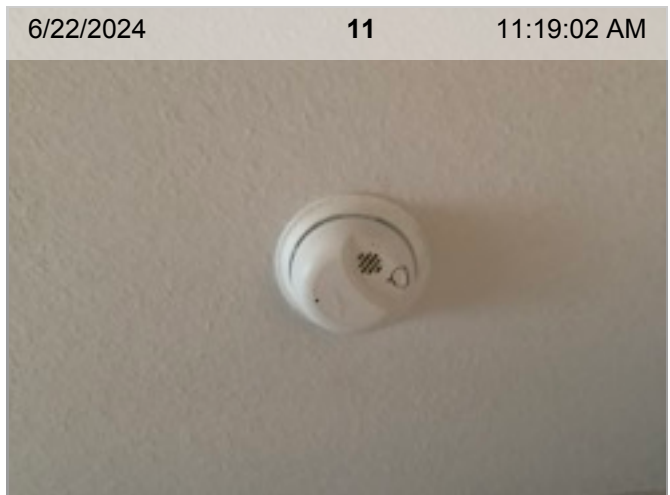
Wired Smoke Alarm (mfd 9/2022) | Smoke test: Passed | Alarm in place

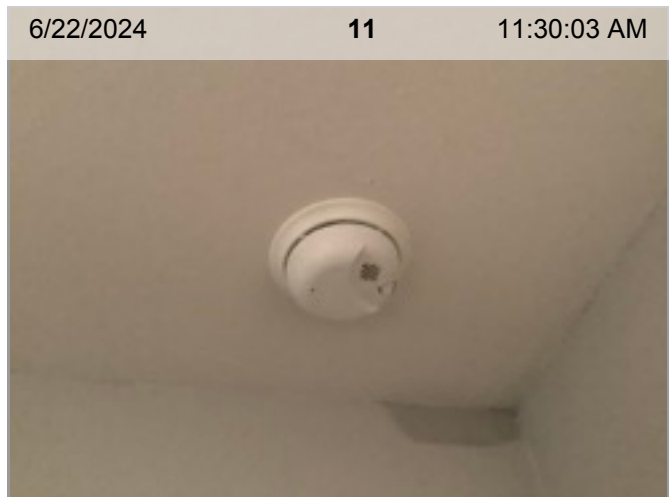
Wired Smoke Alarm (mfd 9/2022) | Smoke test: Passed | Alarm in place

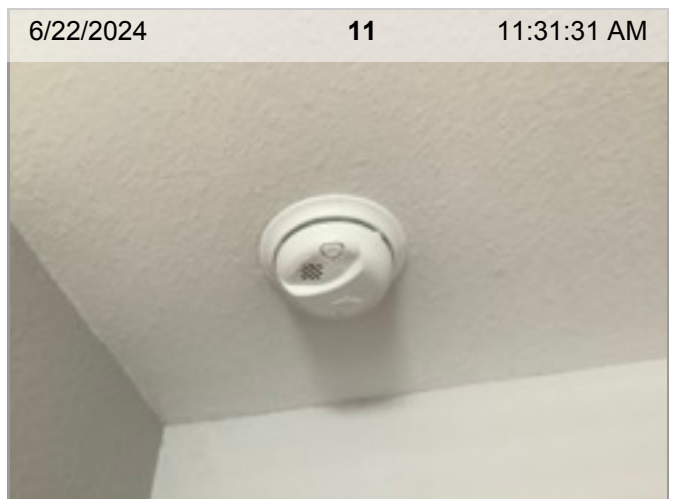
Wired Smoke Alarm (mfd 9/2022) | Smoke test: Passed | Alarm in place
