4202 Dalmatian Drive Houston, Texas 77045

Major systems plus

Rio Bravo - Inspectify Pro - Houston

April 26, 2024, 3:30 PM

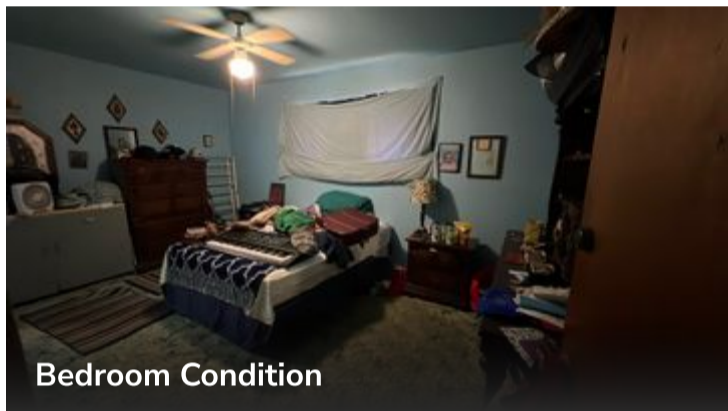
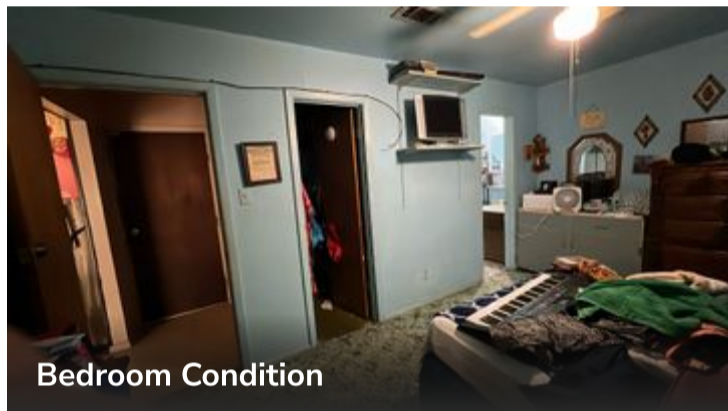
Primary Bedroom photos / videos

Bedroom Condition

Good

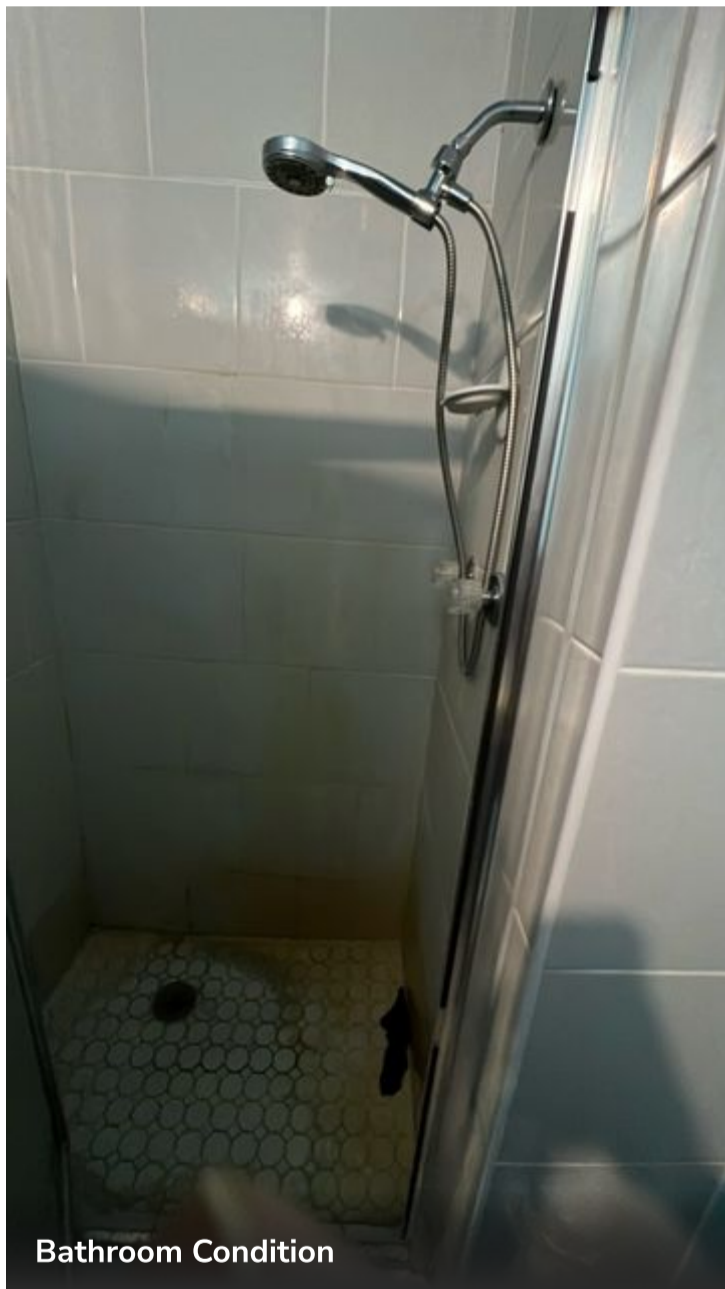
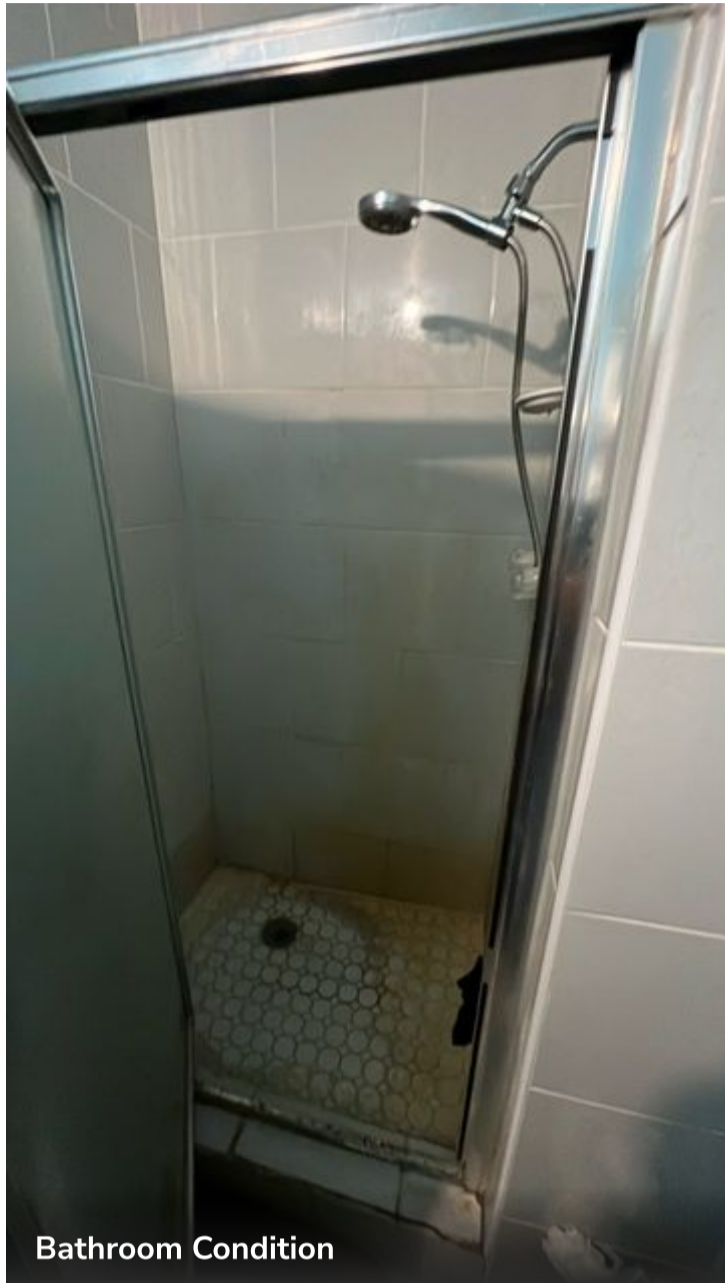
Primary Bathroom photos / videos

Bathroom Condition

Poor

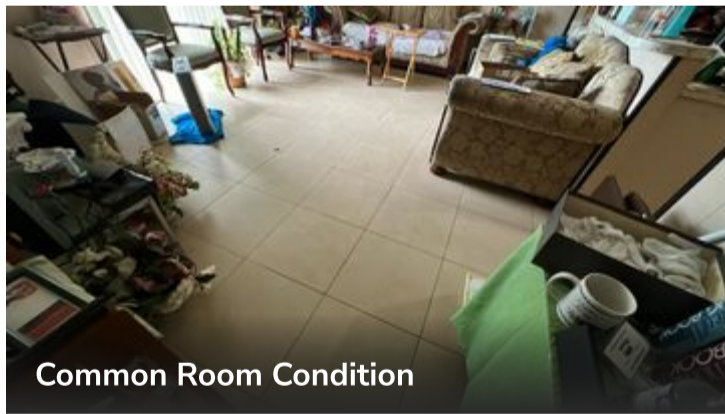
Common Room photos / videos

Common Room Condition

Good

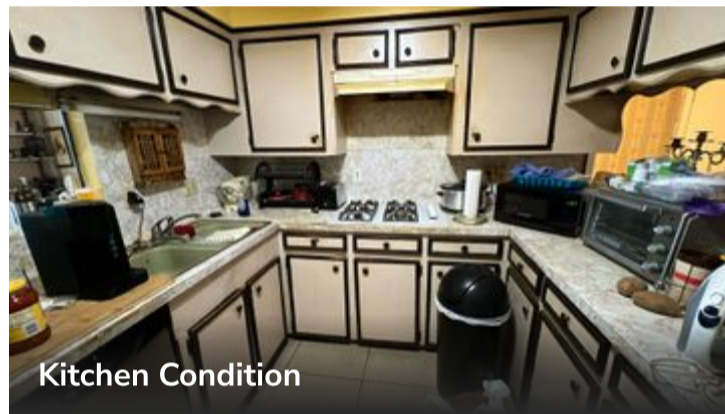
Kitchen photos / videos

Kitchen Condition

Fair

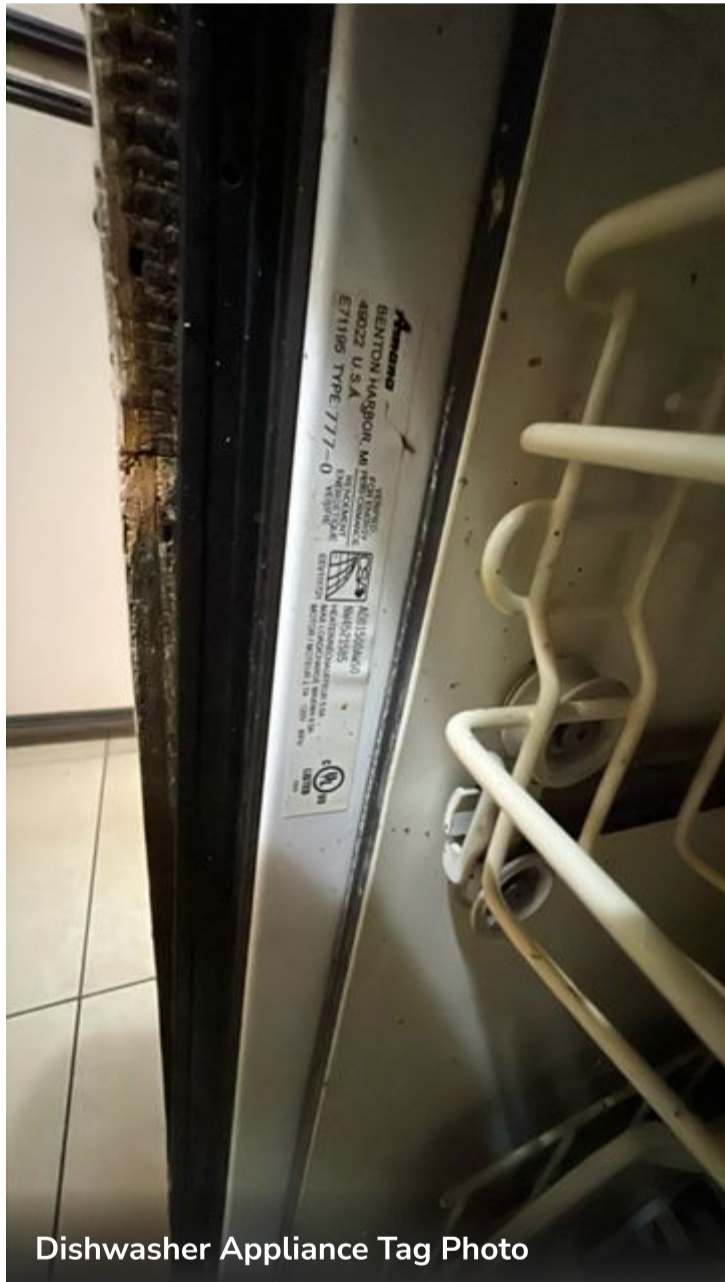
Dishwasher Appliance Tag Photo

The dishwasher is not working / there is no power to the dishwasher. Recommend repairs or replacing by a qualified professional.
