Prepared for Emerson Property Management

5/24/2024

7813 Glass Street #7813

Houston TX 77016

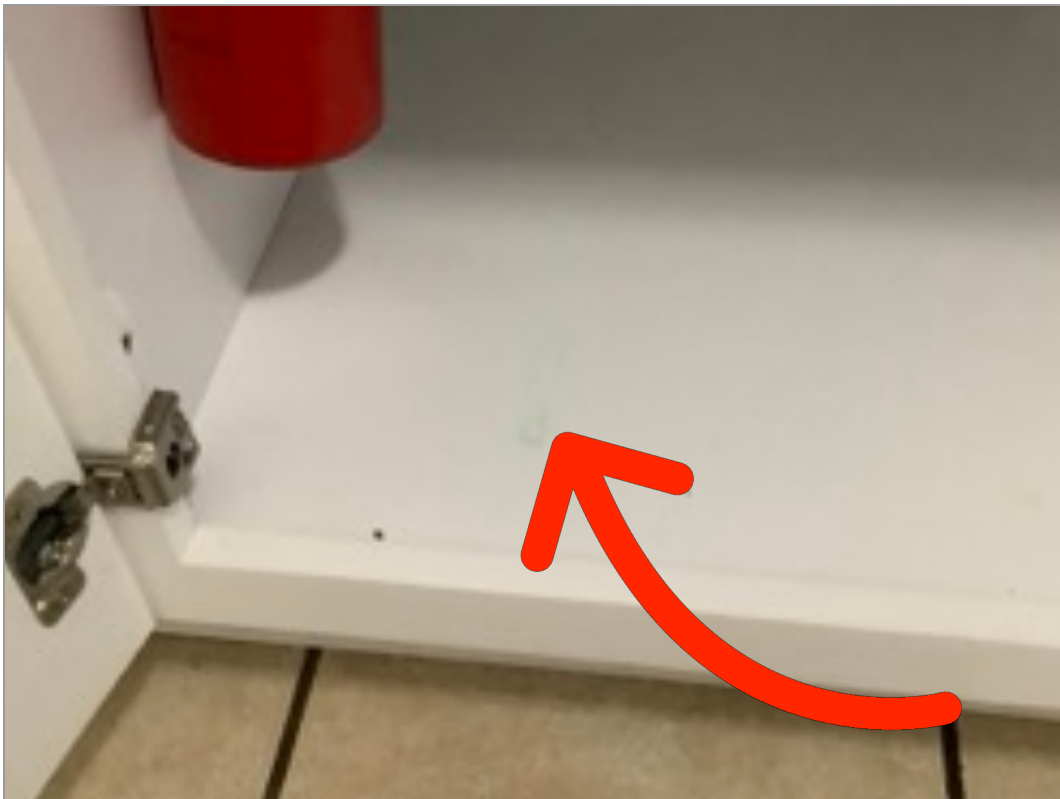
Kitchen
Floors
Crack in flooring.

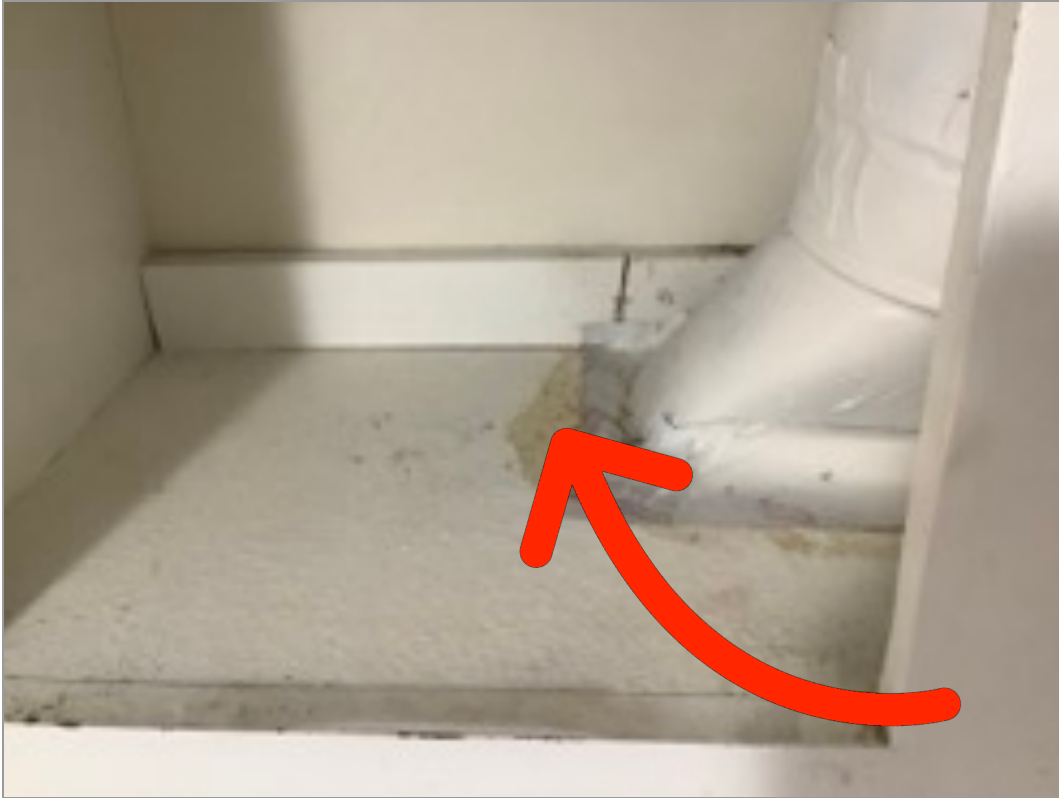
Kitchen
Upper Cabinets - Interior
Base of the cabinet is discolored

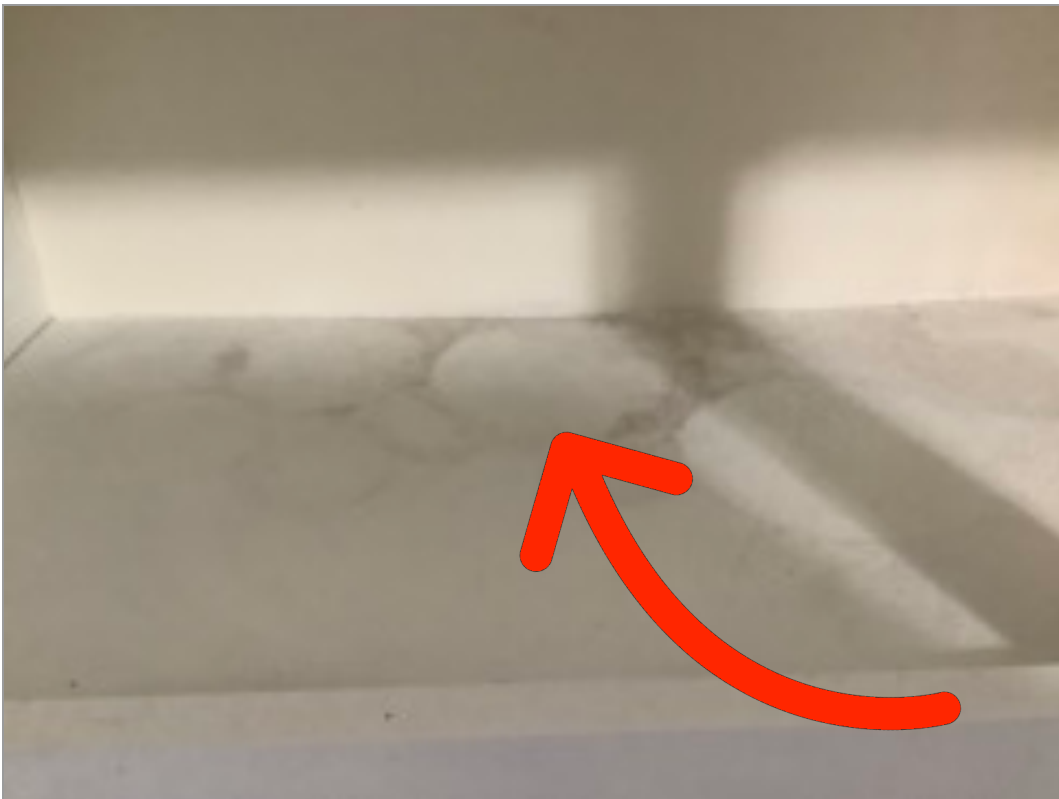
Kitchen
Upper Cabinets - Interior
Base of the cabinet is discolored

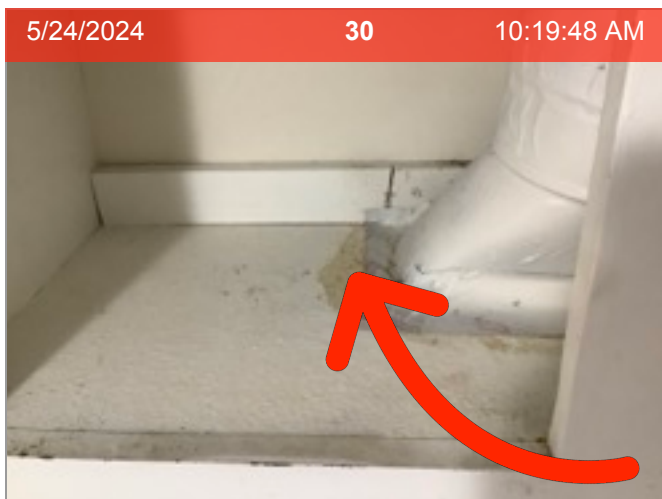
Upper Cabinets - Interior | Base of the cabinet is discolored
