Property Inspection Report

Texas Premium Inspections

6611 Etchstone Dr
Inspection Prepared For: Janice Christiansen
Agent: Lori Delaney -

Date of Inspection: 9/19/2024
Year Built: 1994 Size: 2983
Weather: 79°, sunny, no breeze

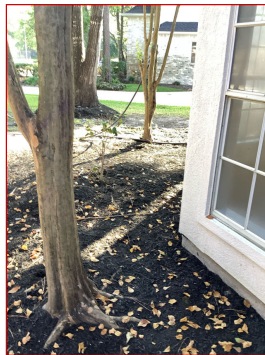
Trees too close

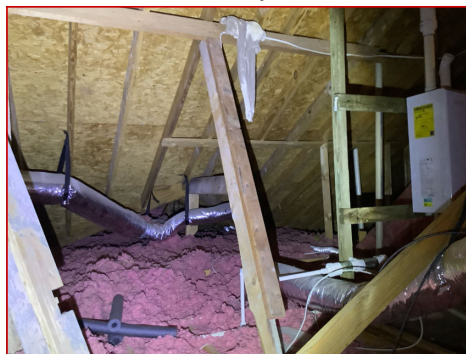
Improper installation

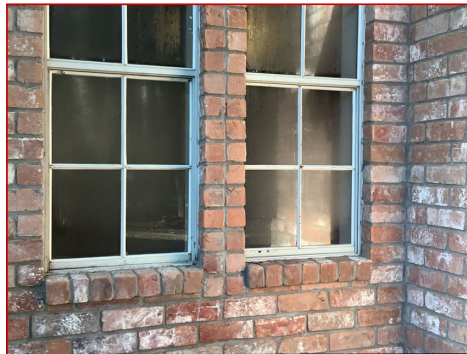
Screens absent

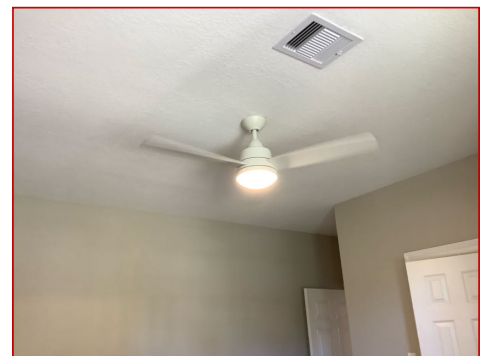
Smoke detectors absent

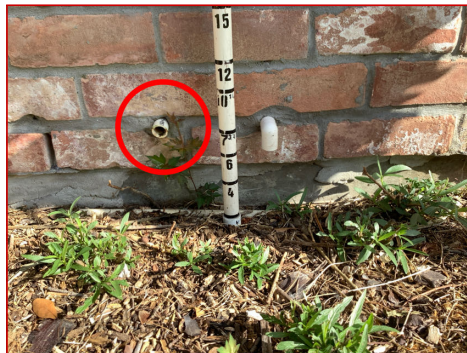
- The discharge pipe serving the catch pan for the water heater should is required to terminate in indirect waste or 6" to 24" inches from grade, pointing downwards with no threads on the end or 6" above the floor in the garage and diverted away from damageable materials. Repairs should be taken for safety reasons.

T&P relief valve and catch pan drain termination

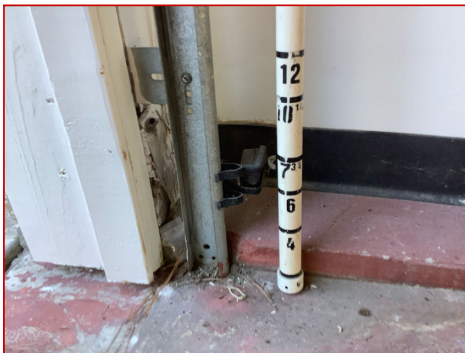
Sensor height

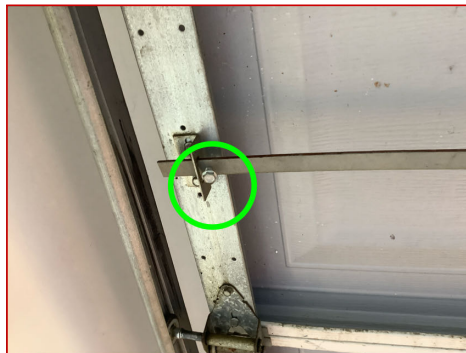
Lock is disabled
