Property Inspection Report

Texas Premium Inspections

16203 Oak Lace Ln
Inspection Prepared For: Marcelo Lopez
Agent: Lawrence Cevallos - Vive Realty

Date of Inspection: 2/26/2025
Year Built: 1997 Size: 1288
Weather: 55° F, Partly Cloudy, Faces East, Vacant

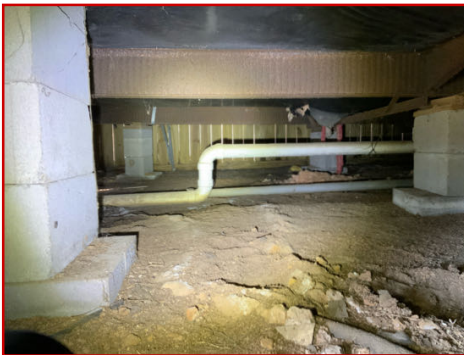
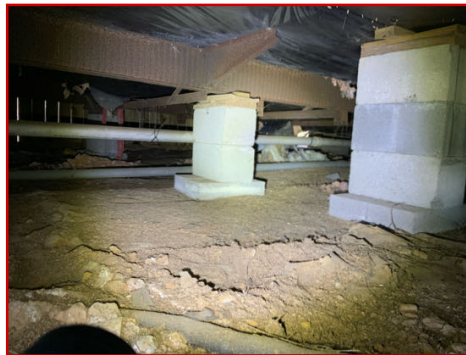
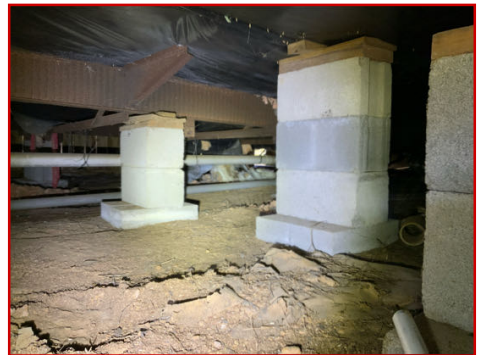
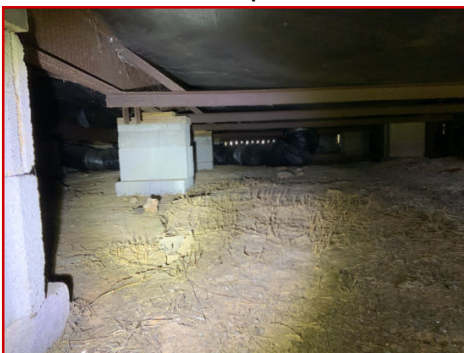
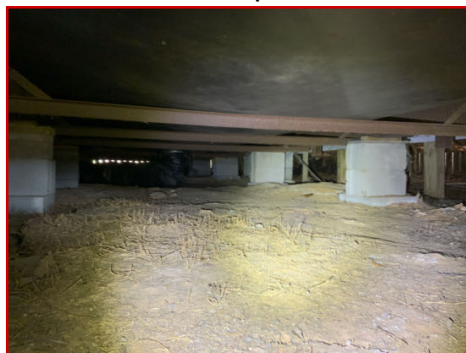
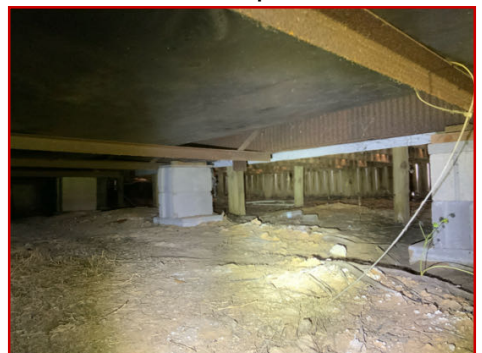
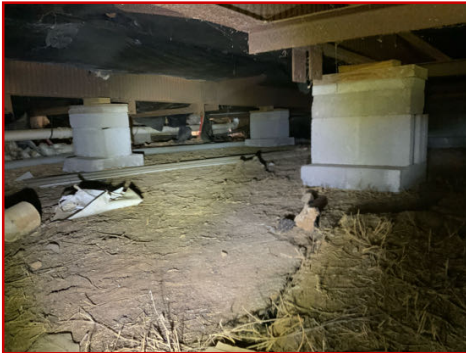
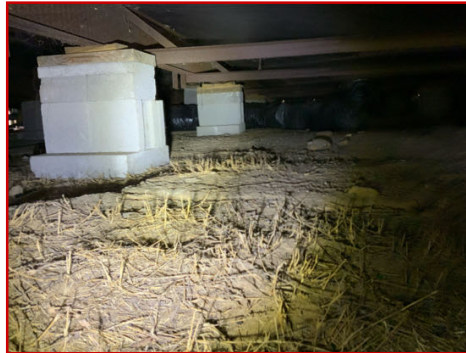
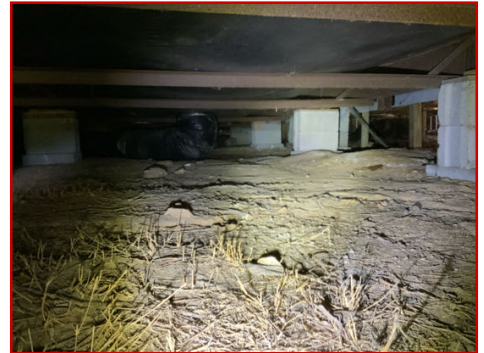
Crawlspace

- No soil cover was installed at the time of the inspection. Soil covers help reduce humidity levels in crawlspaces by limiting moisture evaporation into the air from soil. Reducing humidity levels can help prevent conditions that encourage mold growth and wood decay.

- Insulation has been underneath of the structure, is loose or falling, allowing unwanted conditions to decay the sub-flooring and structure.

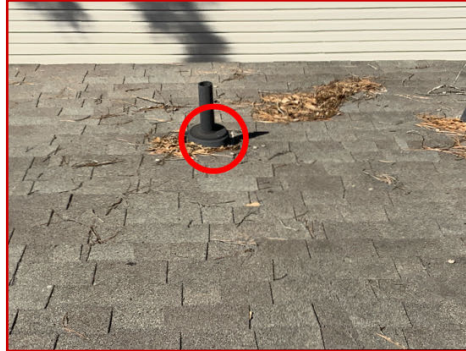
- Exposed nail heads are evident and should be sealed to avoid water penetration.
- Debris should be removed from the roof to avoid moisture damage to the shingles.
- One or more rubber vent boots were concave and will trap and or allow water to penetrate the roof structure.

Concave vent boot

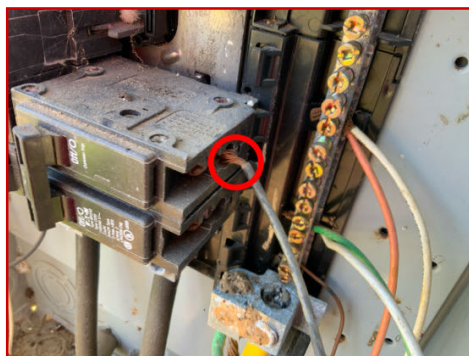
Too much visible copper

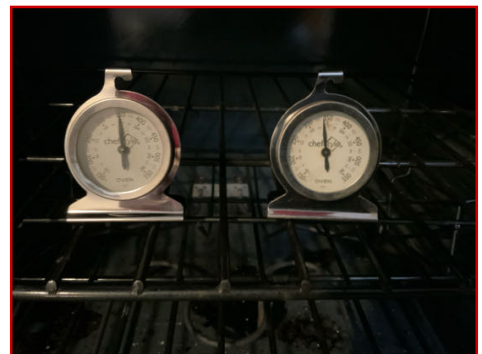
After 30 min thermometer is within range
