# 3714 Blackberry Circle

## Missouri City, Texas 77459

Client	--
Reference id	<b>a2ZPd000000IJ0nMAE</b>
Type	<b>Home Inspection and Floor Plan Report - 3714 Blackberry Circle</b>
Inspected by	<b>Rio Bravo - Inspectify Pro - Houston</b>
State license	<b>TREC 22388</b>
InterNACHI	<b>17031522</b>
Scheduled	<b>January 23, 2025, 4:00 PM</b>
Completed	<b>January 23, 2025, 7:01 PM</b>

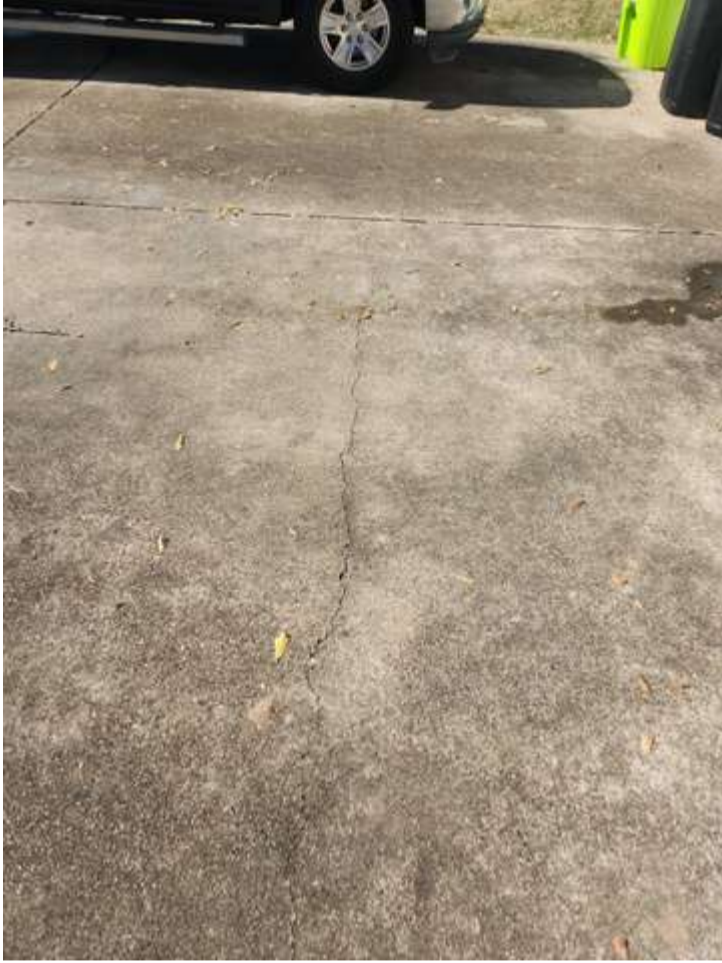
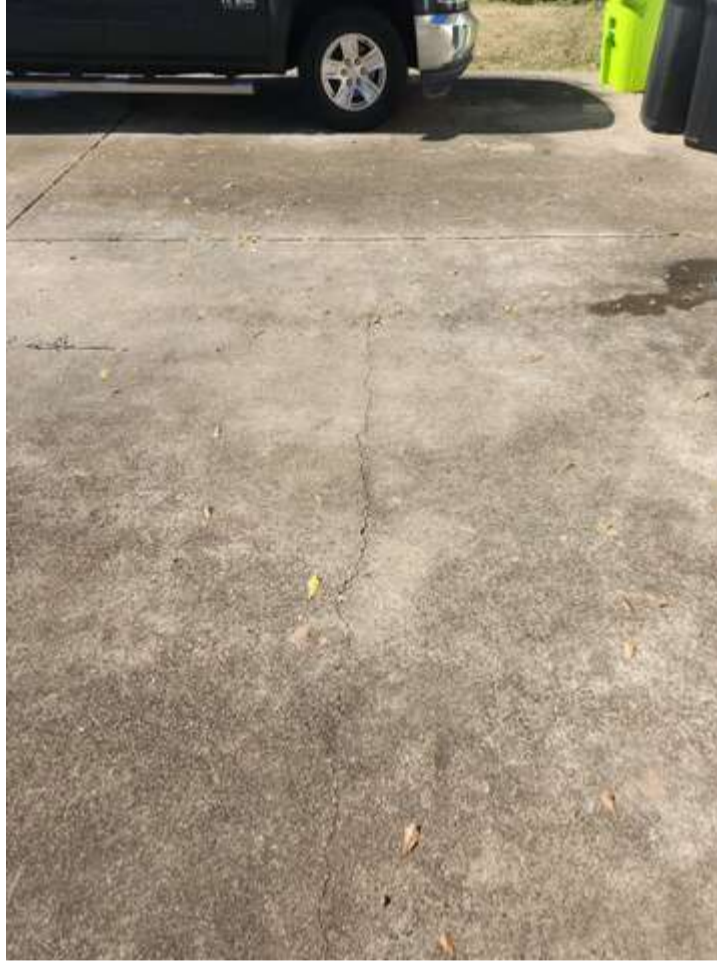
### Minor Cracks in the Driveway

The driveway has minor cosmetic cracks.

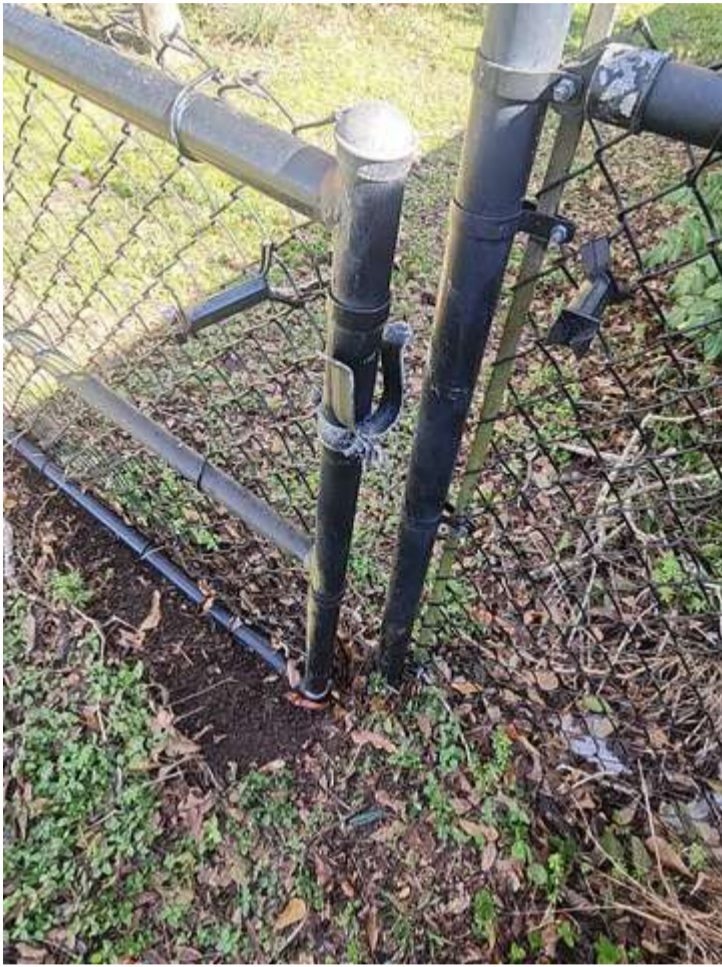
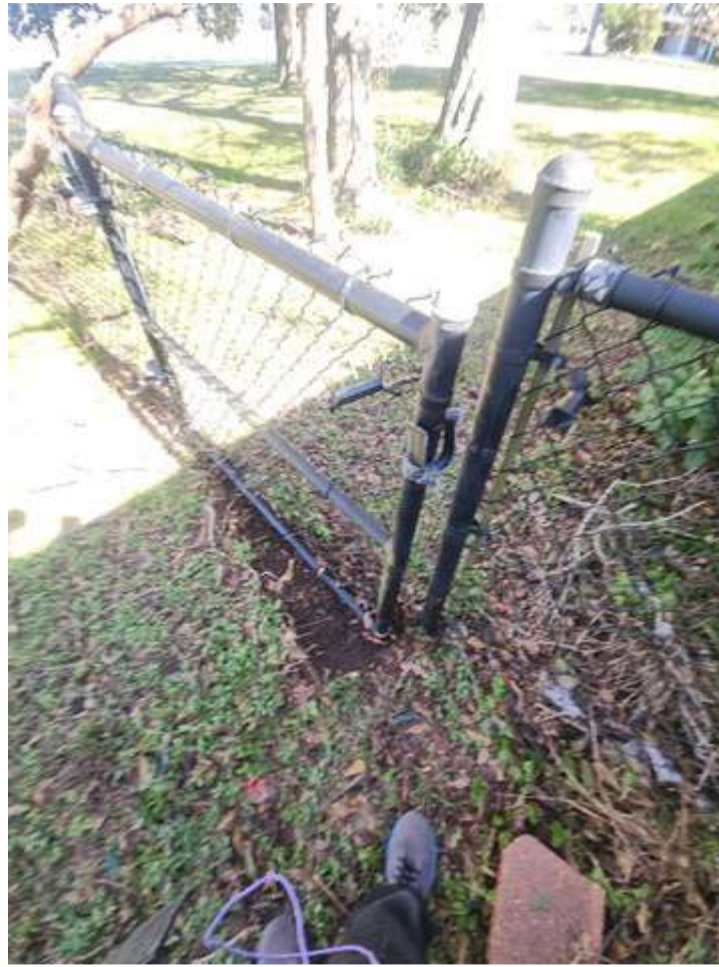
**Right**

**Repair deficiency**

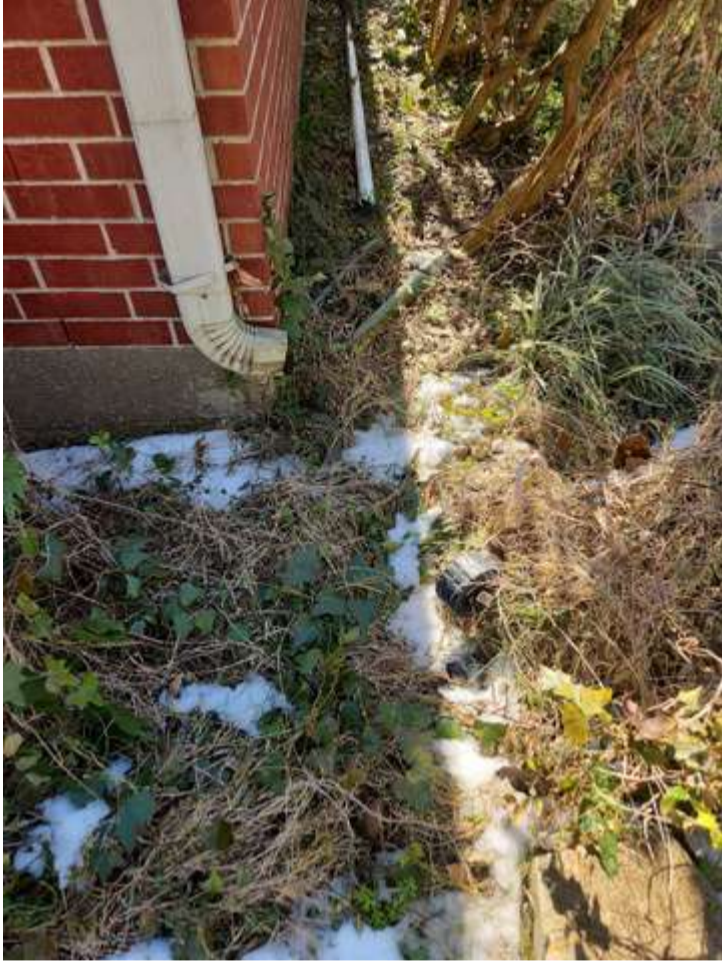
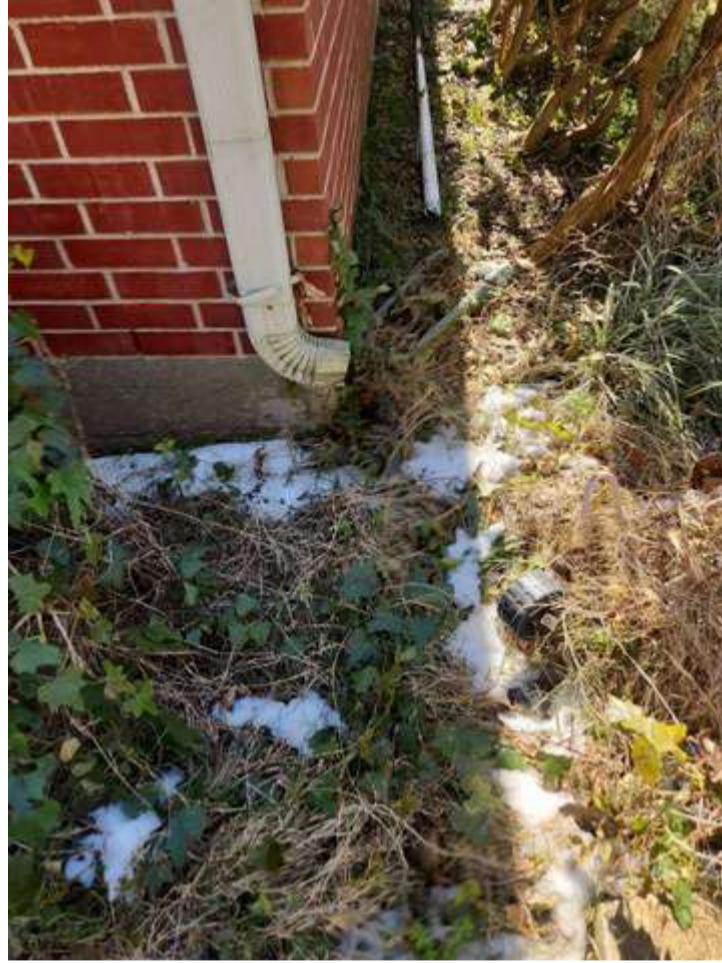
**All downspouts**

### Missing Downspout Splash Blocks

There are no splash blocks for the downspouts.

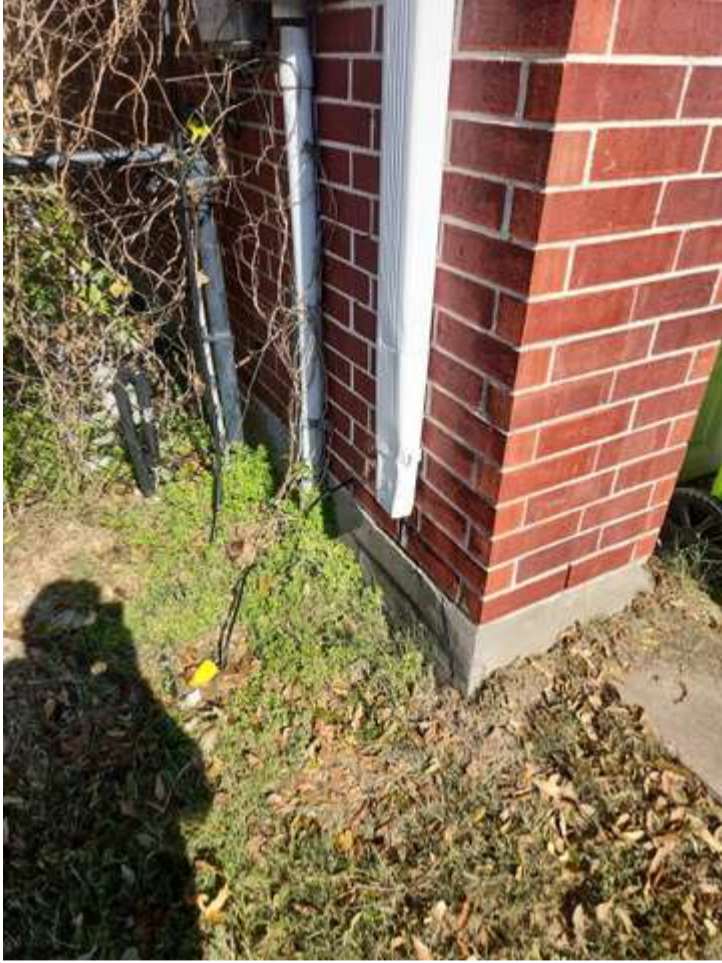
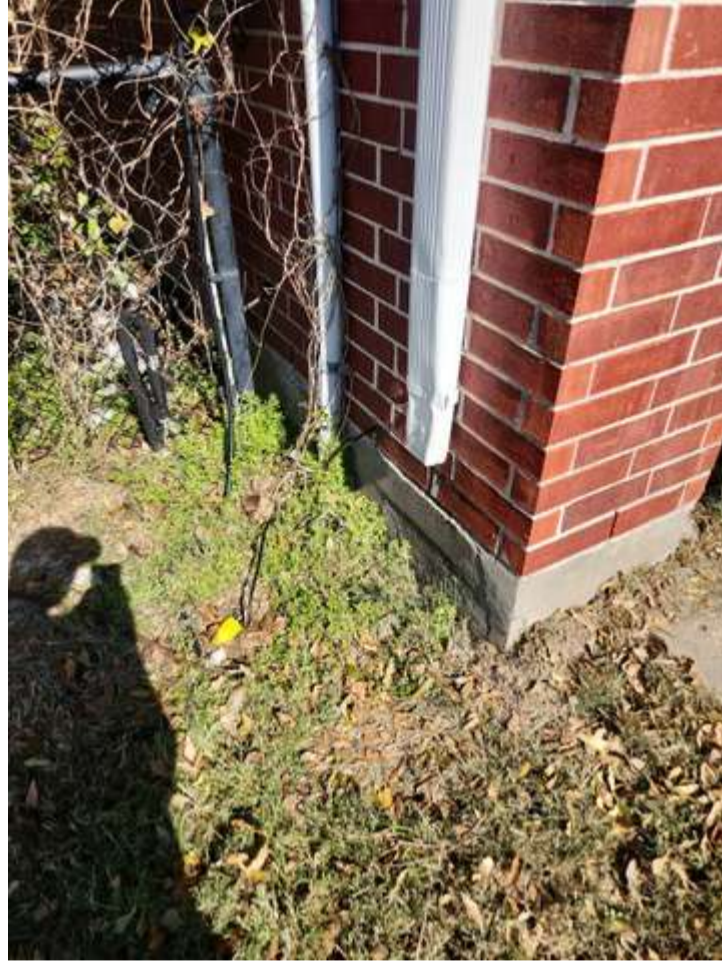
**Left**

One or more downspouts drain too close to the property's foundation.

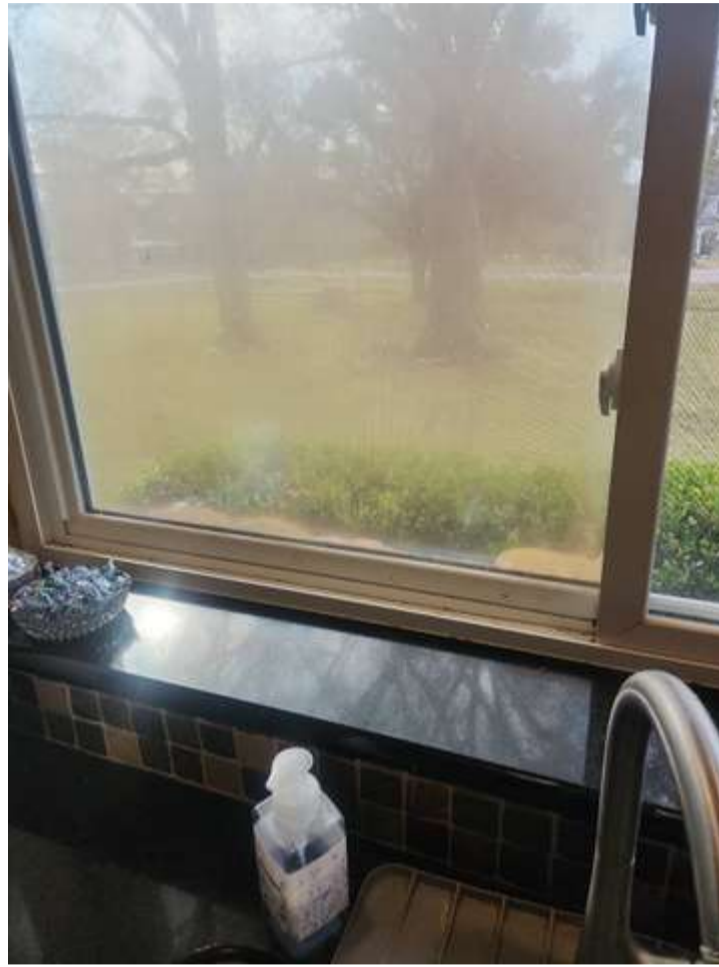
**Kitchen**

### Deteriorated / Failed Window Seal

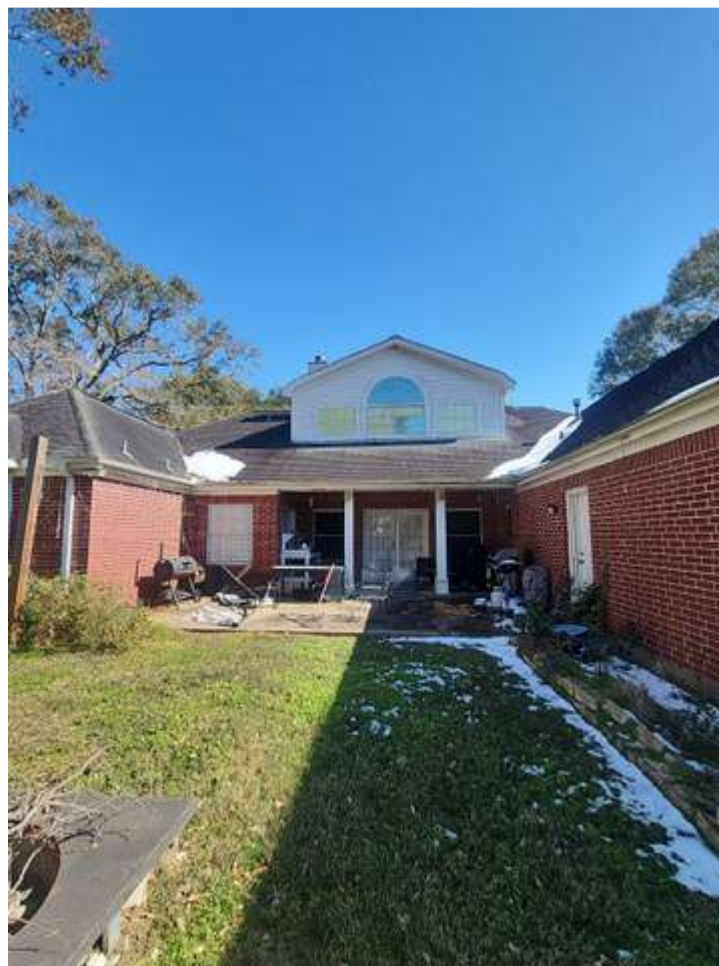
**Noted on a few Windows around the home**

### Missing Window Screen

One or more windows are missing a screen.

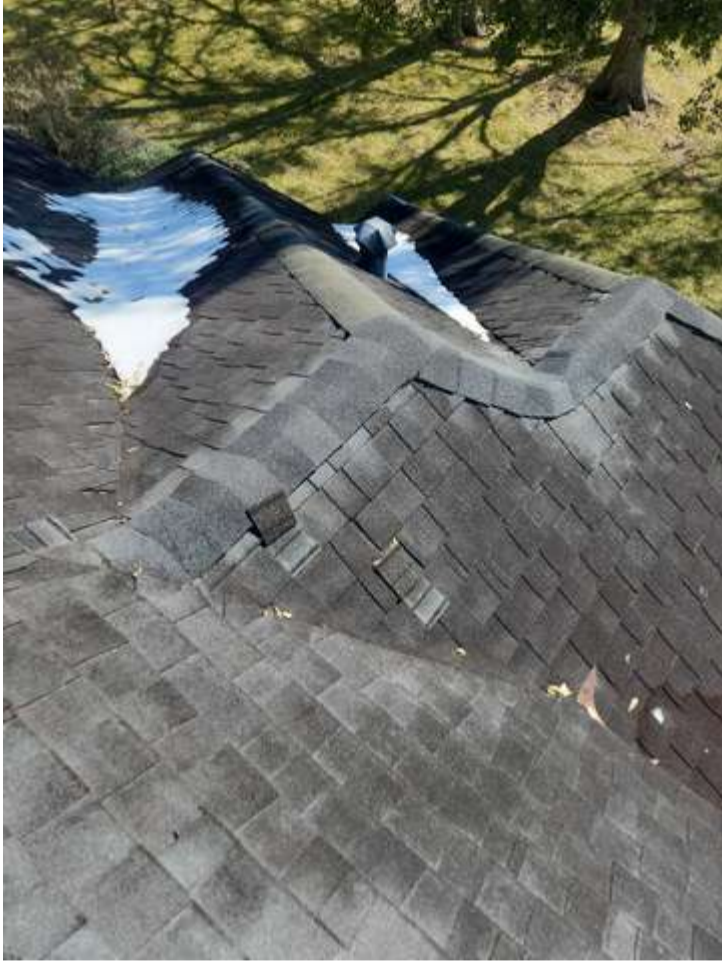
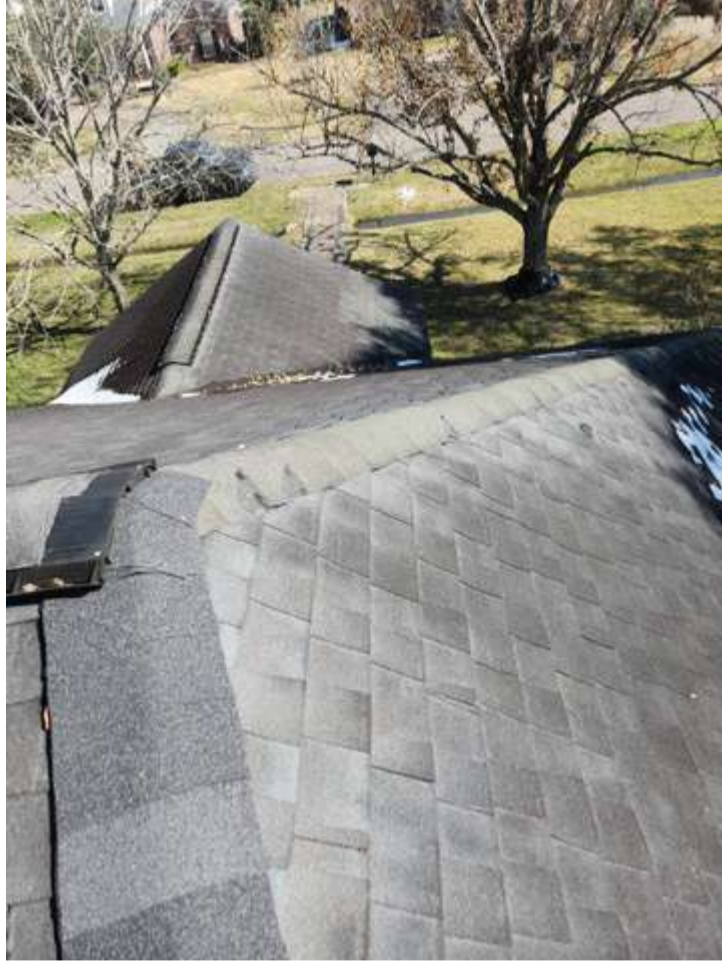
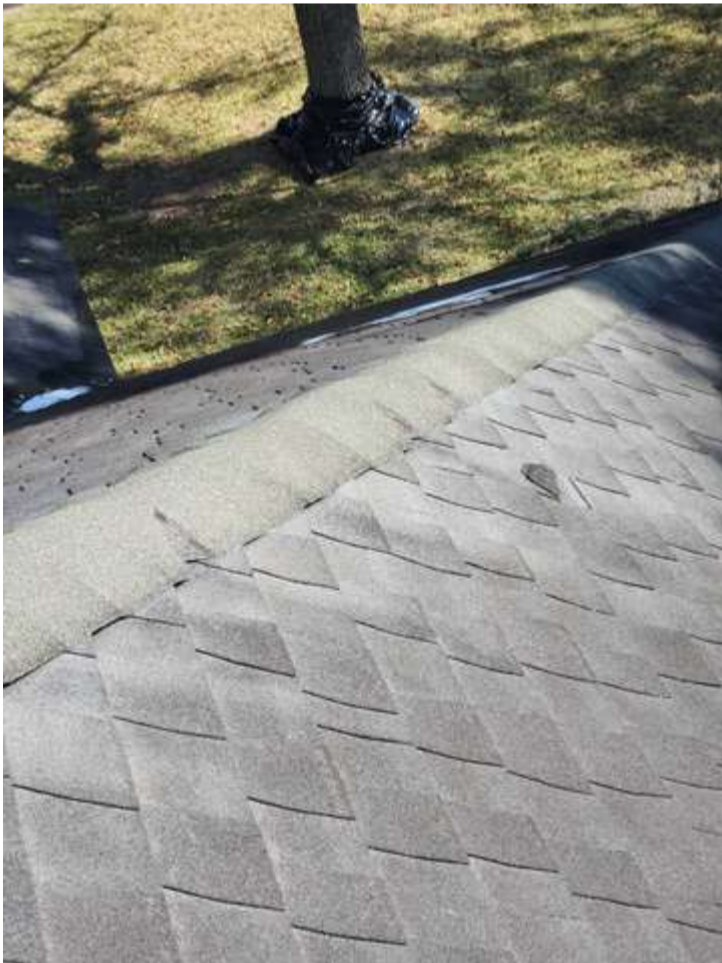
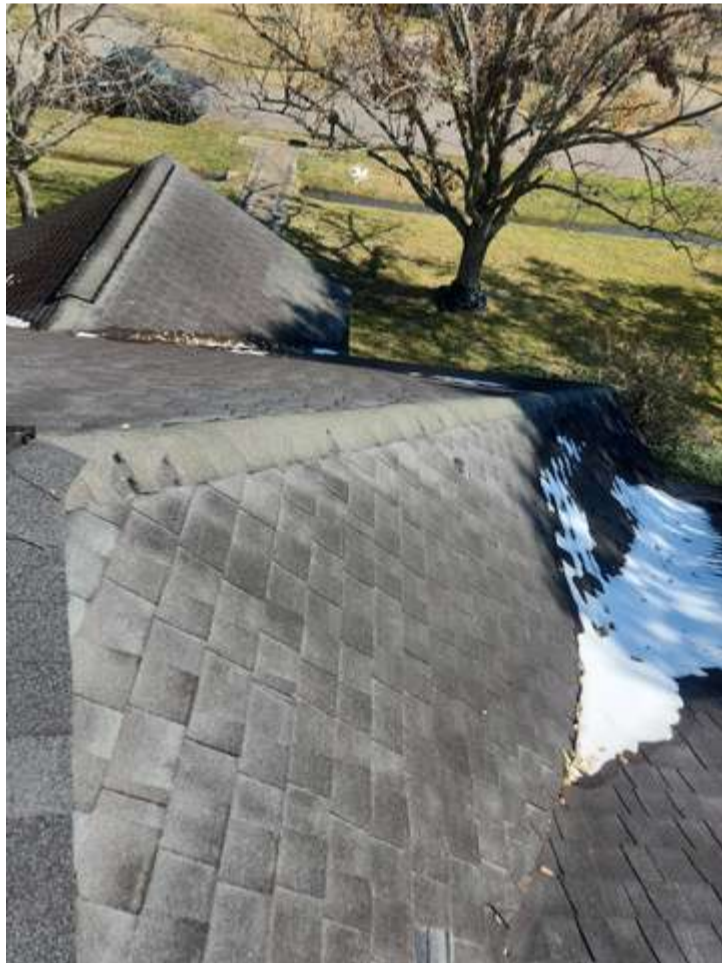
### Damaged Shingles

One or more shingles are cracked or torn.

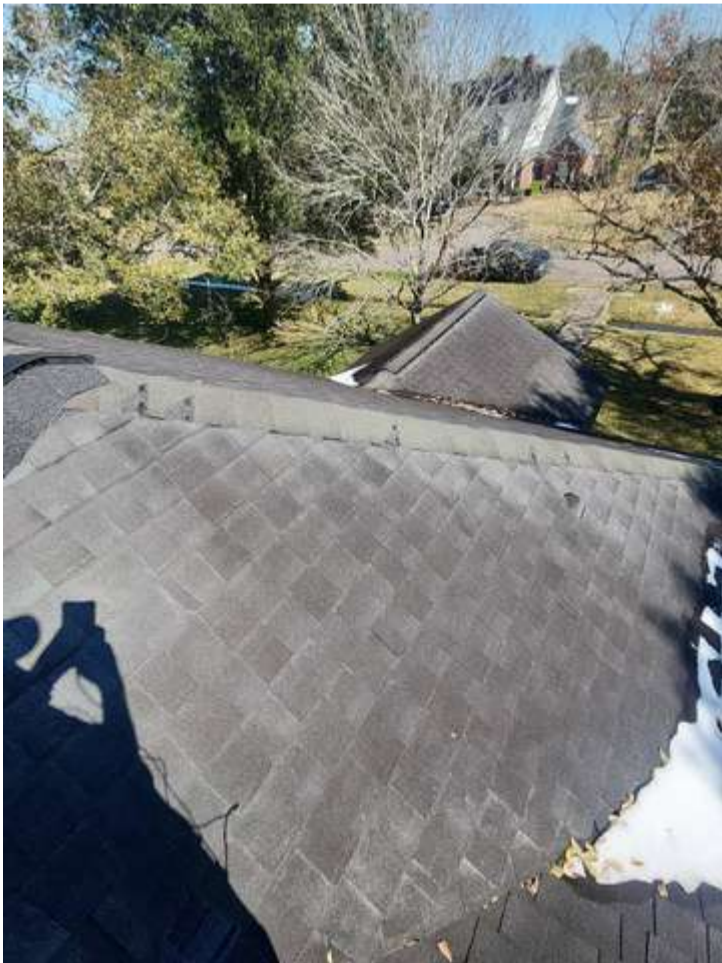
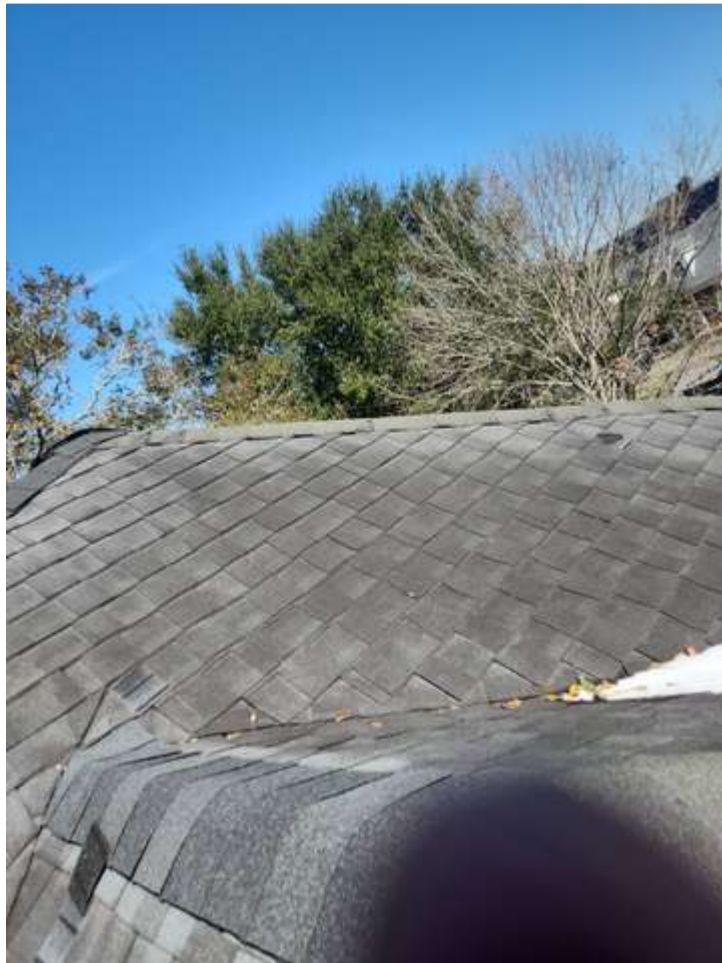
### Damaged Shingles

One or more shingles are cracked or torn.

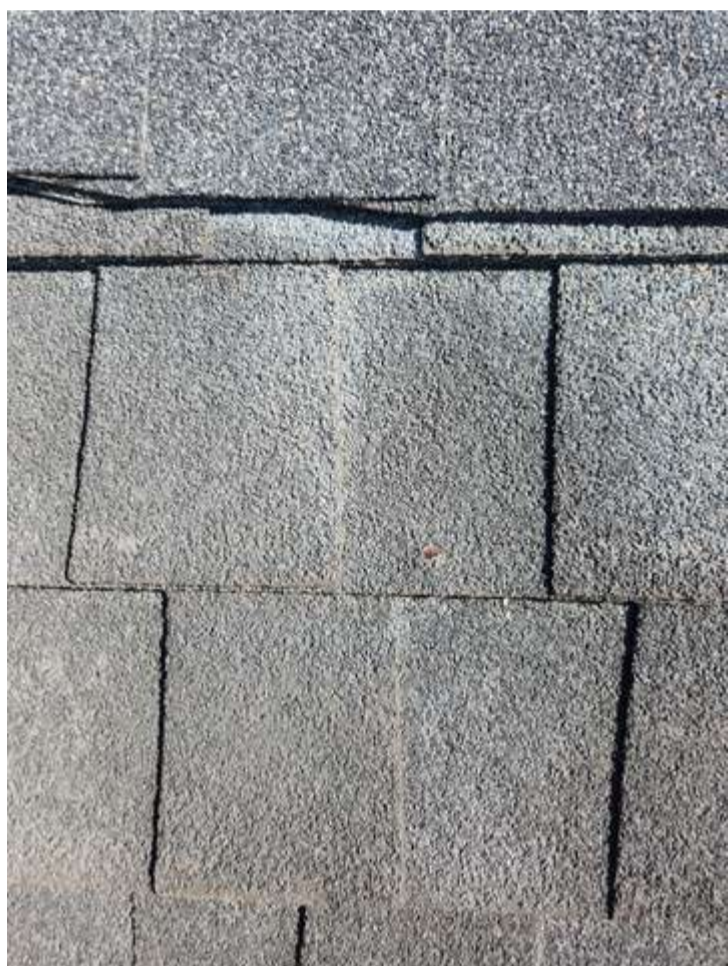
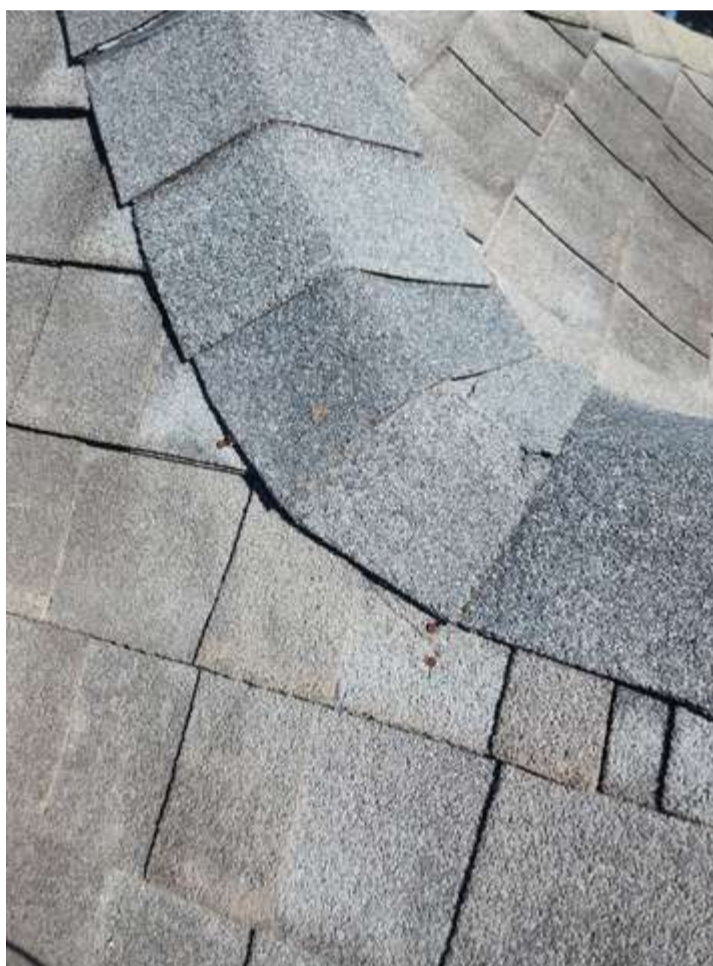
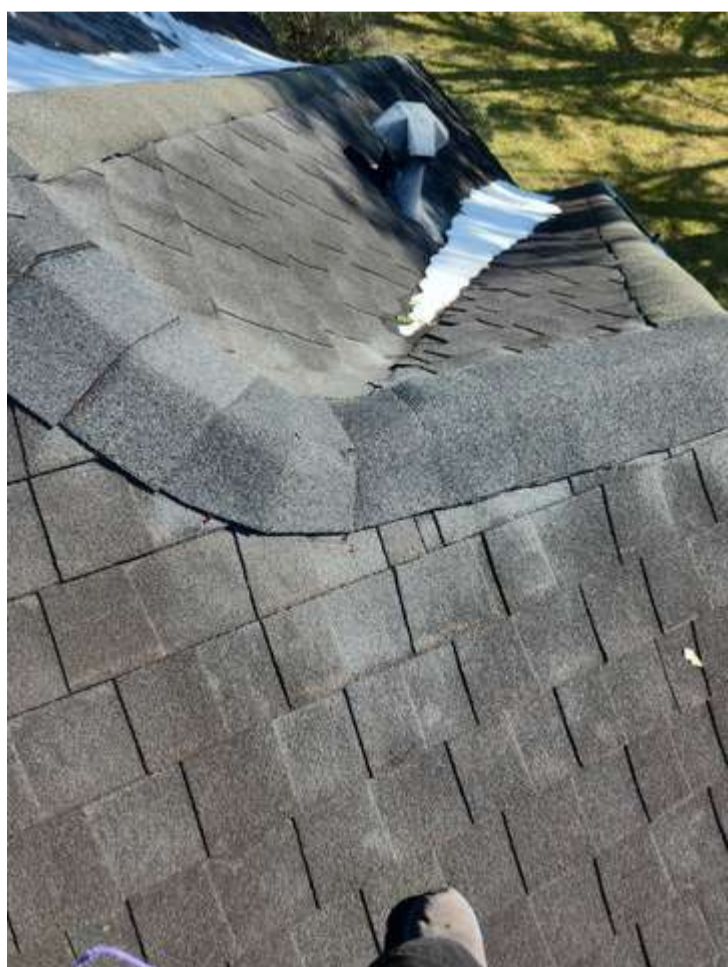
**Left**

**Repair deficiency**

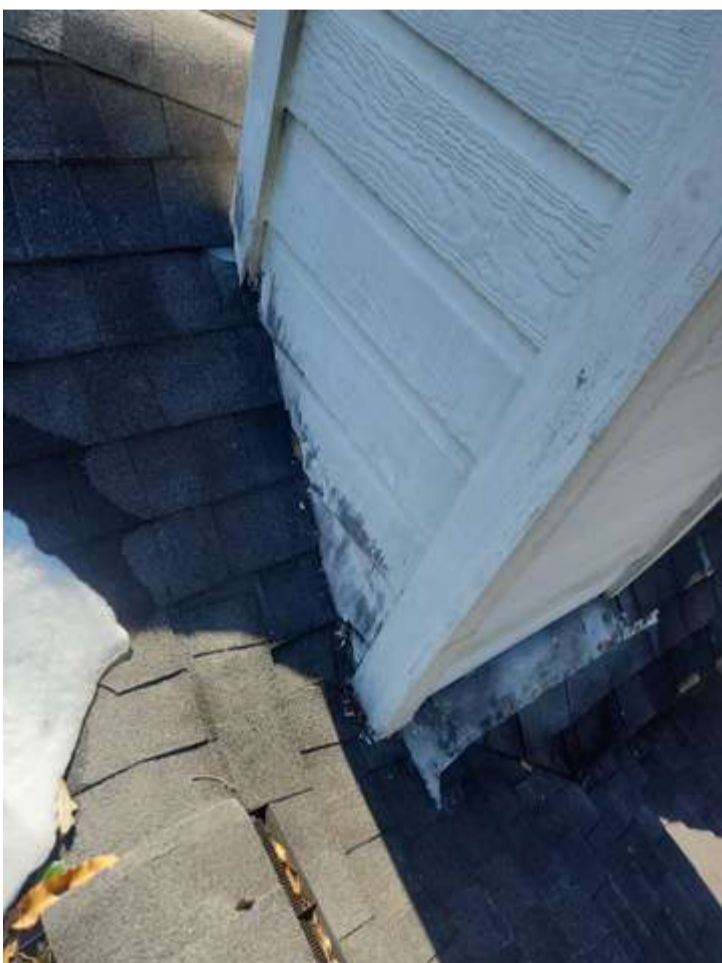
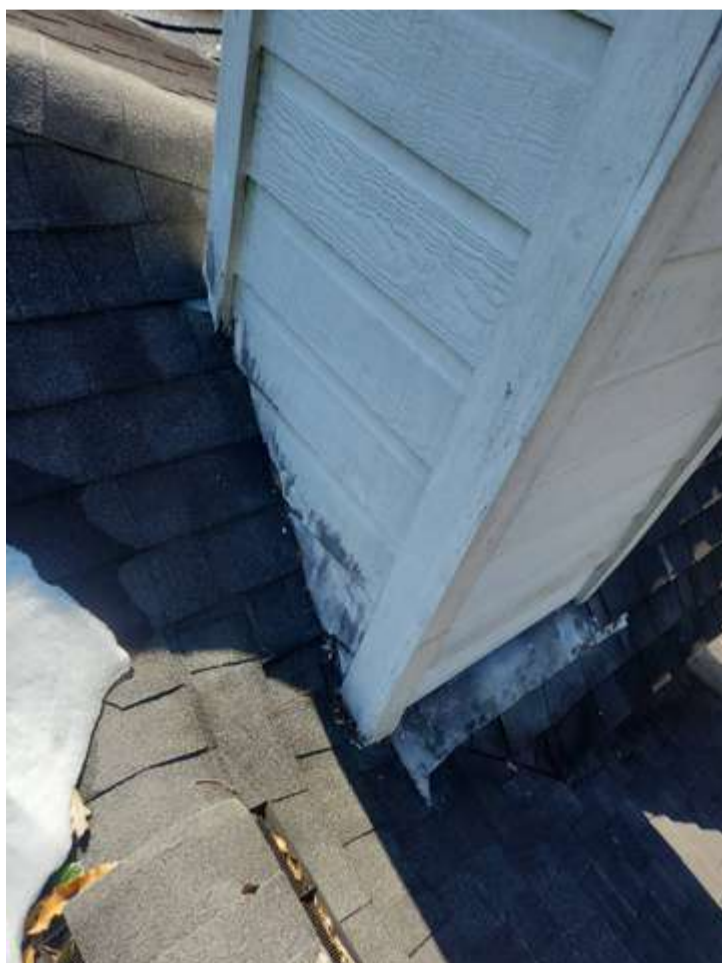
**Repair deficiency**

### Deteriorating Exterior

One or more areas of the exterior are rotting.

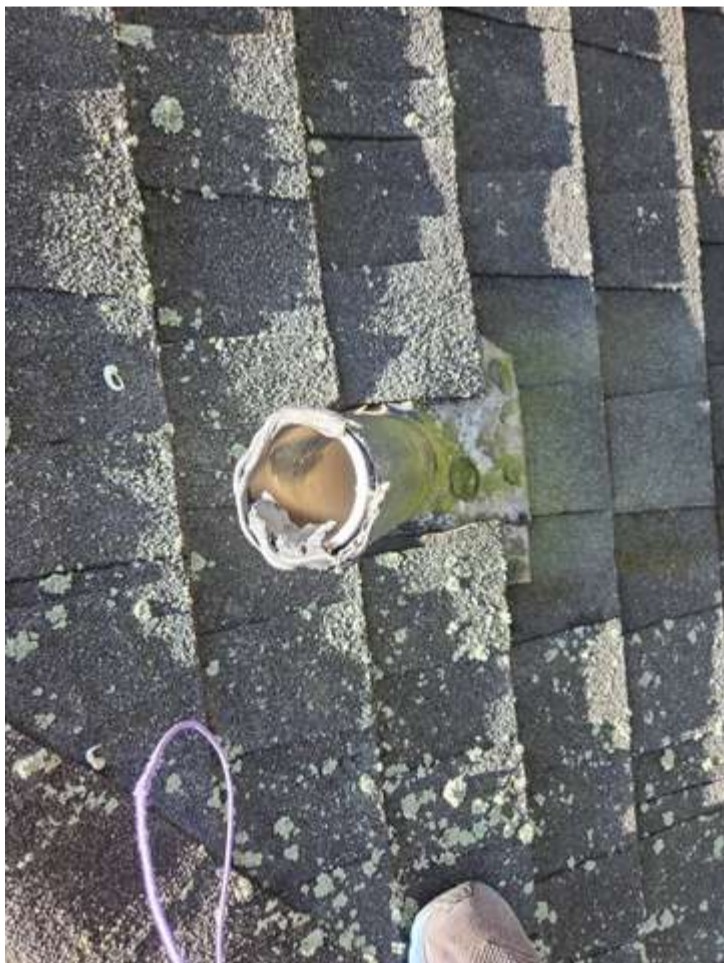
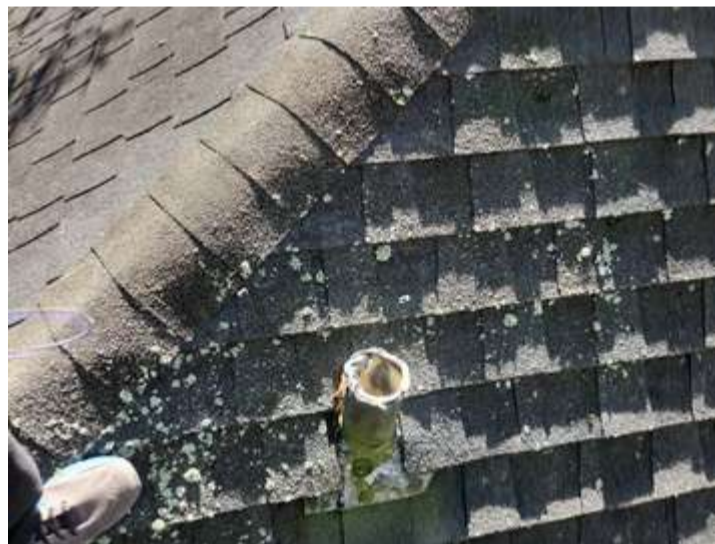
**Right**

🔧 Repair deficiency

Vent pipe flashing was damaged

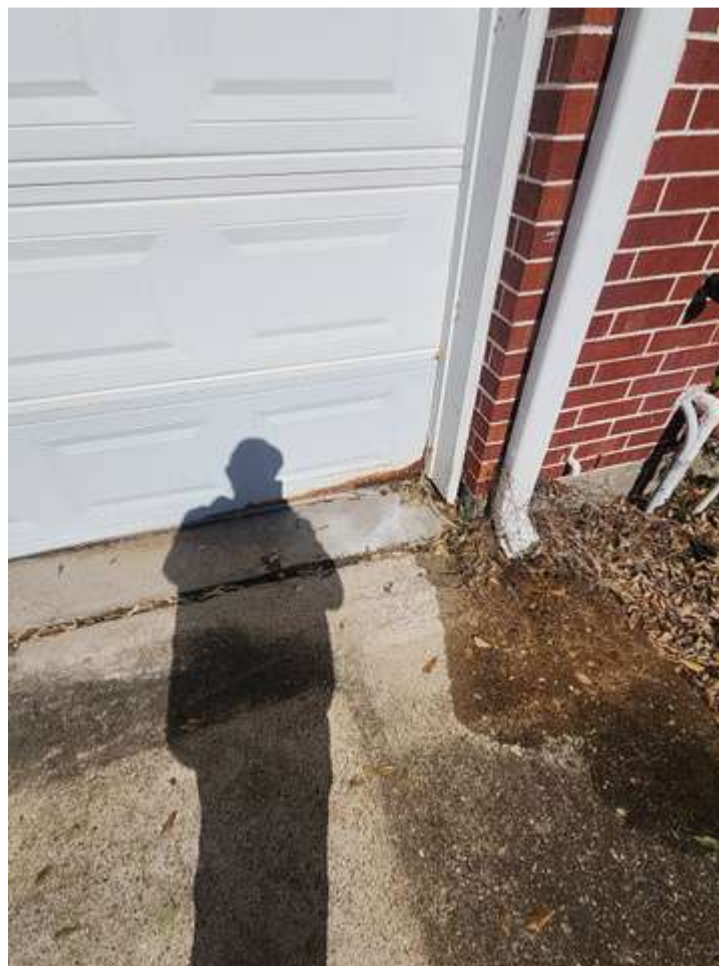
**Repair deficiency**

### Damaged Garage Door Panels

One or more garage door panels are damaged.

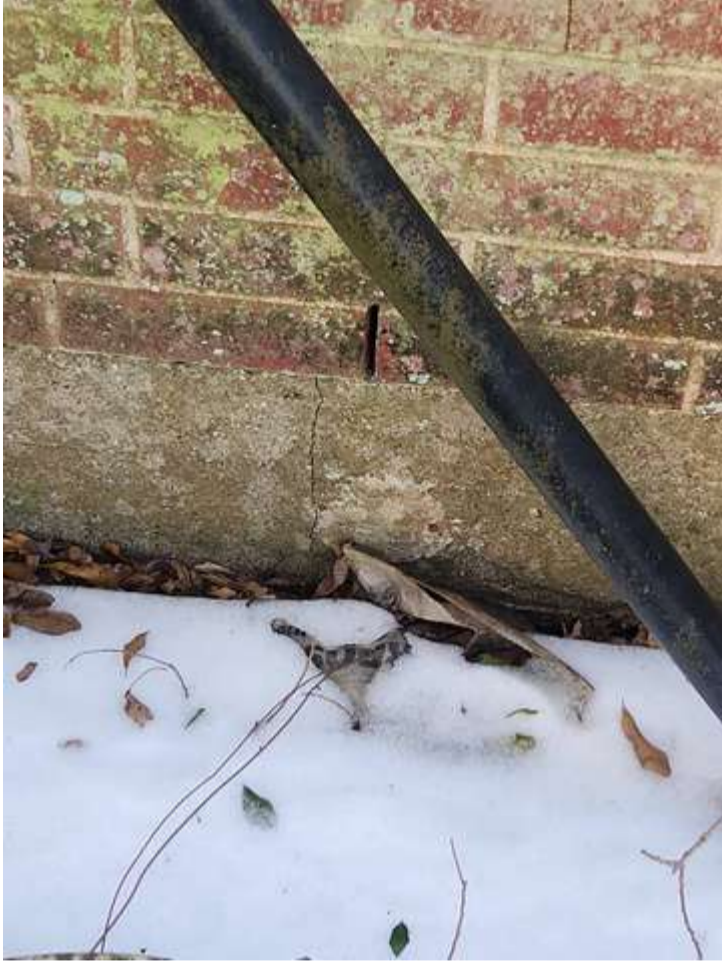
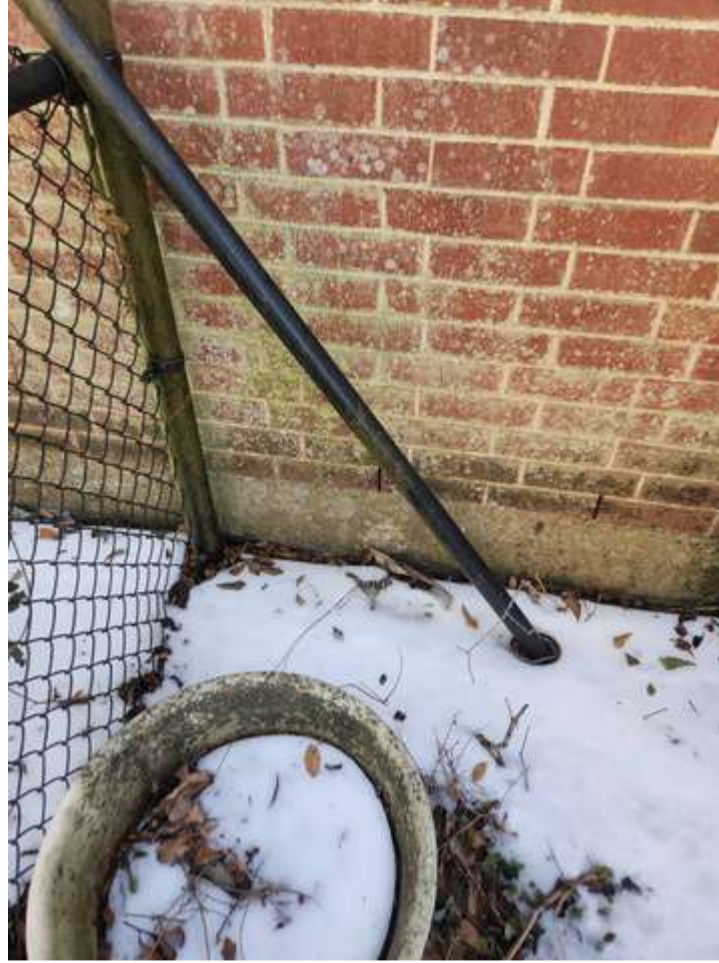
**Right**

Monitor deficiency

### Minor Foundation Cracks

One or more areas of the foundation have minor cracking.

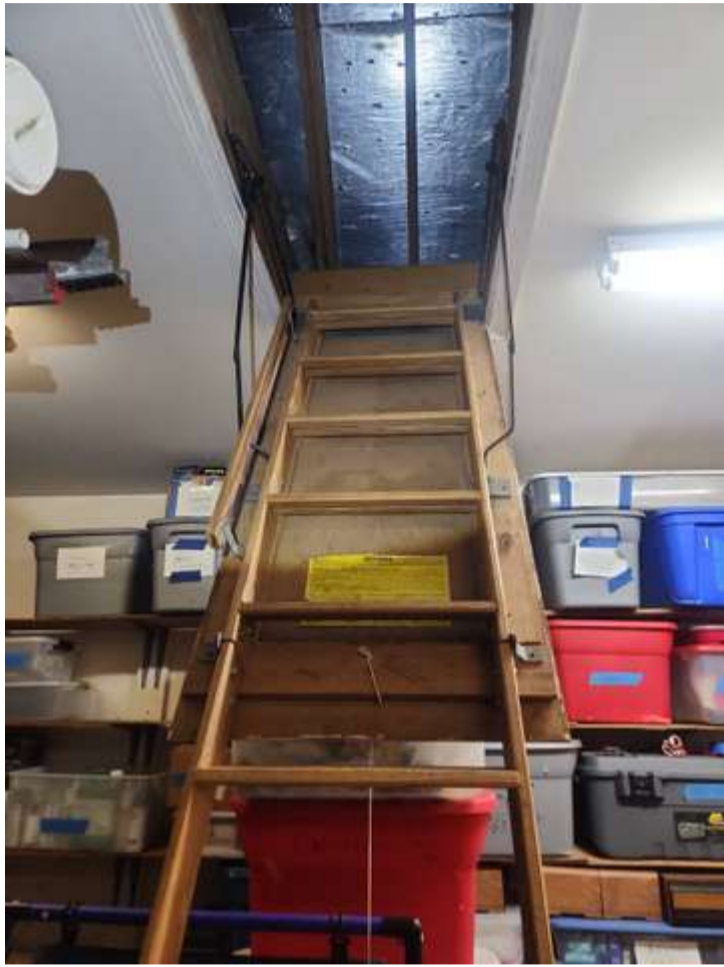
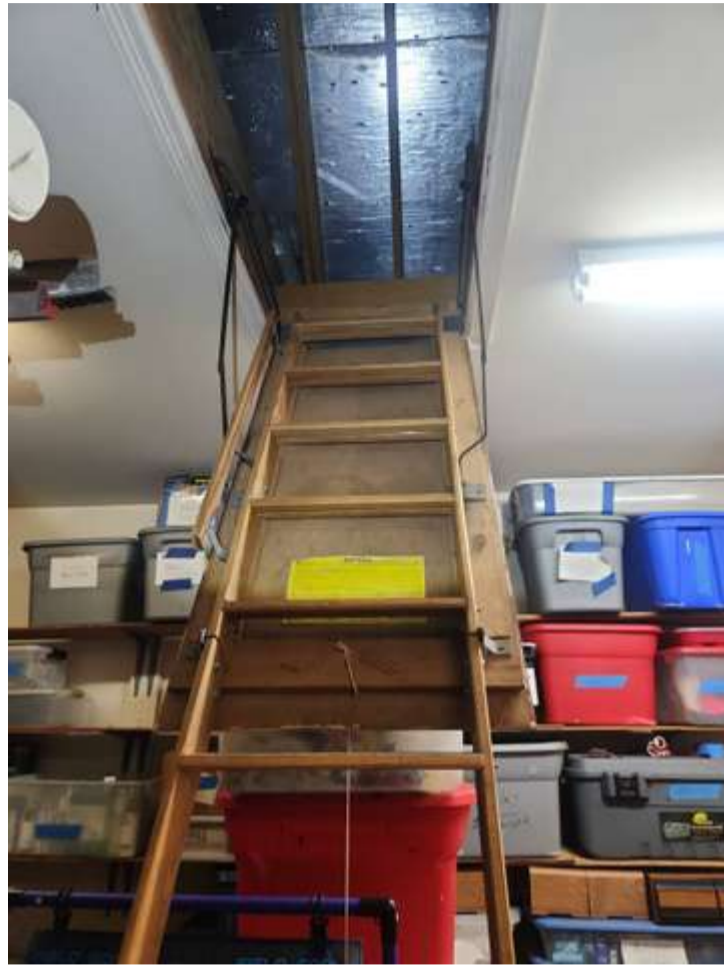
**Garage**

**Safety deficiency**

The attic pull-down ladder is not fire-rated. Recommend repairs or replacing by a qualified professional.

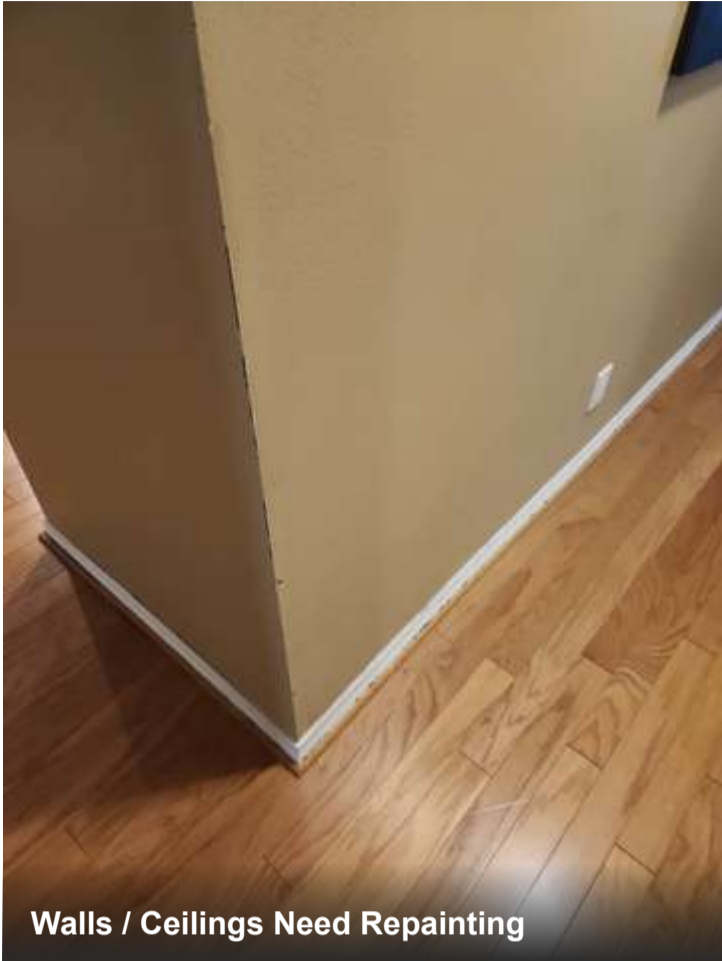
**Walls / Ceilings Need Repainting**

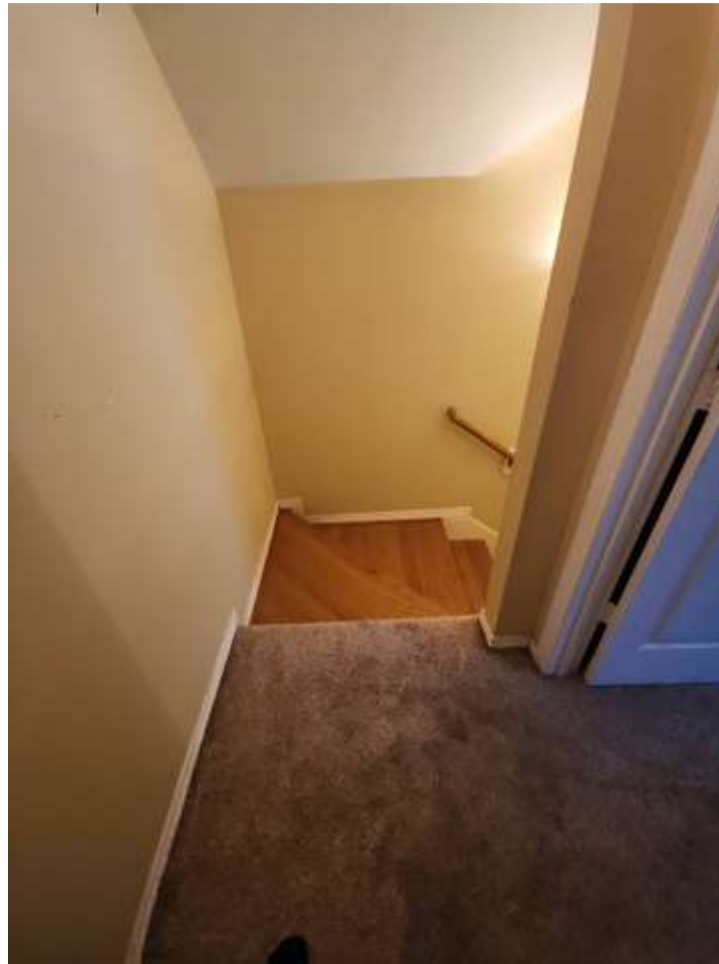
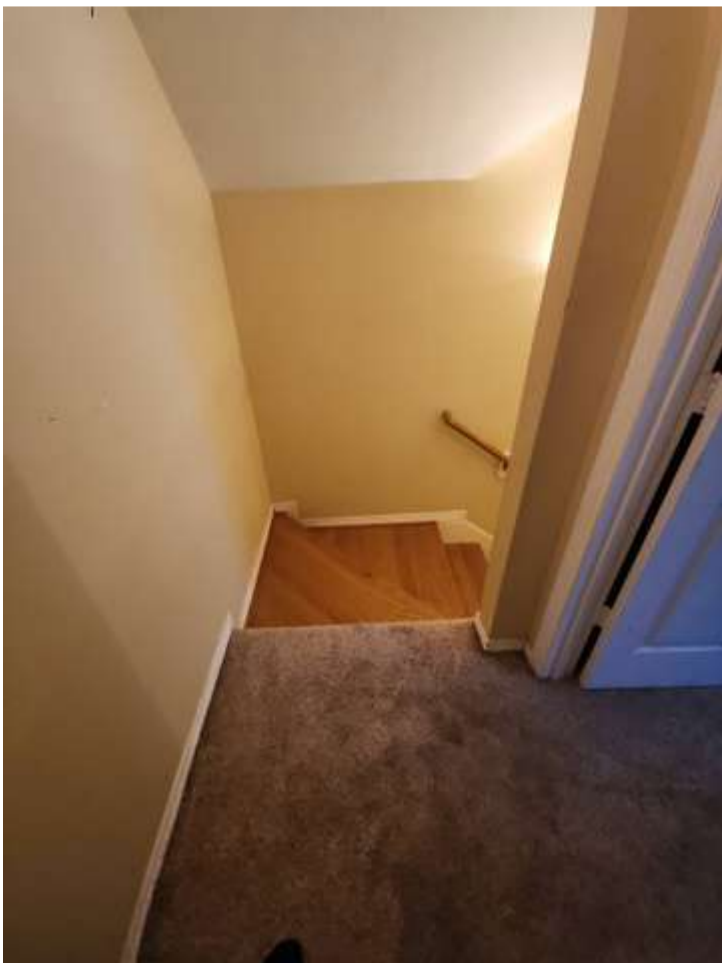
**Repair deficiency**

The handrail did not extend the full length of the stairway

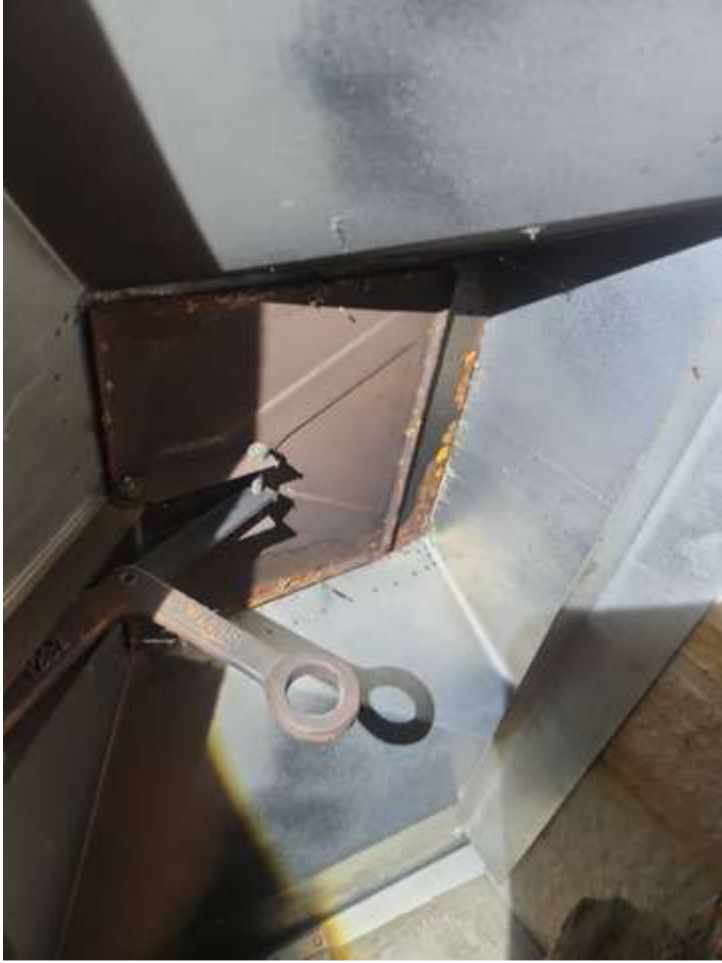
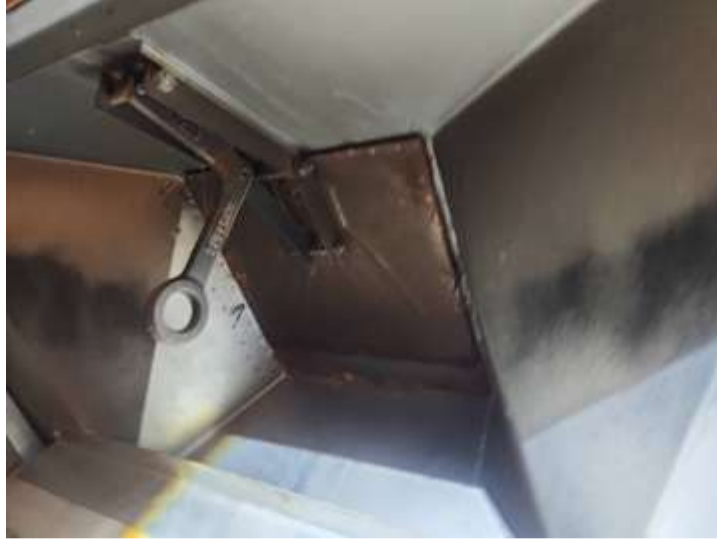
**Living Room**

### Missing Damper Locks
