# 3714 Blackberry Circle

## Missouri City, Texas 77459

Client	--
Reference id	<b>a2ZPd000000IJ0nMAE</b>
Type	<b>Home Inspection and Floor Plan Report - 3714 Blackberry Circle</b>
Inspected by	<b>Rio Bravo - Inspectify Pro - Houston</b>
State license	<b>TREC 22388</b>
InterNACHI	<b>17031522</b>
Scheduled	<b>January 23, 2025, 4:00 PM</b>
Completed	<b>January 23, 2025, 7:01 PM</b>

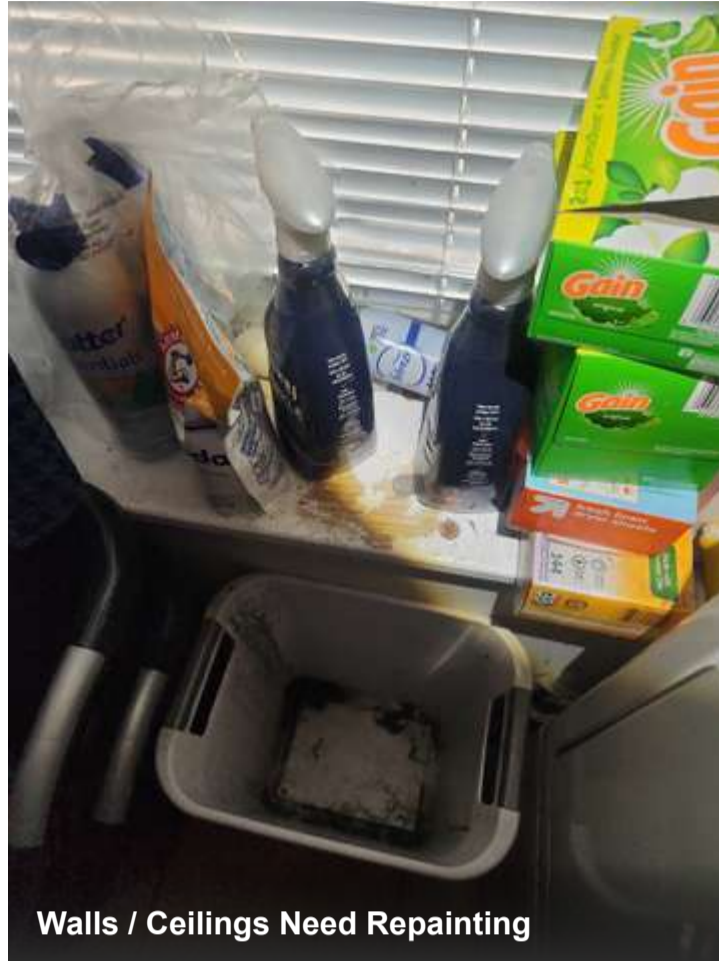
Walls / Ceilings Need Repainting

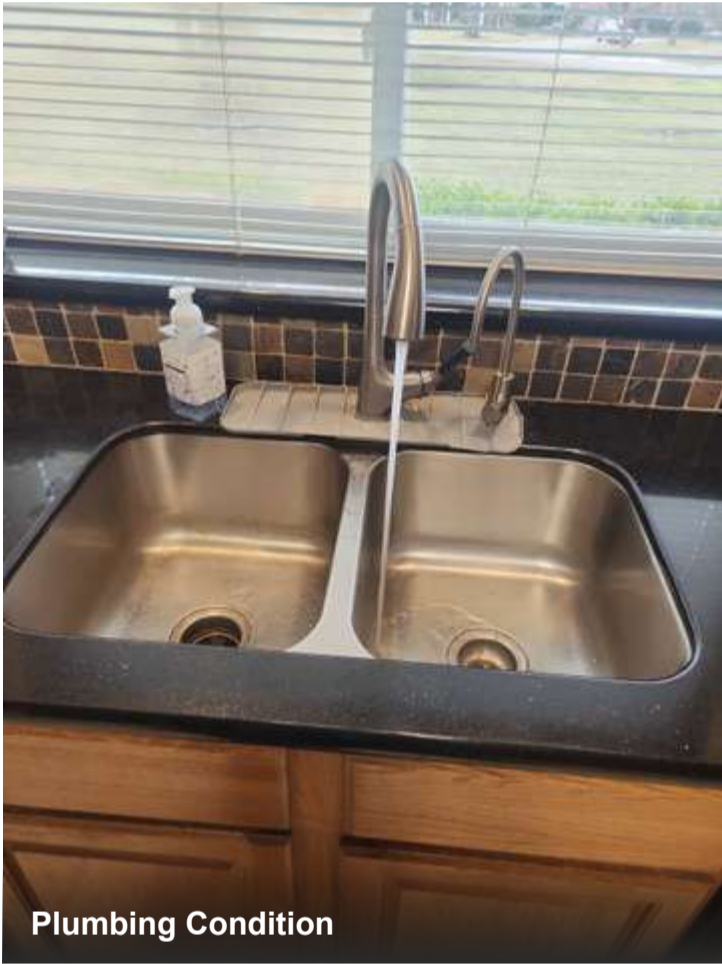
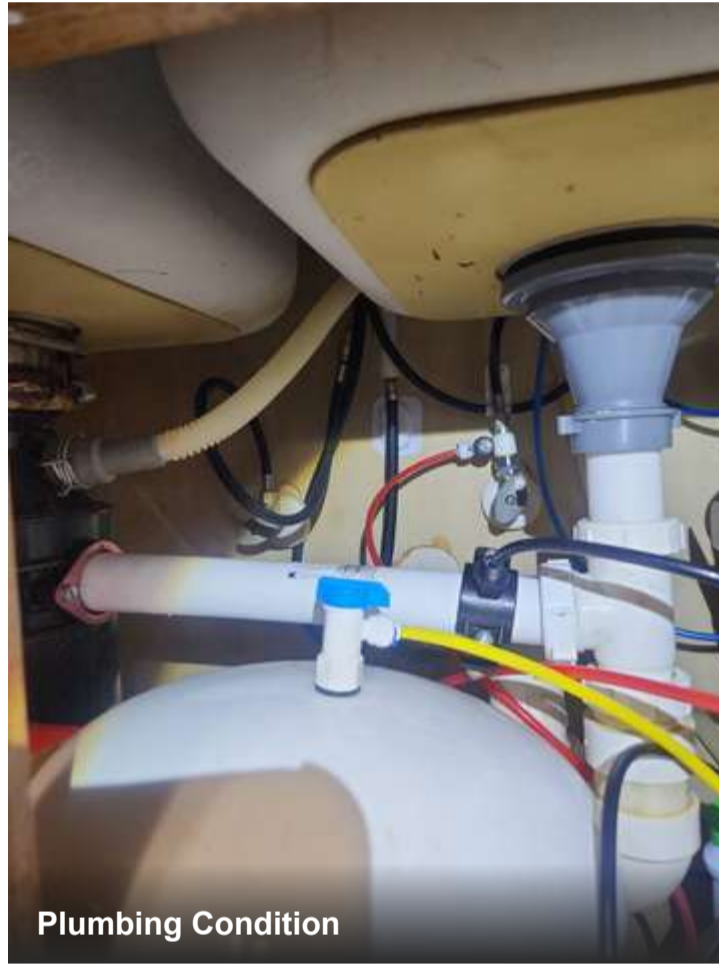
### Water Damage in Cabinet

The cabinet had water damage in one or more areas.

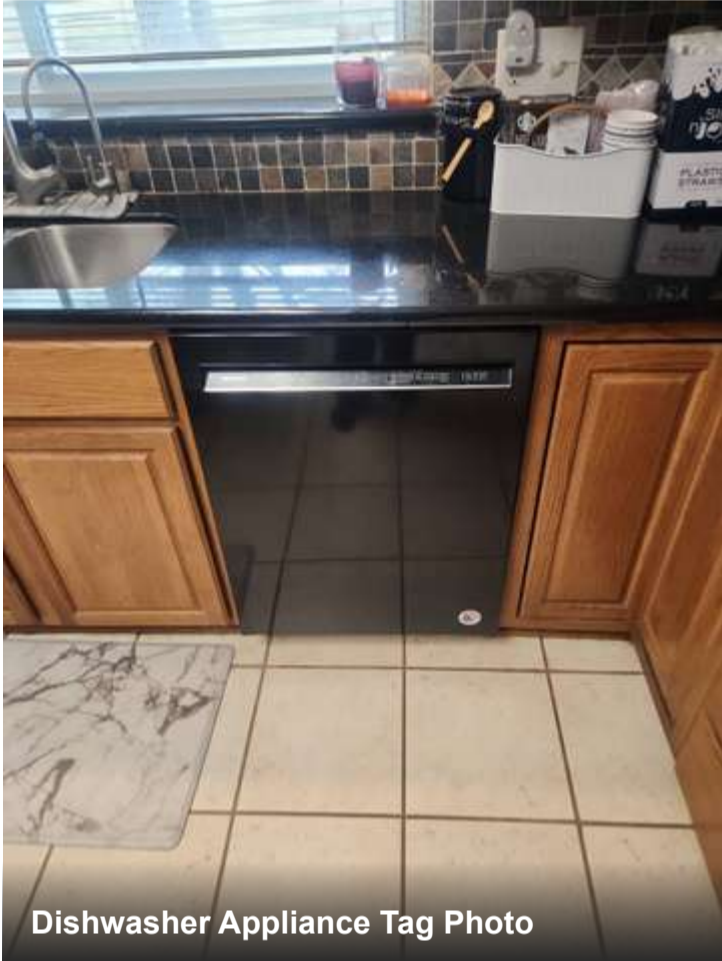
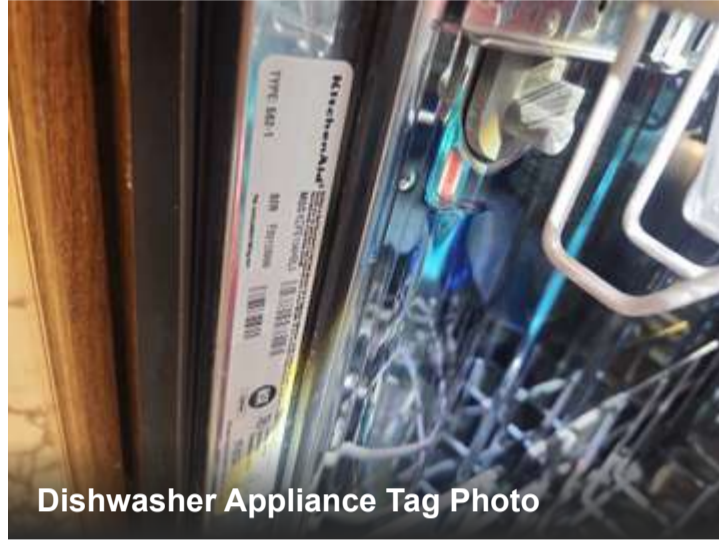
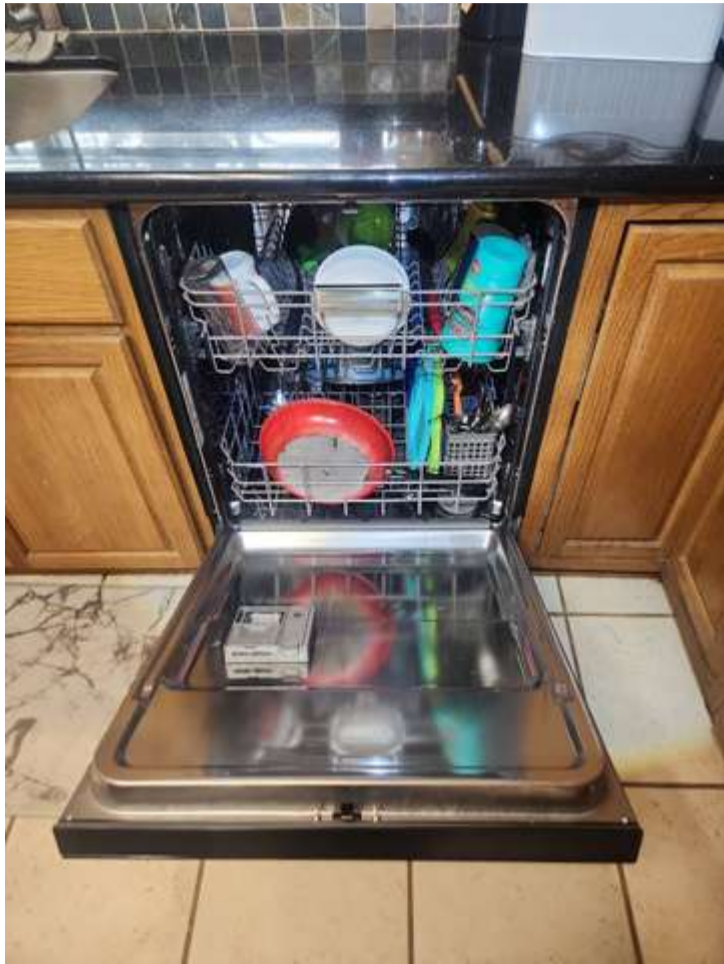
### Dishwasher Condition: Other

Did not operate dishwasher due to personal items in dishwasher

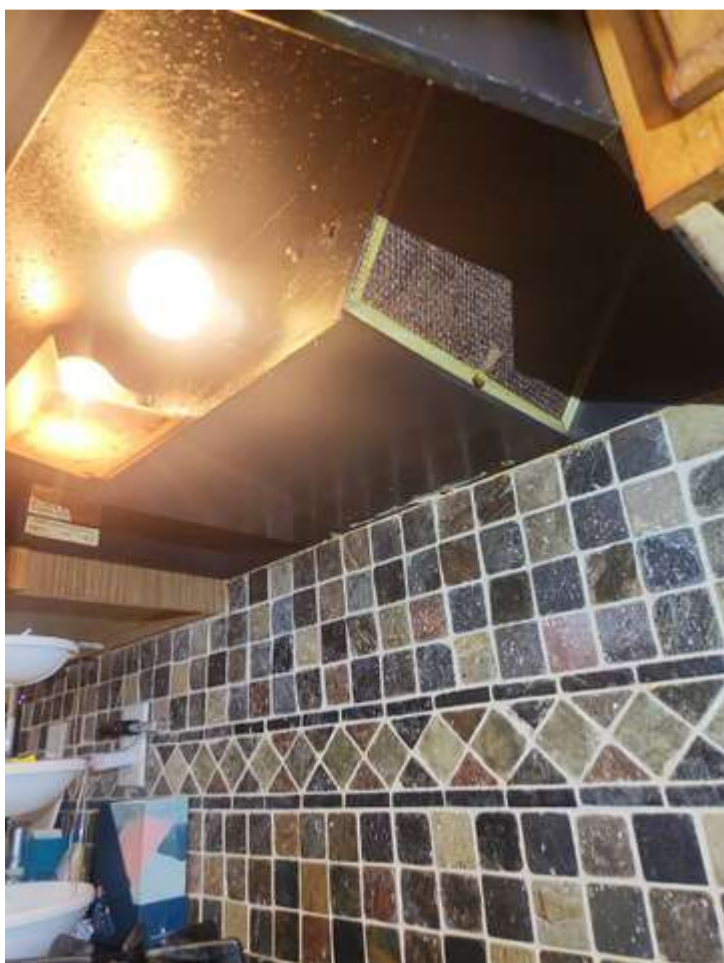
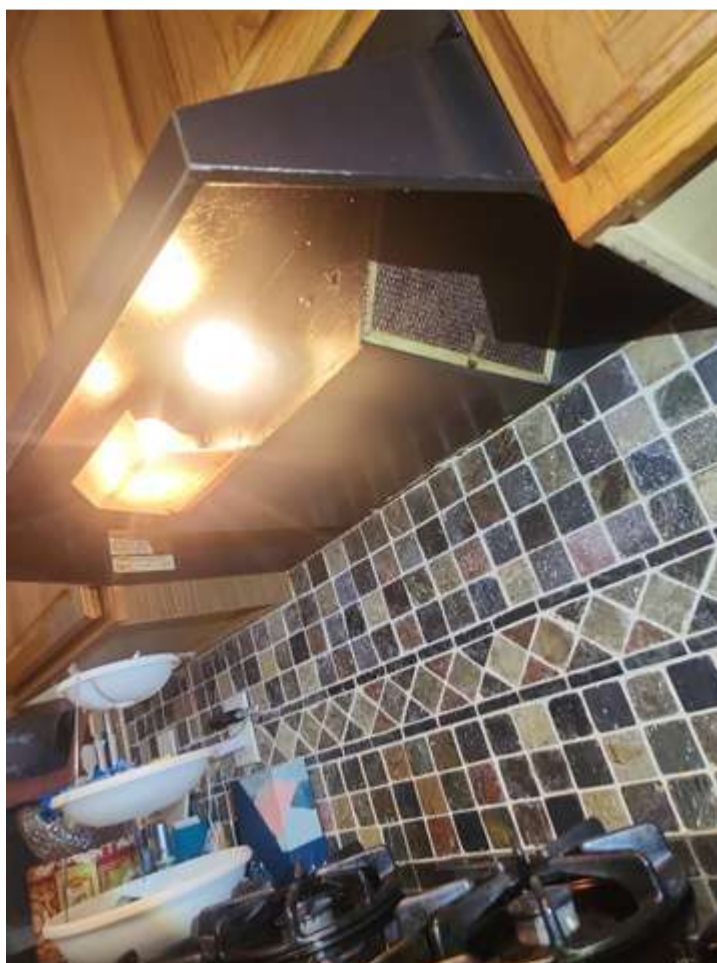
The kitchen exhaust hood / range hood filter is dirty.

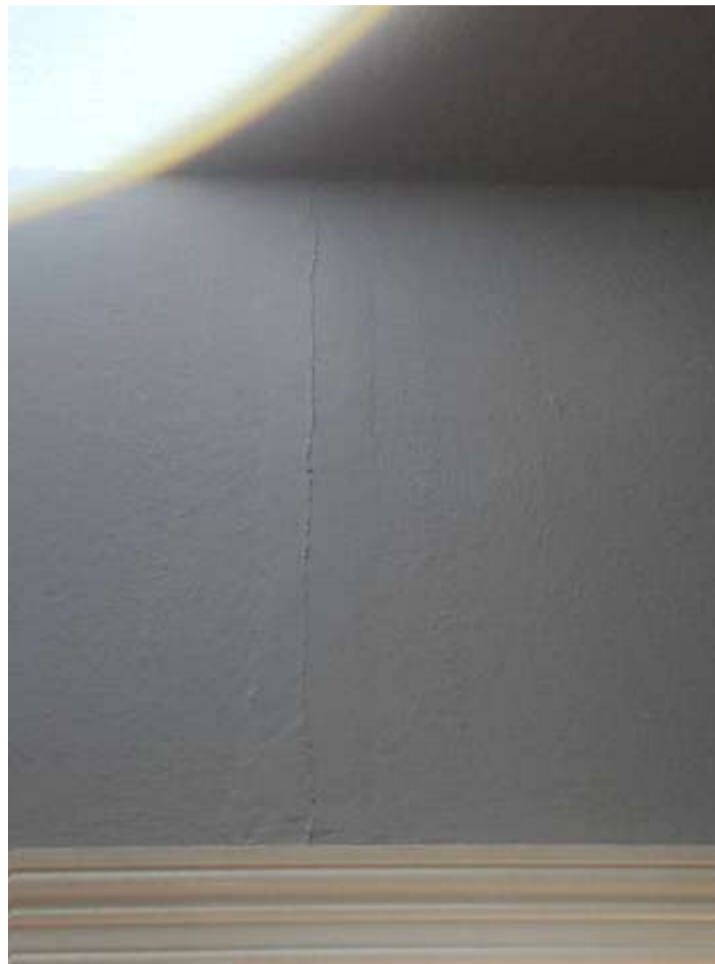
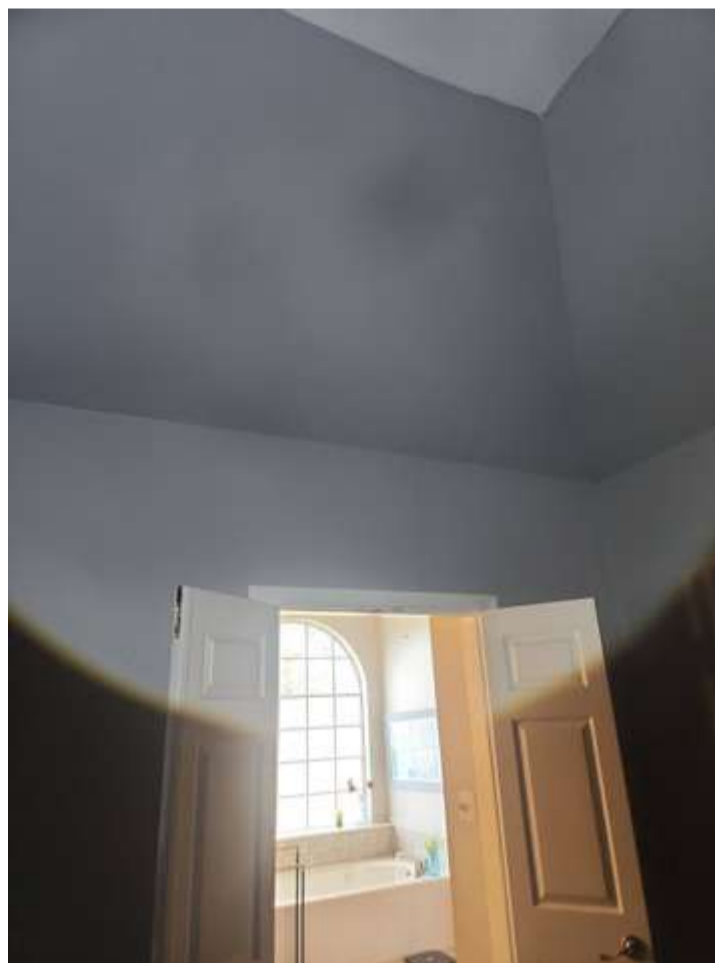
### Minor Wall Cracks

There is minor cracking on the wall / ceiling.

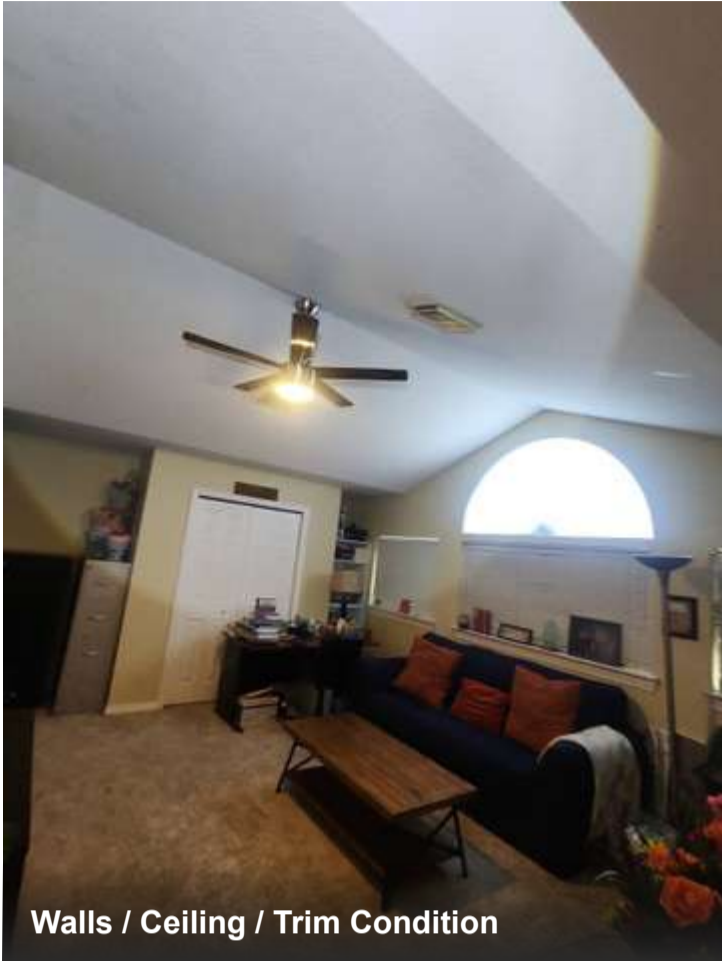
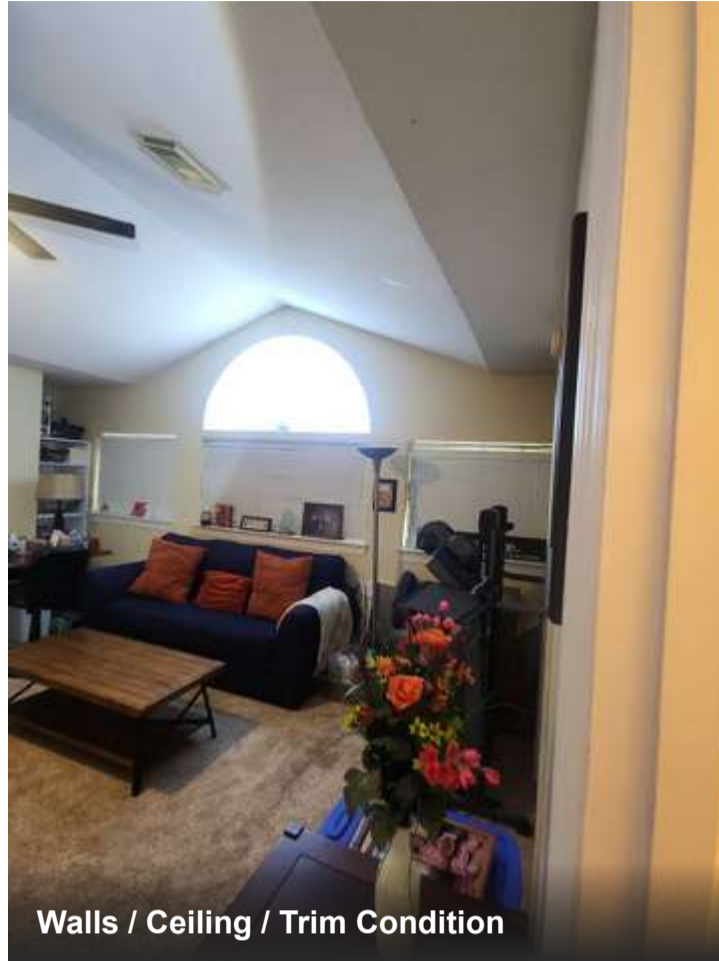
## Minor Wall Cracks

There is minor cracking on the wall / ceiling.

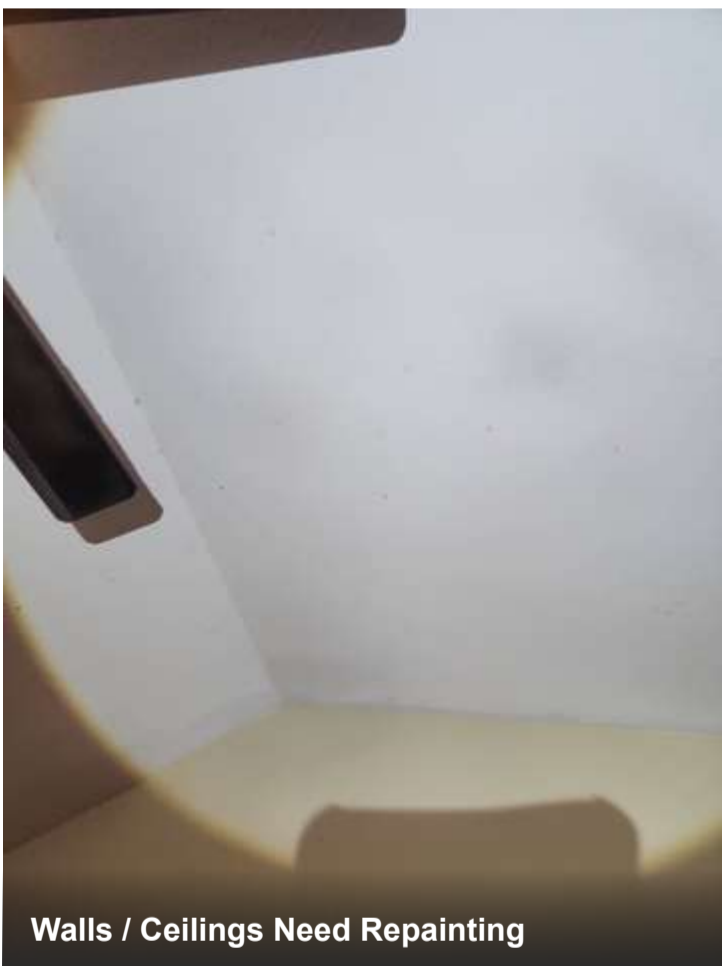
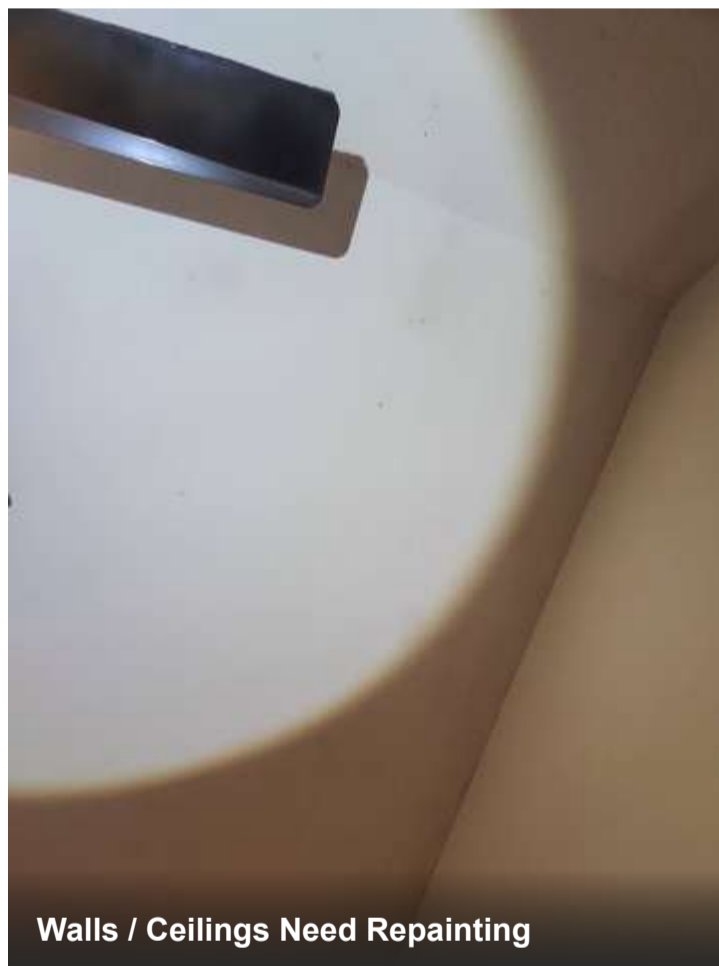
Walls / Ceilings Need Repainting

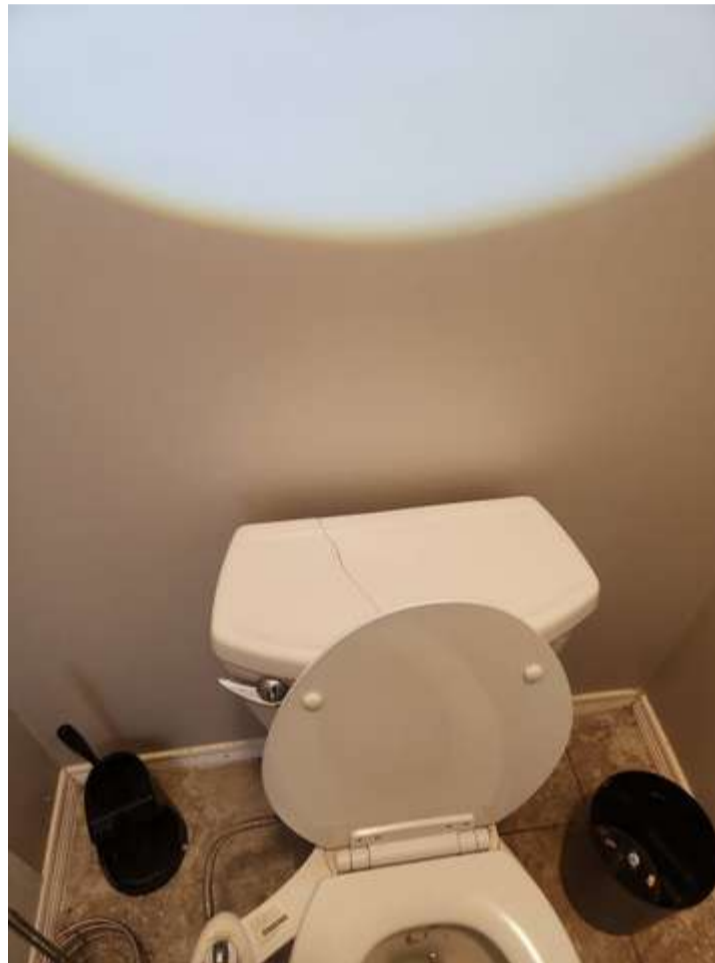
**Master, Bathroom**

### Cracked / Broken Toilet

The toilet is cracked, broken, or otherwise damaged.

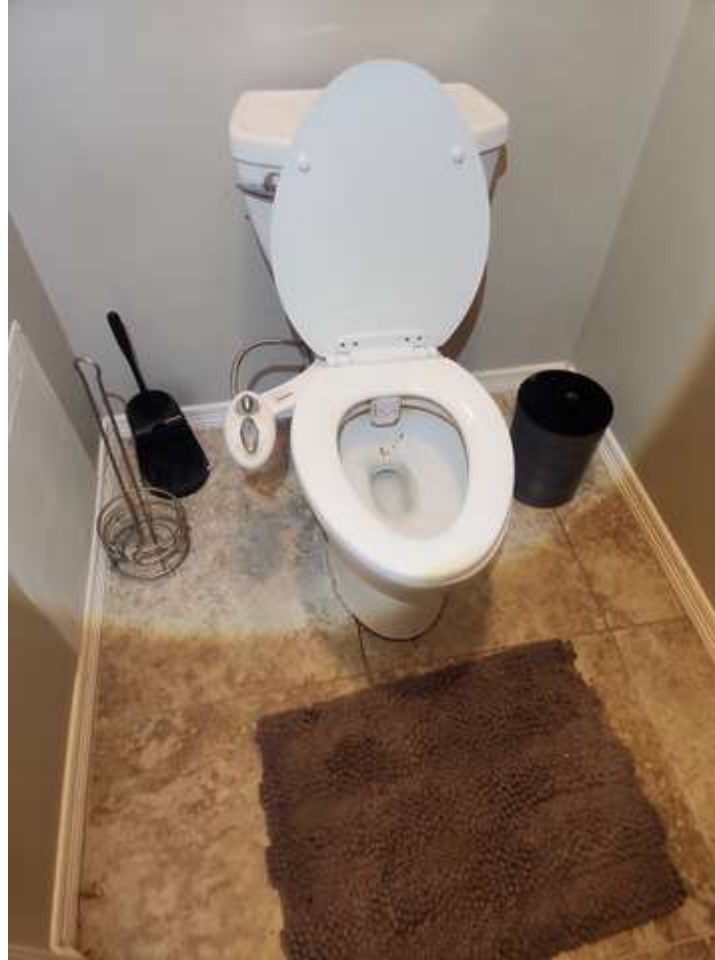
**Master, Bathroom**

### Loose Toilet

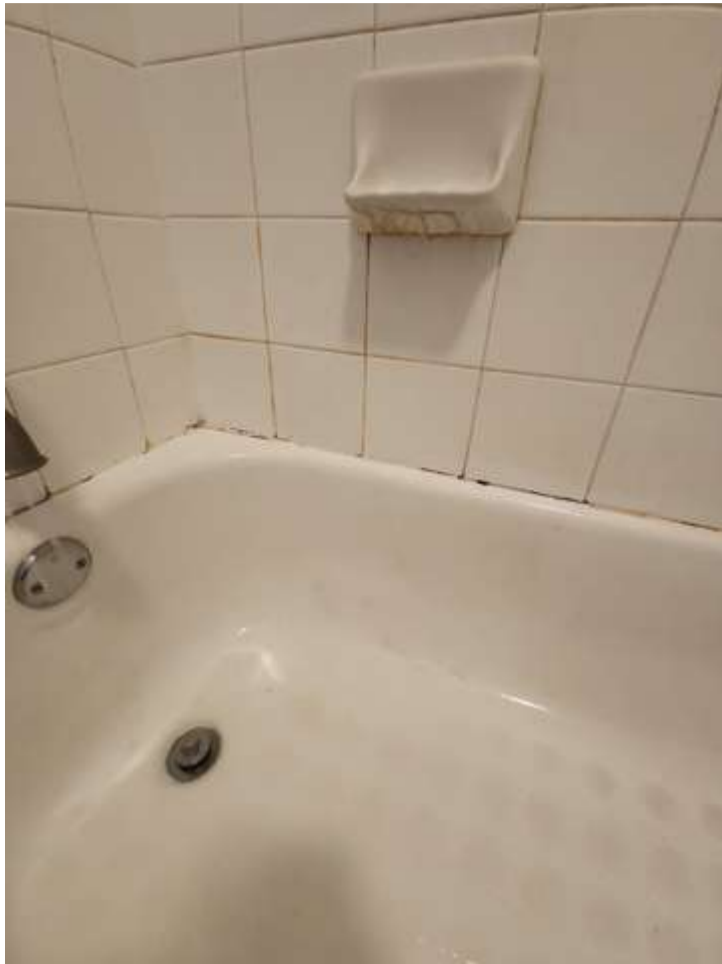
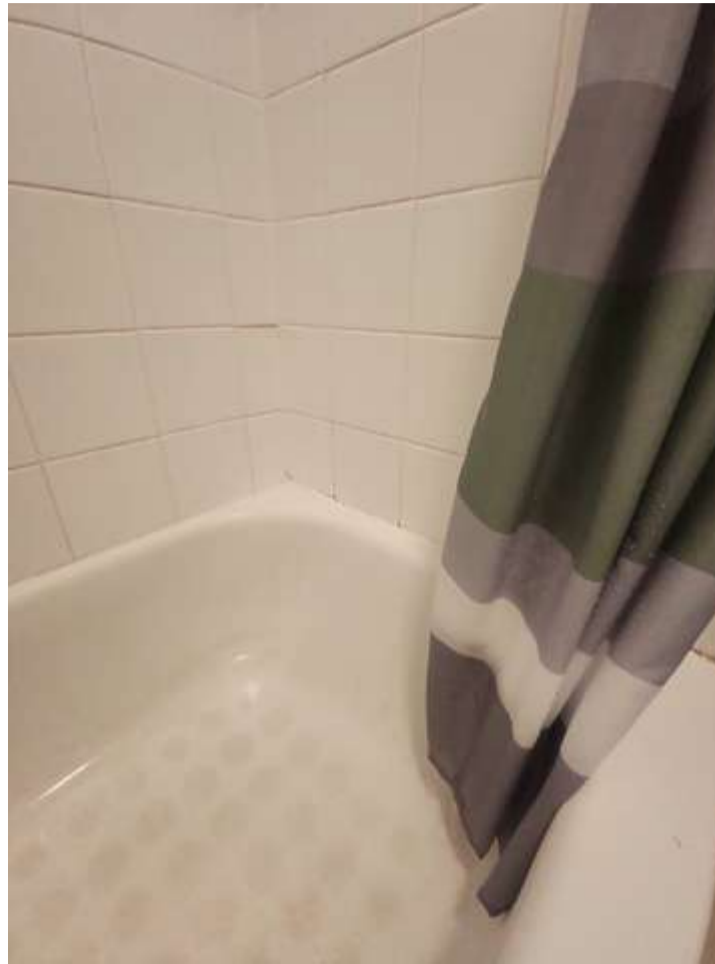
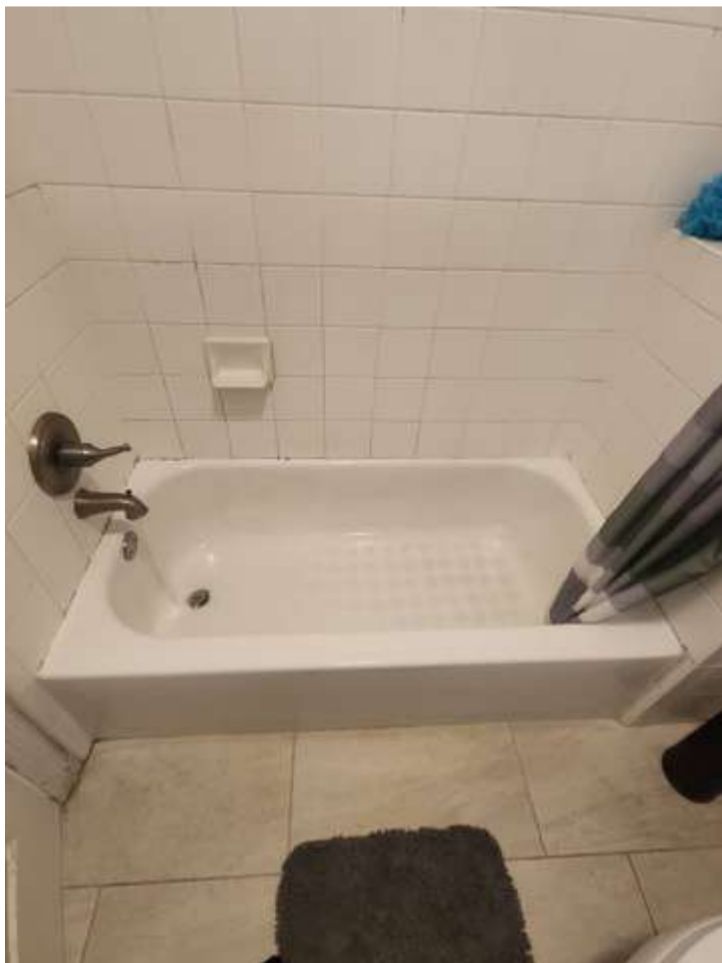
**1st Floor, Southeast, Bathroom**

### Deteriorated Caulking Around Tub / Surround

The caulking around the tub / surround has deteriorated.

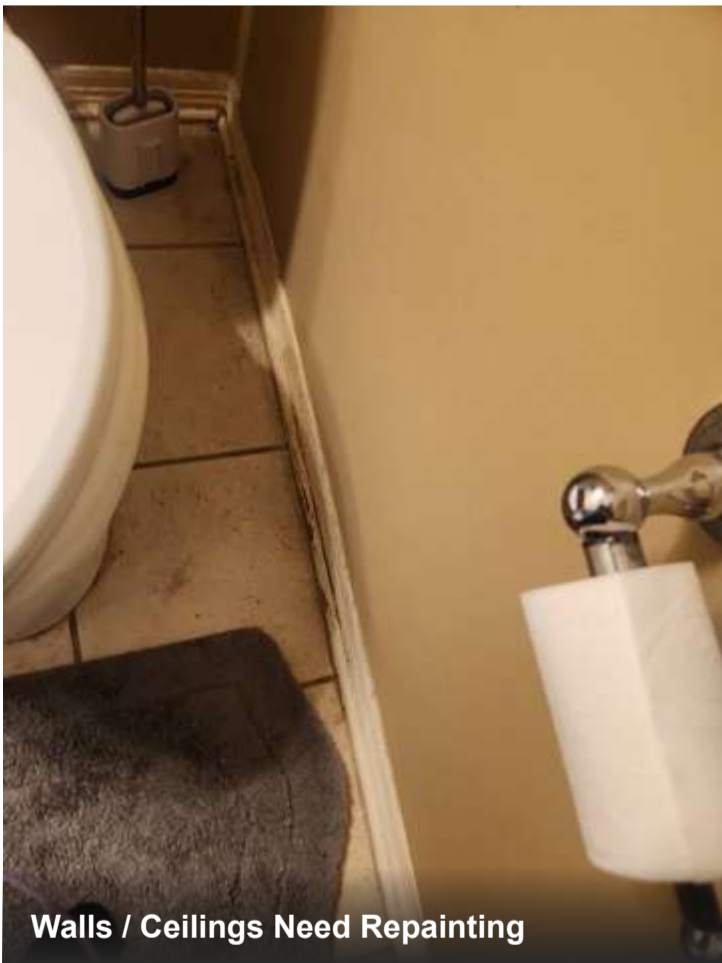
Walls / Ceilings Need Repainting

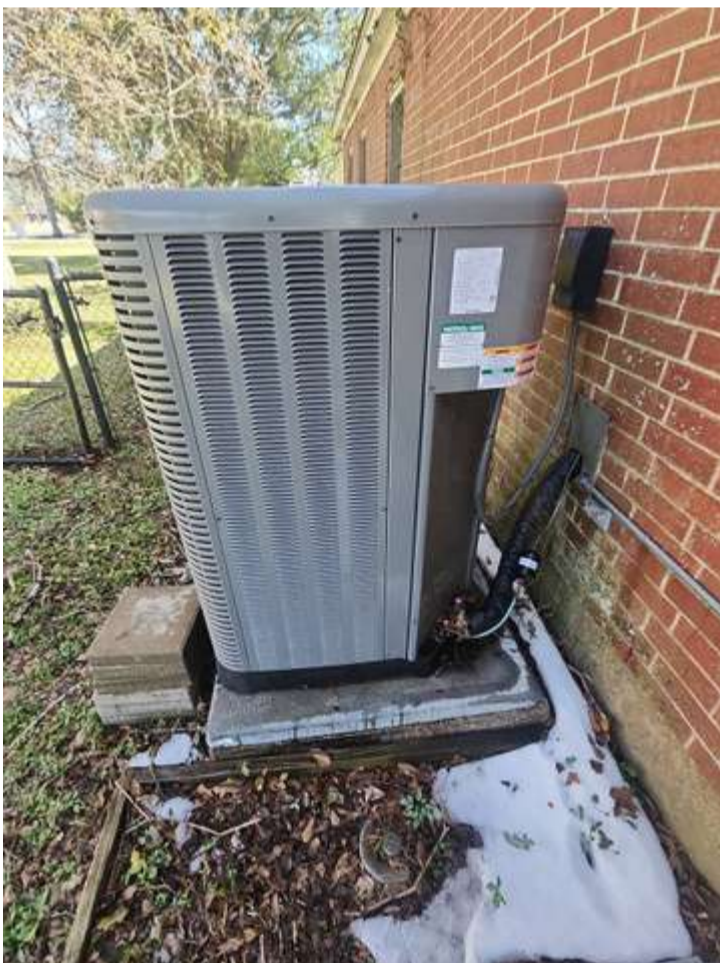
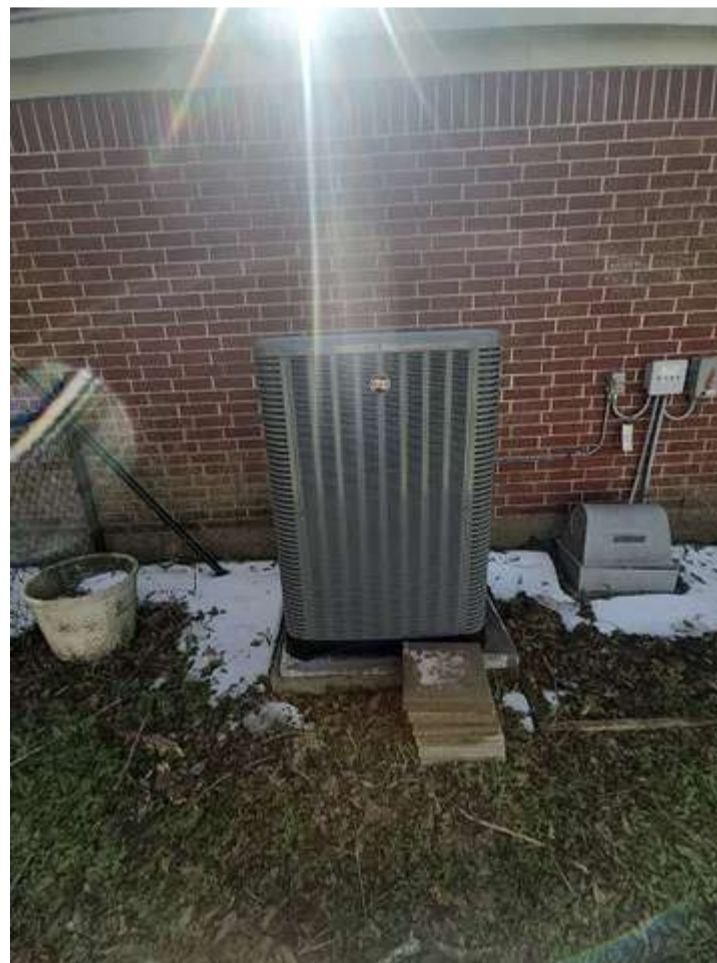
### Cooling Equipment Condition: Other

Below 60 degrees

Because the outside temperature was too cool to operate the air conditioner without the possibility of damaging the system, I did not operate the cooling system.

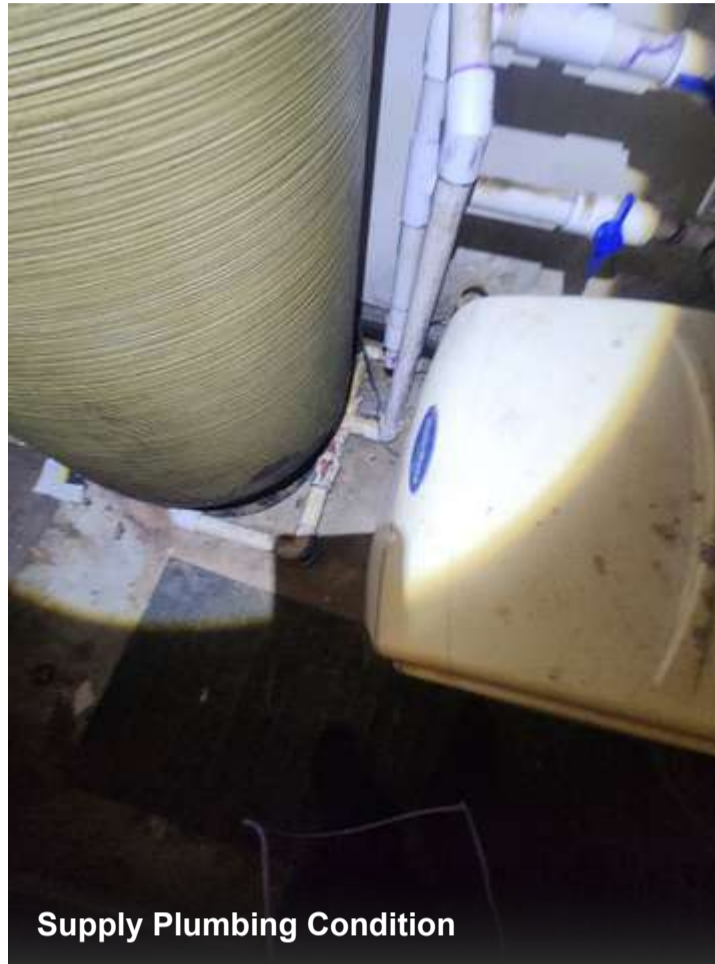
**Garage**

### Leaking Distribution Pipe

The distribution pipe is leaking.

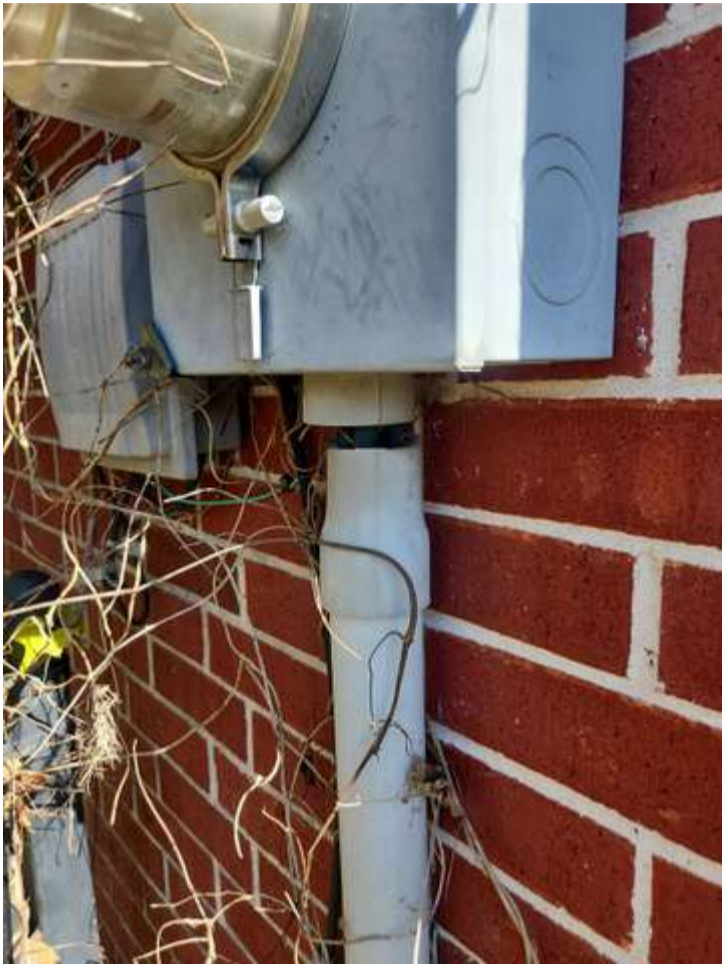
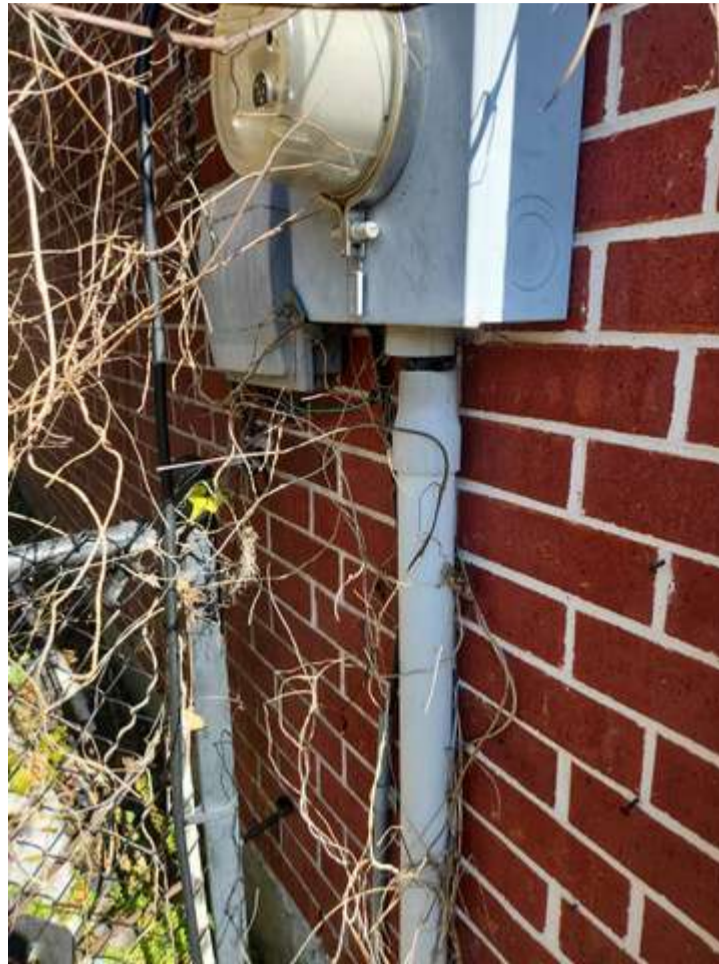
### Disconnected or Damaged Conduit

The conduit is disconnected or damaged.

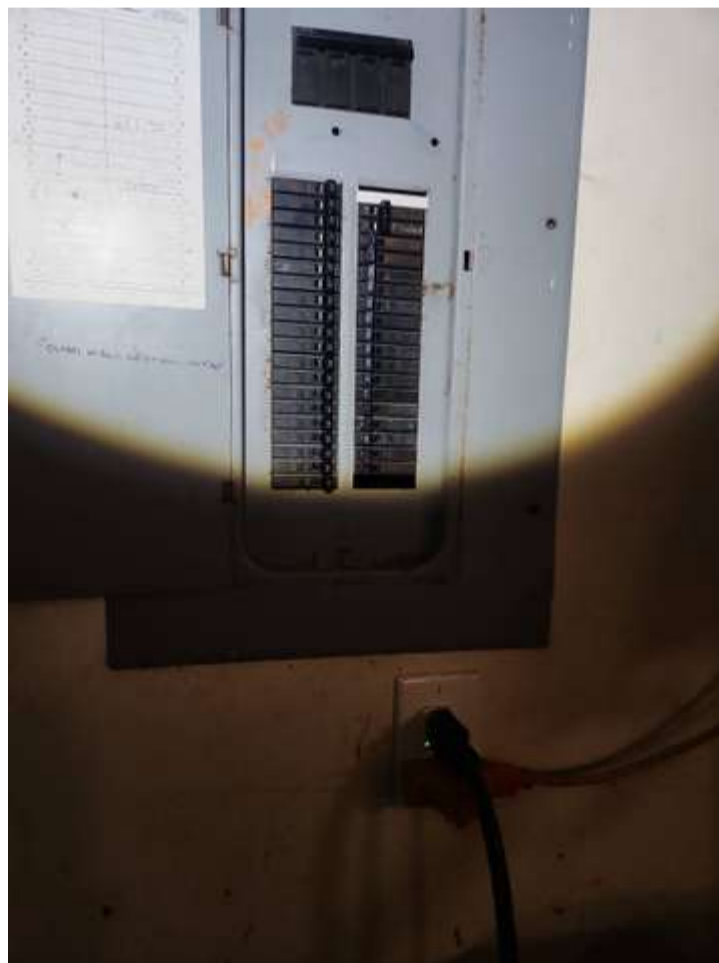
## Missing Electrical Panel Knockouts

The electric panel knockouts are missing.

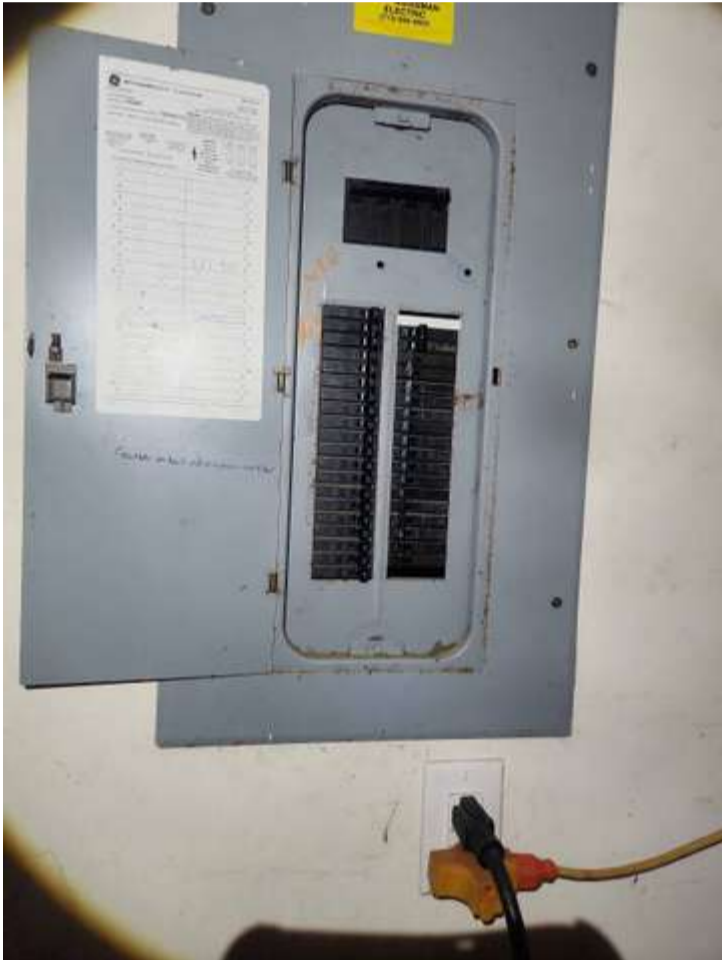
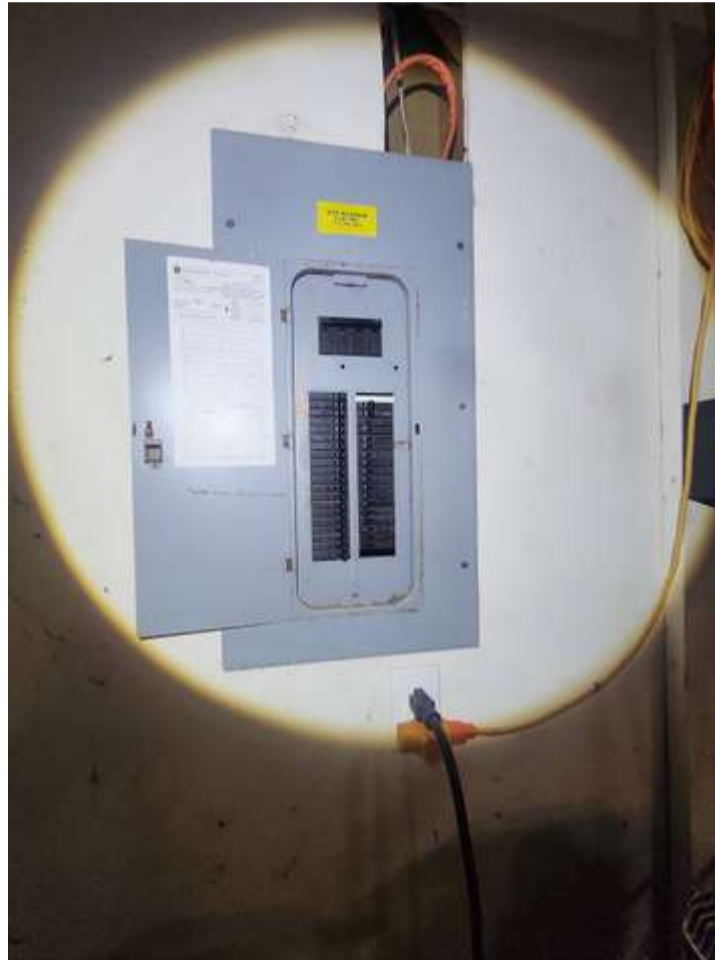
### Missing AFCI Breaker

A required Arc-Fault Circuit Interrupter is missing.

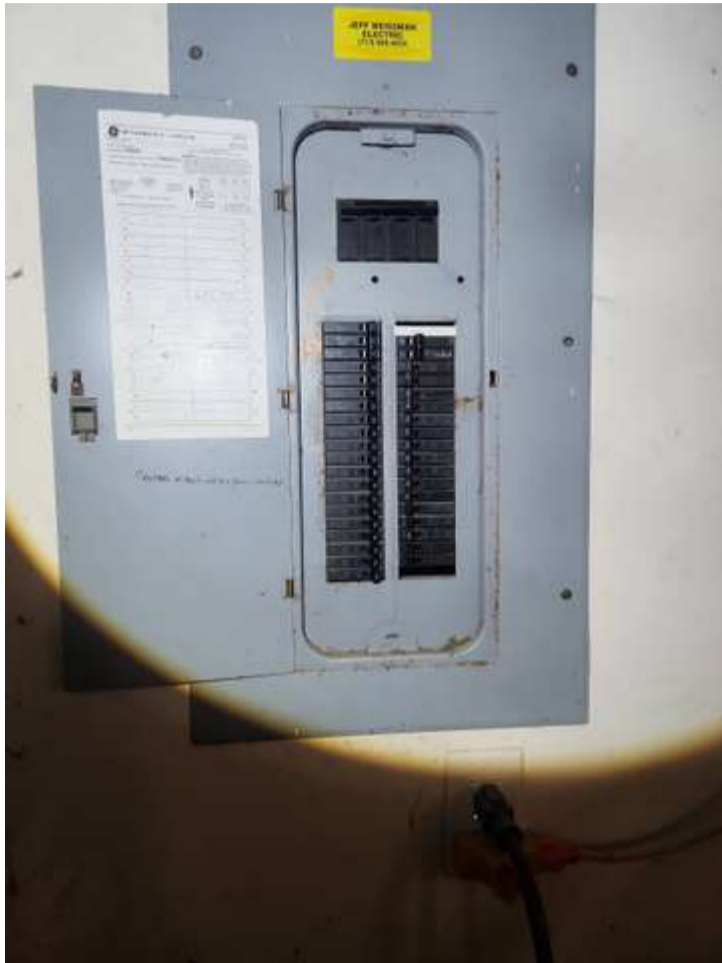
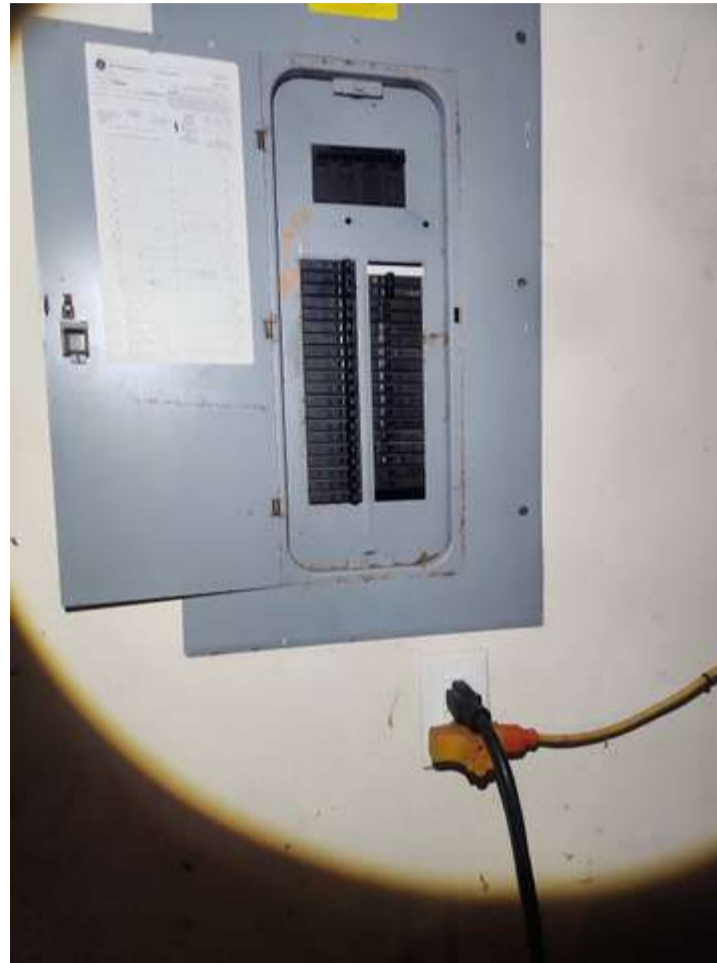
### Missing Surge Protection

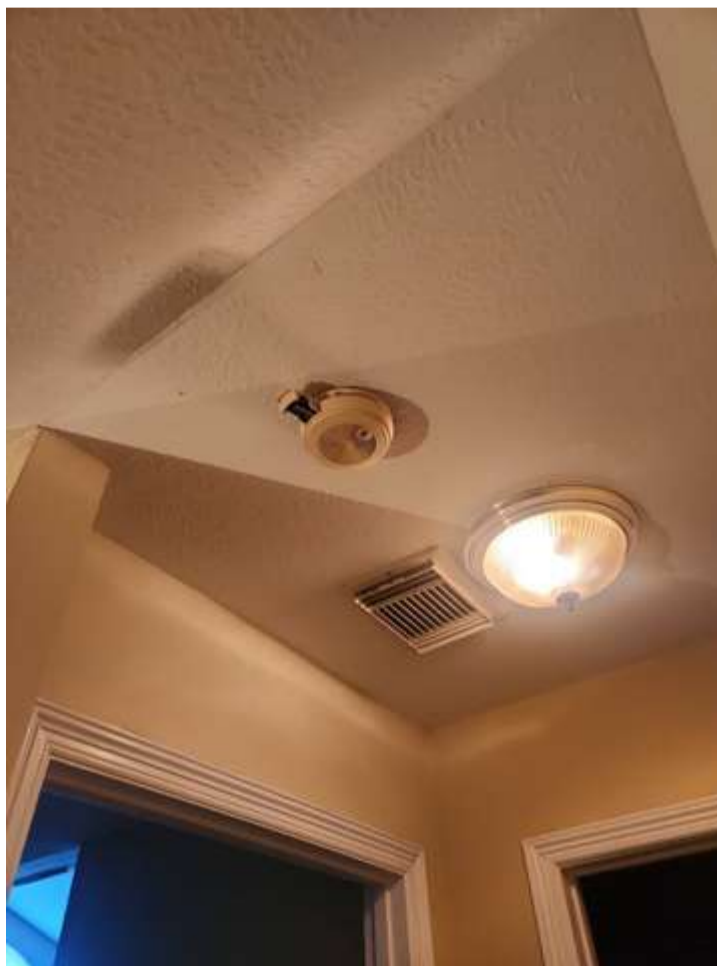
### Smoke Detector Batteries Missing / Needs Replacement

The smoke detector batteries are missing or need replacement.

**Noted at majority of smoke detectors**
