GC Home Inspection

PROPERTY INSPECTION REPORT FORM

John Settlemyre <i>Name of Client</i>	06/30/2025 <i>Date of Inspection</i>
113 Plum Cir, Lake Jackson, TX 77566 <i>Address of Inspected Property</i>	
Chad Gregory Langston Jr. <i>Name of Inspector</i>	25839 <i>TREC License #</i>
Chad Langston <i>Name of Sponsor (if applicable)</i>	7946 <i>TREC License #</i>

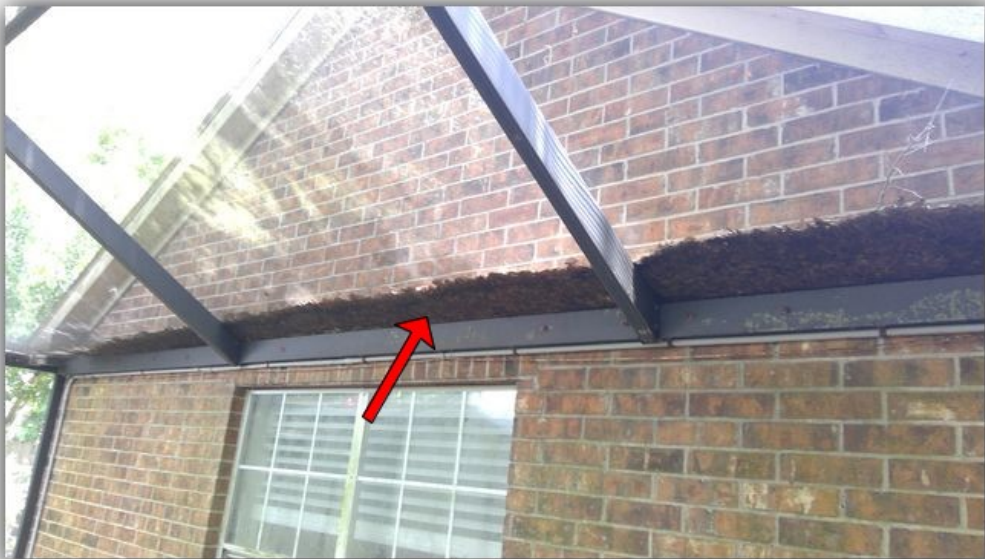
Debris should be removed from the roofing.

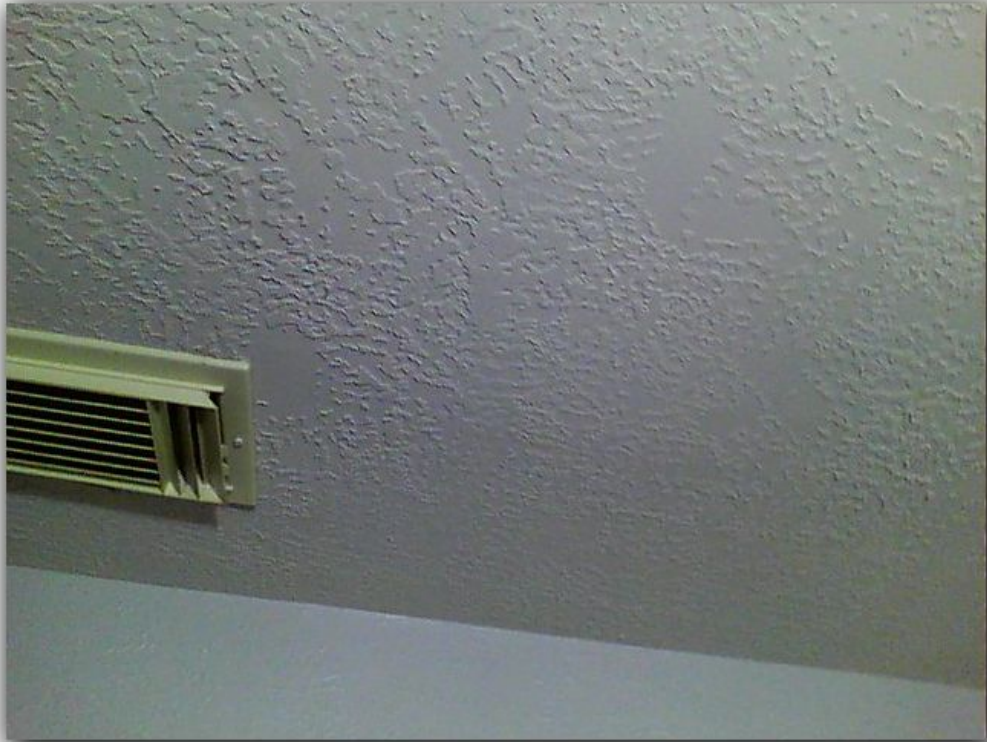
Water stains were noted on the ceiling in the in the study.

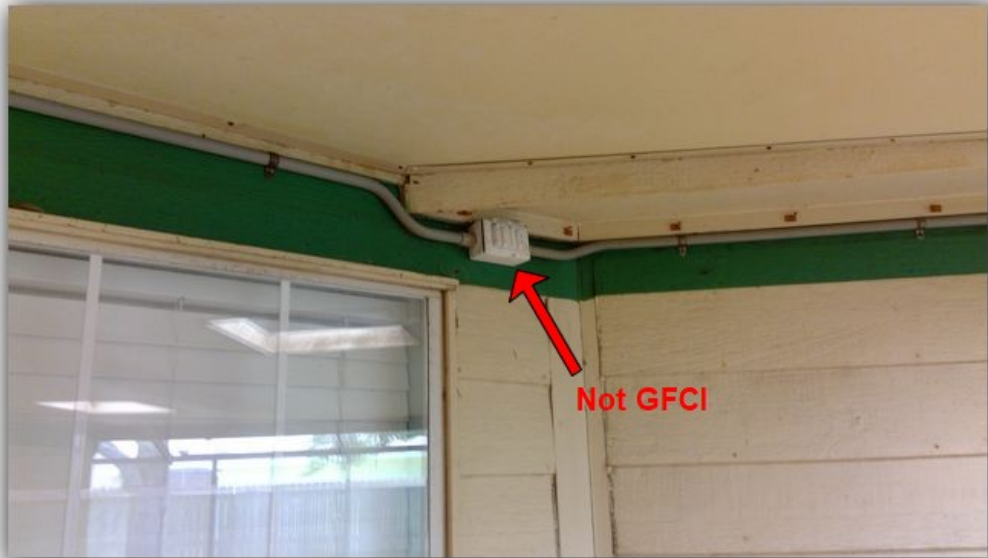
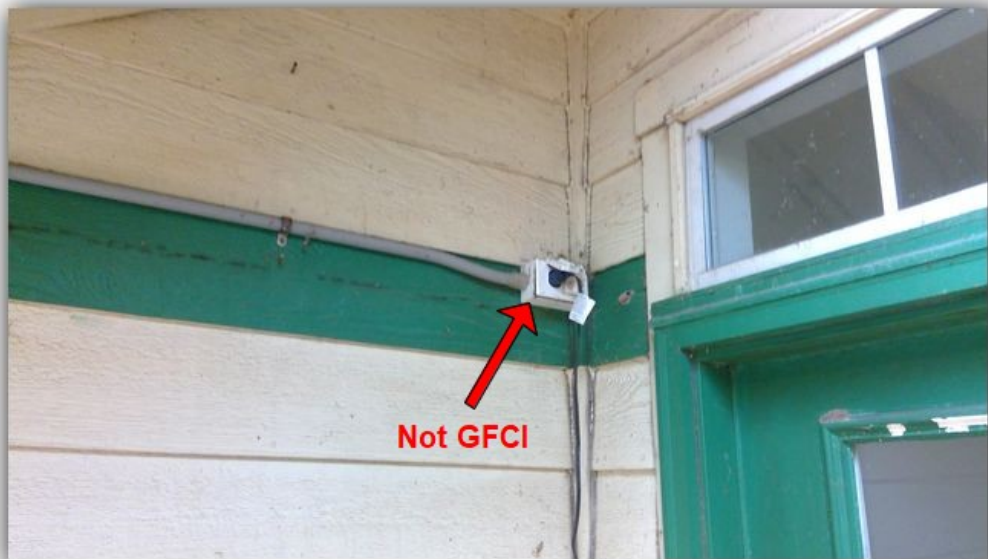
The weather cap on the exterior outlet on the rear elevation is missing and should be replaced.
